An Investigation of Improving Wear of 390 Die-cast Aluminum Through Hardcoat Anodizing

AN INVESTIGATION OF IMPROVING WEAR OF 390 DIE-CAST
ALUMINUM THROUGH HARDCOAT ANODIZING

Master of Science

Department of Mechanical Engineering

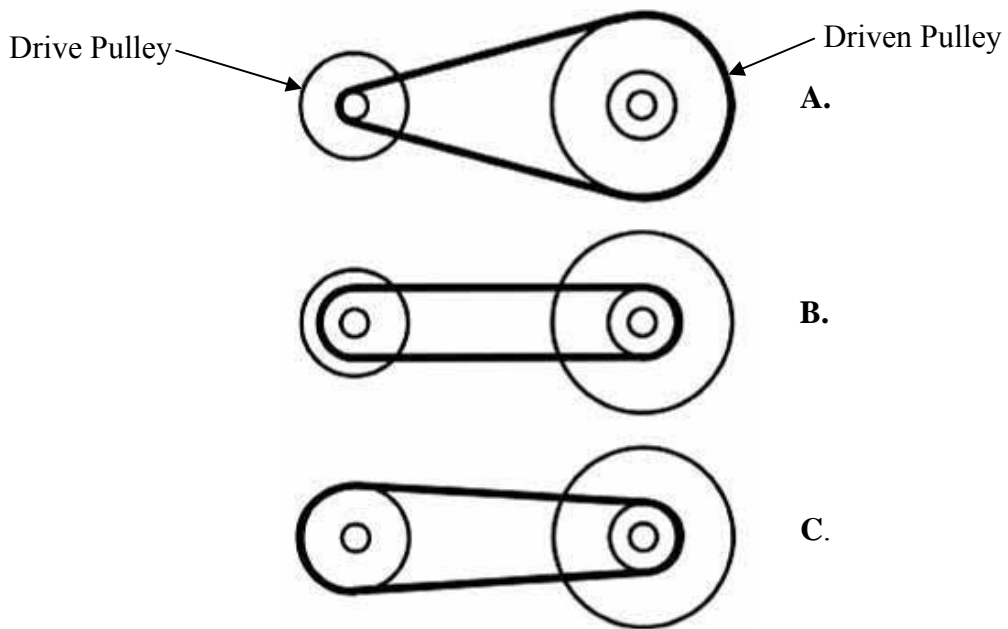
Figure 1.4 Schematic of the various locations of the belt for a running CVT A) Idle or Engagement B) Intermediate C) Overdrive

sheaves against the belt, Figure 1.4 A. The belt begins to rotate initiating the rotation of the driven pulley. As the drive pulley's speed increases the sheaves squeeze the belt up the sheave face, increasing the pulley's pitch diameter, Figure 1.4 B. The belt continues to move up and down the sheave face in relation to the driven resistance torque or the driven pulley RPM, Figure 1.4 C. This is the reason that a CVT is a transmission. It has the ability to automatically change drive ratios according to the requirements of the system.

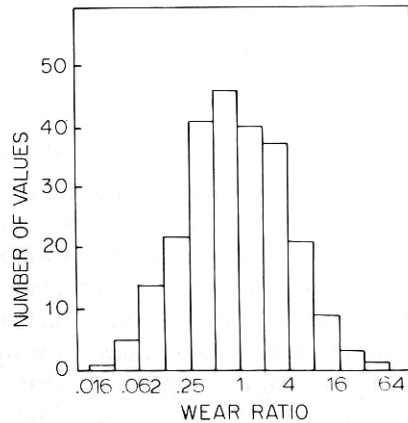
Figure 2.6 Histogram showing the distribution of measured wear coefficients from [Rabinowicz 1980]

Rabinowicz also comments on and tests the reliability of tabulated wear coefficient values [Rabinowicz 1980]. These tests were of 240 sliding systems including metals, lubricants and other variables. For each system, the measured wear coefficient was computed and then compared to the tabulated wear coefficient values. A ratio of the measured value to the tabulated value ($k_{\text{measured}}/k_{\text{table}}$) was calculated to find any correlations between the values. Rabinowicz shows the results of this study in the histogram seen in Figure 2.6.

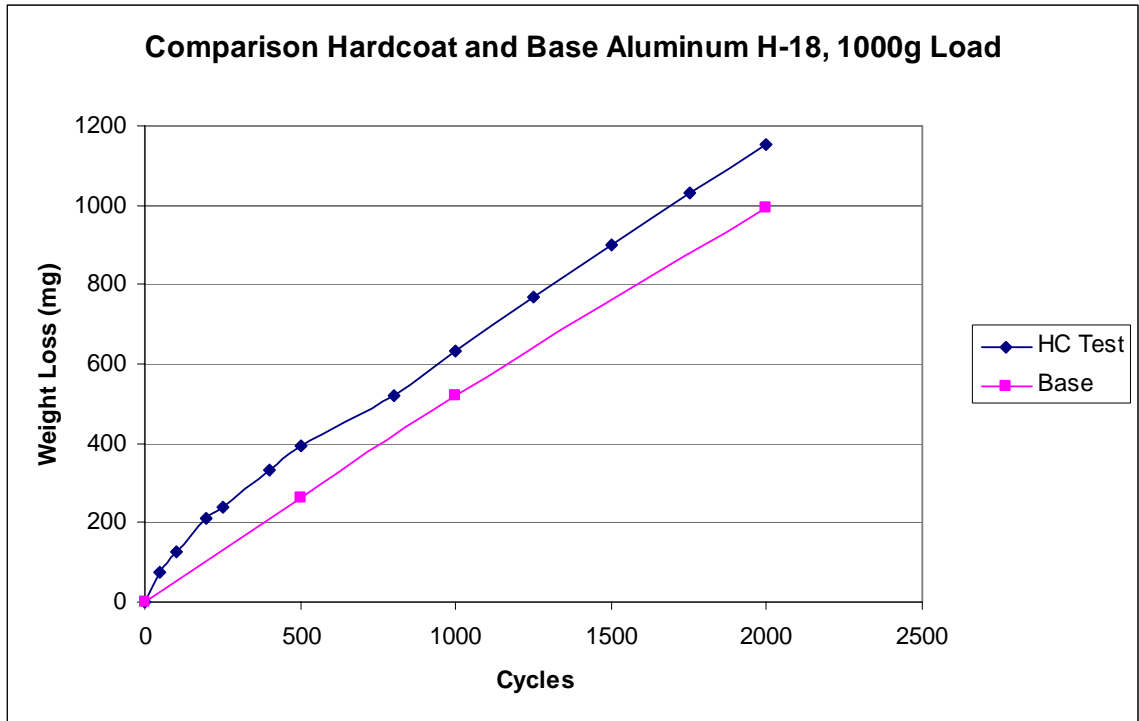
Figure 4.7 Comparison of the Hardcoat anodized and Base aluminum Taber samples using an H-18 wheel-set under 1000g load.

When the data was compared and the graphs overlaid it was evident that the Hardcoat anodized sample wore more significantly than the base aluminum under the Taber test conditions used, refer to Figure 4.7. Initially the Hardcoat anodized surface wore at a higher rate, but tapered off and the wear rate became nearly linear. It was noted that the linear portion of the Hardcoat anodized wear curve (cycles 800-2000 cycles) was nearly parallel to the base aluminum wear curve. The parallel lines were an indication that the Hardcoat anodized surface had in-fact worn through and the substrate material is now the wearing surface.

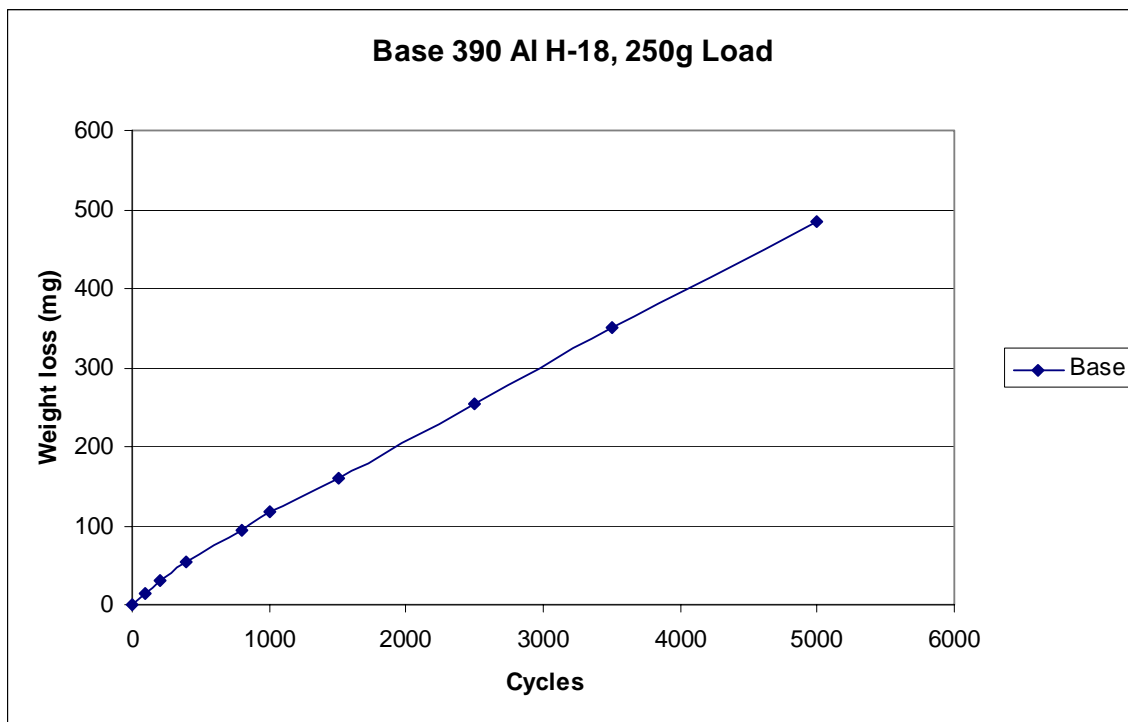
Figure 4.8 Graph showing the wear of the base aluminum under a 250g load using H-18 wheel-set

The base aluminum was first tested under the 250g load and it was quickly evident that the amount of wear occurring was significantly lower from the first round of tests, Figure 4.8. More weight measurements were taken during this round of testing to indicate any nonlinear changes in the wear rate. As was seen from the data in Figure 4.8, the wear rate was still nearly linear, indicating that loading of the wheels was not a significant factor at the 250g weight under these test conditions.

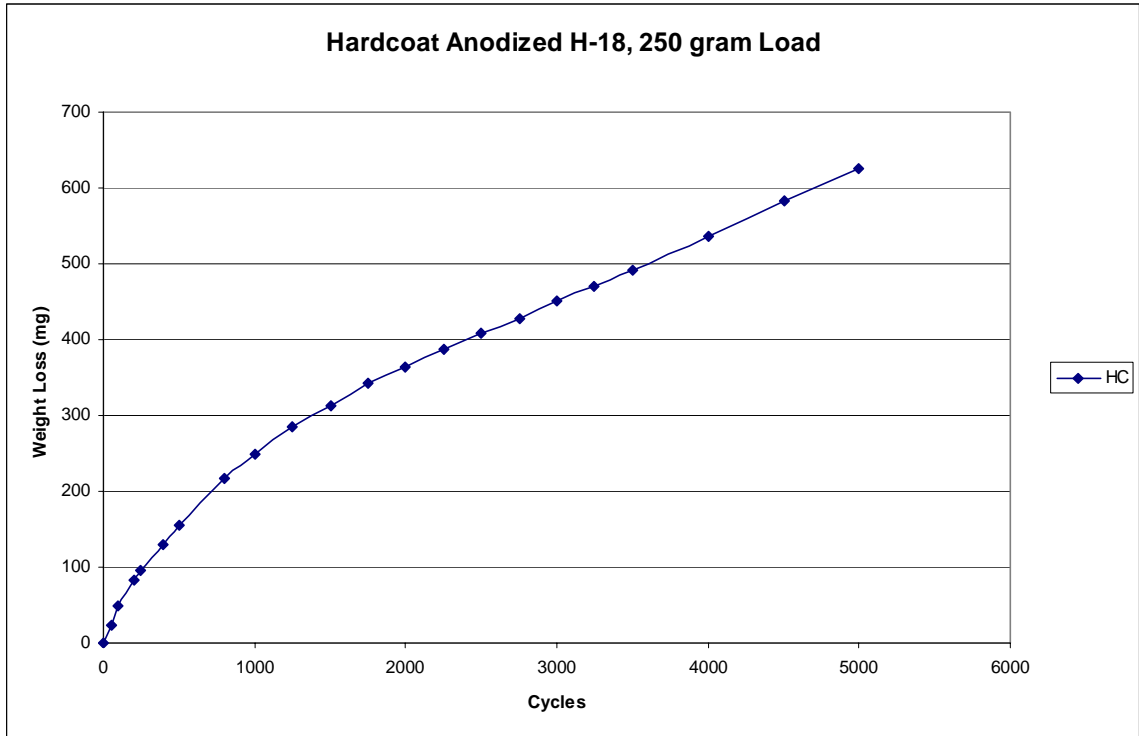
Figure 4.9 Graph indicating the wear rate of the Hardcoat anodized surface under 250g load using an H-18 wheel set.

The Hardcoat anodized sample was tested next to find its wear rate. A similar trend to the previous test was noticed when compared to the first round of testing, in that the wear rate of the Hardcoat anodized sample initially wore at a higher rate then began tapering off, trending toward linear, Figure 4.9. In both the first and now this round of tests, the trends were similar, although the magnitudes of the total wear were different.

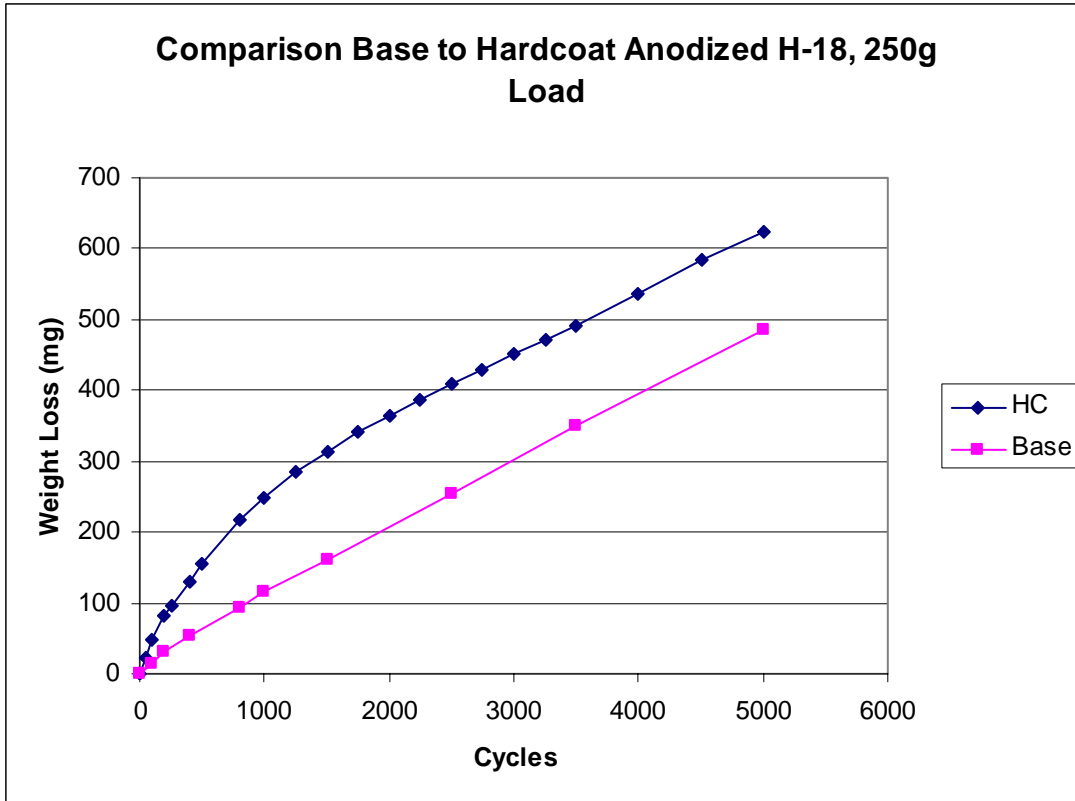
Figure 4.10 Graph showing a comparison between tests on the base aluminum and the Hardcoat anodized aluminum under a 250 gram load using an H-18 wheel set.

When the data was overlaid, it showed that the change in load did not have a significant effect on the relative wear rate difference (see Figure 4.10).

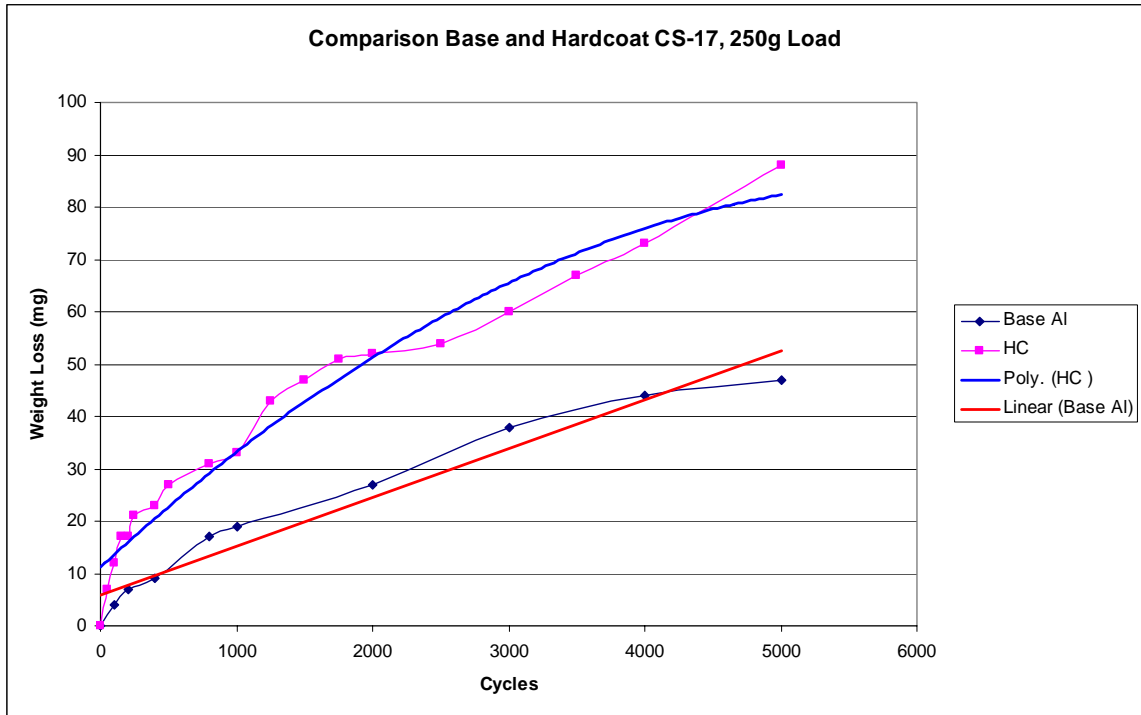
Figure 4.13 Chart showing a comparison between Base 390 and Hardcoat surfaces under 250g load using CS-17 wheel sets. The trendlines indicate that the wear rates are similar in pattern to previous comparisons shown.

Comparing the two sets of data, there was a similar trend to previous testing (Figure 4.13). The wear rate of the Hardcoat anodized sample began at a higher rate and tapered off to nearly linear (2500-3000 cycles).

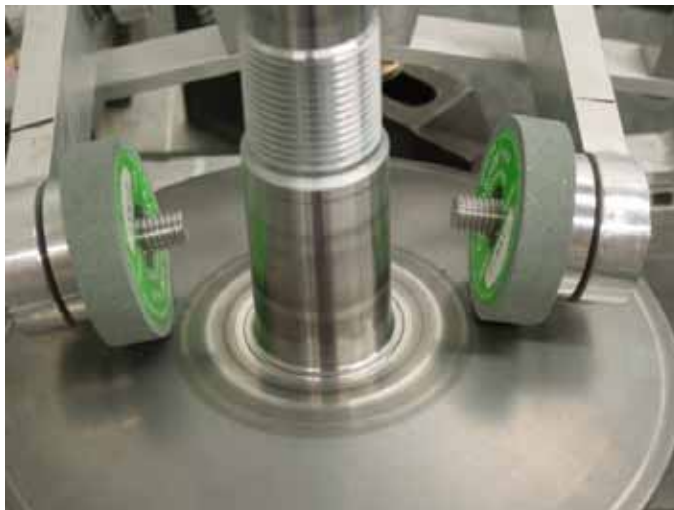
Figure 4.14 Figure showing abrasion test stand based off the Taber Abraser design. The two arms were at the same angle as the sheave surface allowing the wheels to rest normal to the surface.

In order to understand the influence of the test sample processing on the wear data, a special abrasion test stand was constructed based off the Taber Abraser test stand. This test stand used the same principles as the Taber Abraser by scuffing the Taber wheel sets as the sample disk rotated, but the wheels were set at an angle so they contacted the sheave normal to the surface.

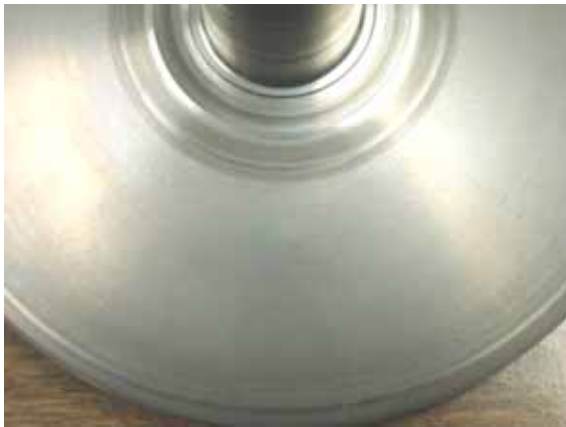
Figure 4.15 Image of the stationary sheave off the stock drive clutch.

The stock drive clutch ran for a distance of 1076 miles before being removed and inspected. As seen in figures 4.15 and 4.16 there was a darkened ring near the outer diameter of both the stationary and movable sheaves. This coloration indicates that the belt spent a considerable amount of running time in this location relative to the rest of the sheave. Also visible was a similar darkened ring near the inner diameter on the stationary sheave. Faint rings in the same region were visible on the movable sheave, but were not nearly as pronounced. The belt rubbing against the stationary sheave surface during idle caused this inner ring. The movable sheave would fully disengage (not contact) the belt during idle thus the full slip condition caused the difference in appearance. There were a number of small scratches on both sheave surfaces in a radially outward direction. These scratches were an indication of dust or other particles caught between the belt and sheave.

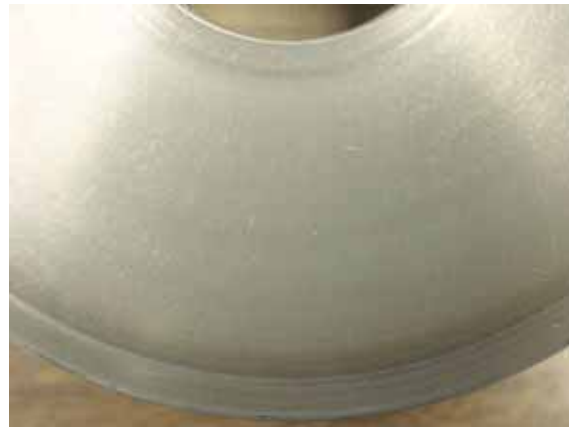
Figure 4.16 Image of the movable sheave surface of the stock drive clutch

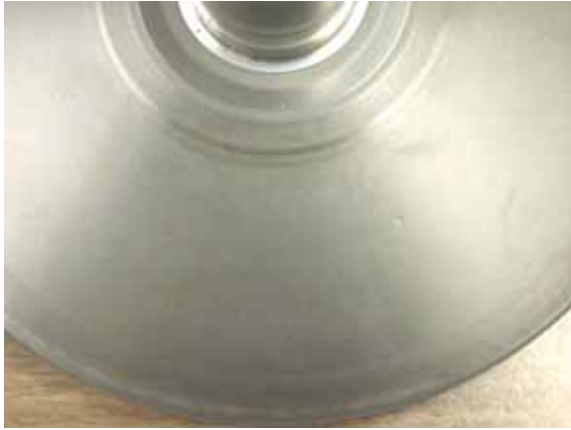
Figure 4.19 Image of the Hardcoat anodized stationary sheave.

sheave. A faint line of base aluminum was evident in the outer ring on the stationary sheave.

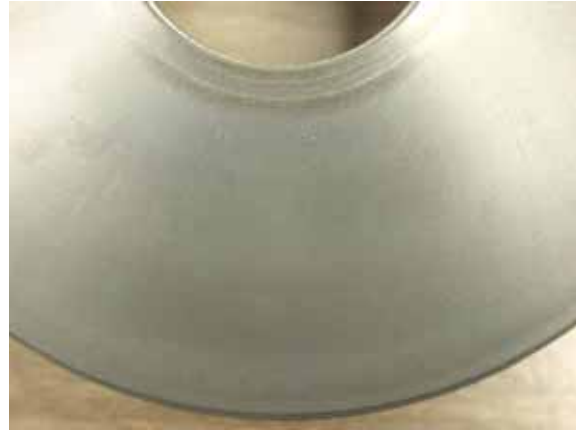
Figure 4.20 Image of the Hardcoat anodized movable sheave.

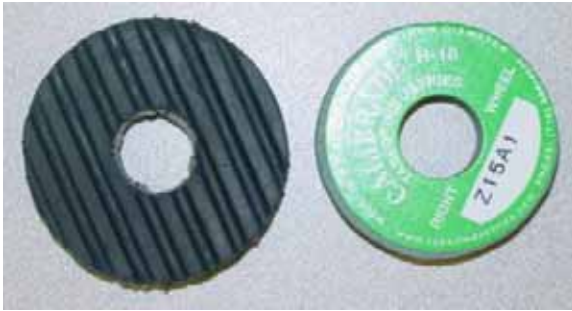
Figure 4.23 Image of composite rubber belt wheel (left) cut from V-belt material, used on Modified Taber Test Stand.
