Delineation of mass movement prone areas by Landsat 7 and digital image processing

DELINEATION OF MASS MOVEMENT-PRONE AREAS BY LANDSAT 7 AND
DIGITAL IMAGE PROCESSING

Master of Science

Department of Geology

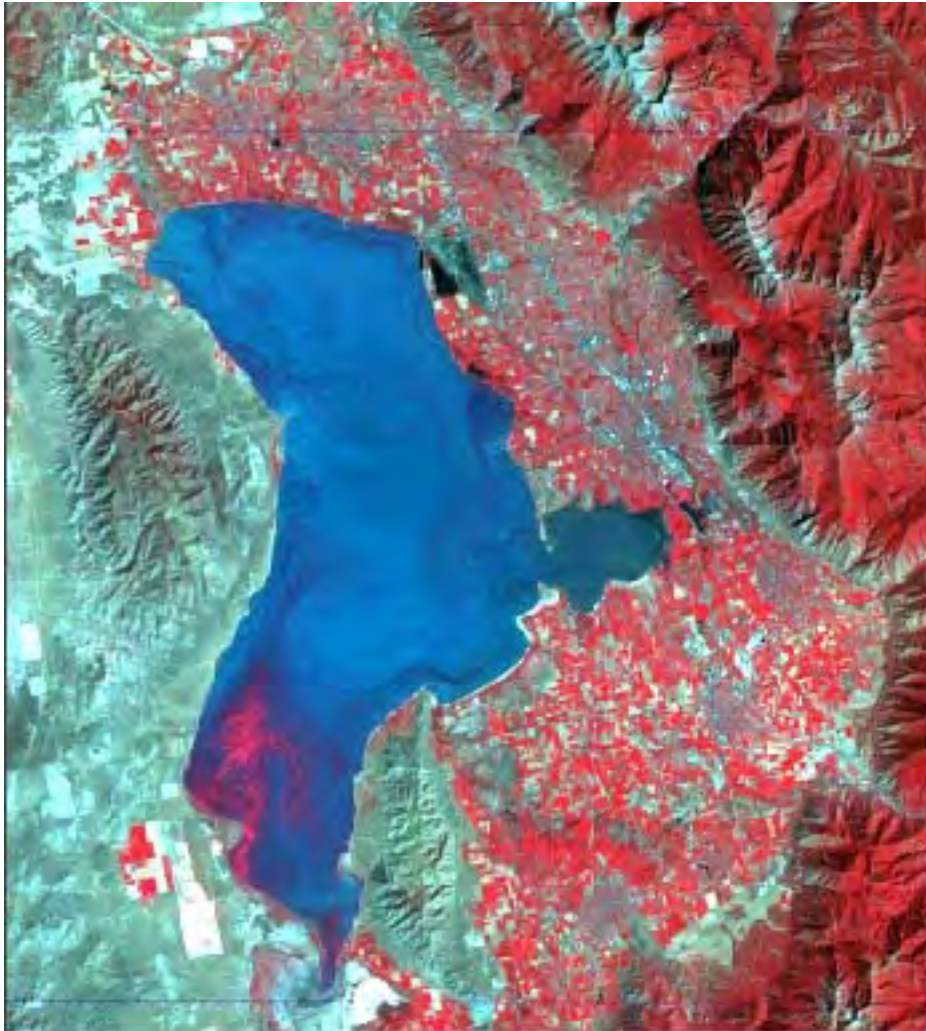
Figure 1: Landsat-7 ETM+ subset image of Utah Valley, May 28, 2000. Near infrared (band 4) shown in the red plane, red (band 3) shown in the green plane and green (band 2) shown in the blue plane.

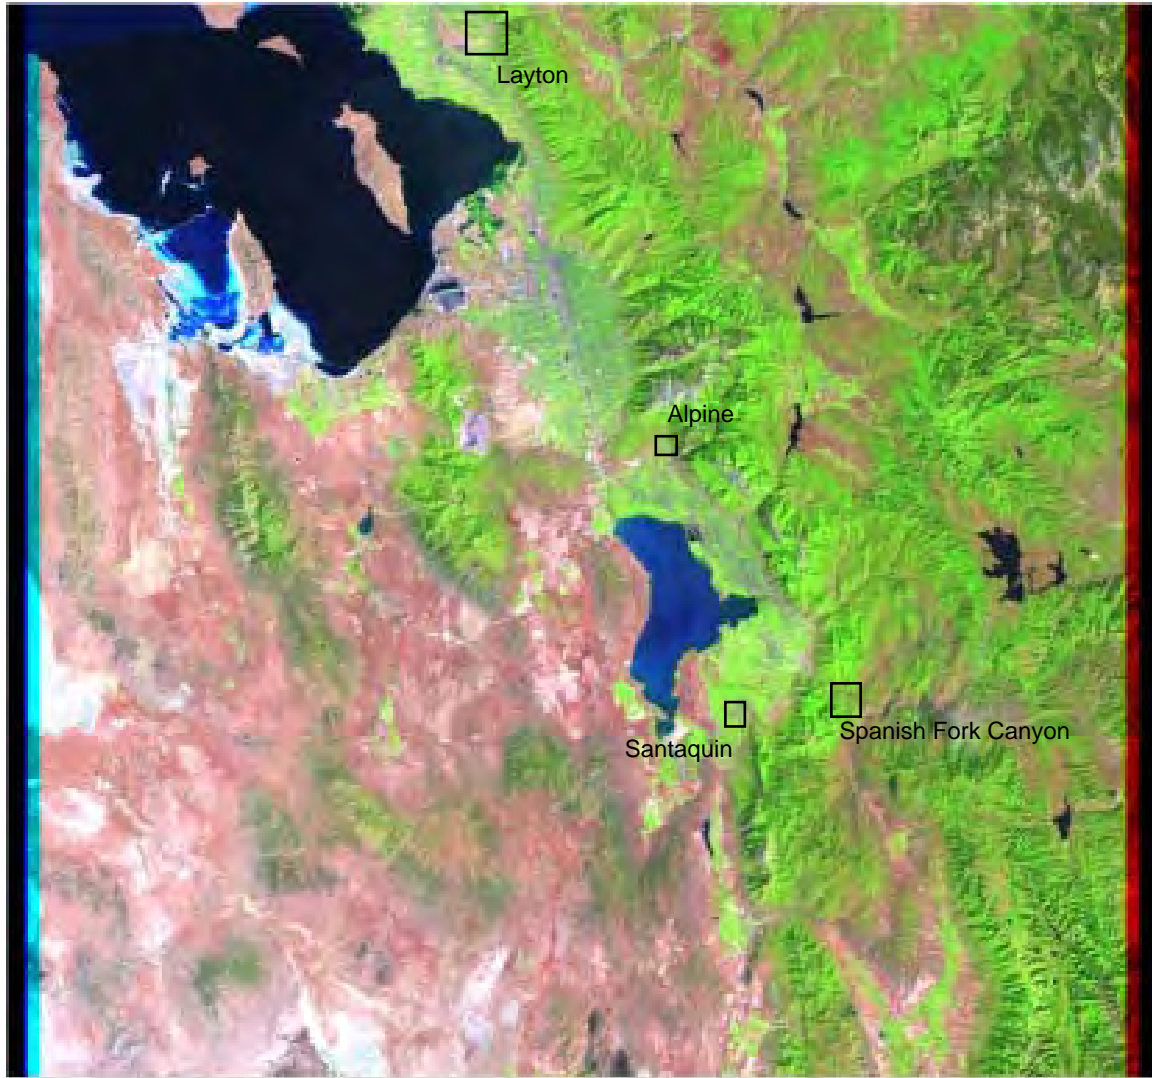
Figure 2: The study areas for this research - Landsat 7 scene, path 38, row 32, May 28, 2000. The image is displayed as 7, 4, 2; middle infrared (band 7) in the red plane, near infrared (band 4) in the green plane and green (band 2) in the blue plane. The four study areas are marked.

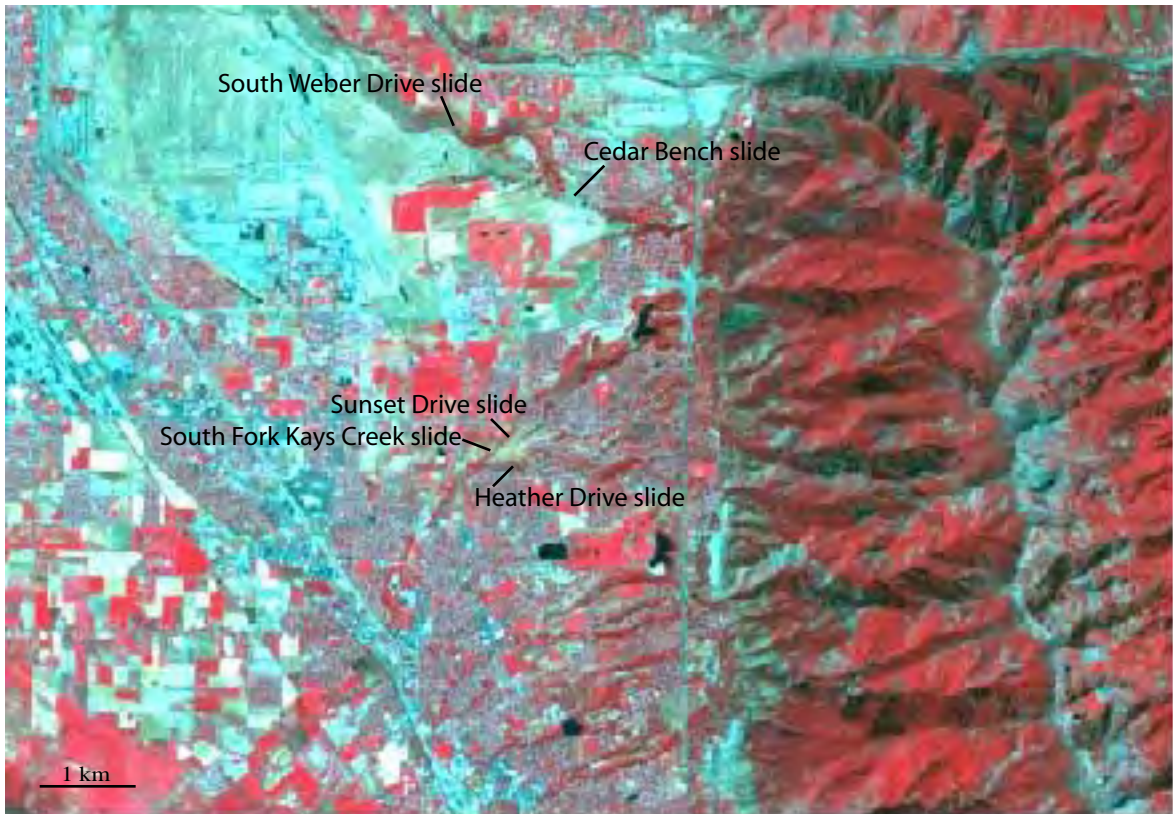
Figure 3: Landslides (1998-2001) of the Layton and South Weber area. The image was taken on May 28, 2000 and is displayed as bands 4, 3, 2.

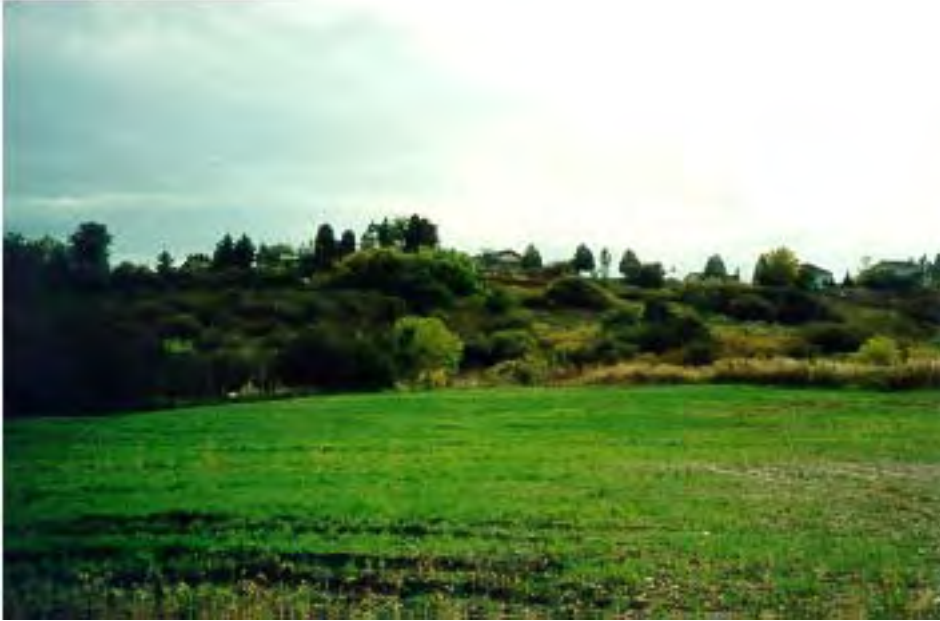
Figure 6: The Heather Drive landslide; houses remaining on Heather Drive are visible at the top of the bluff. The landslide itself is mostly revegetated and not clearly visible.(August 2002)

Heather Drive. The Heather Drive landslide in Layton moved as early as August 1998 when homeowners had to repair driveways and noticed foundation cracks (Figure 6). Movement continued at a slow rate until late August 2001 when it failed rapidly (Giraud, 2002b). This landslide is unusual because it continued in late summer during a year with below-average precipitation. The Heather Drive landslide was the only Layton landslide to occur in 2001. The scarp (410 m long and 3 m high) follows an arcuate crest which was interpreted as a reactivation of a previous landslide (Giraud, 2002b).

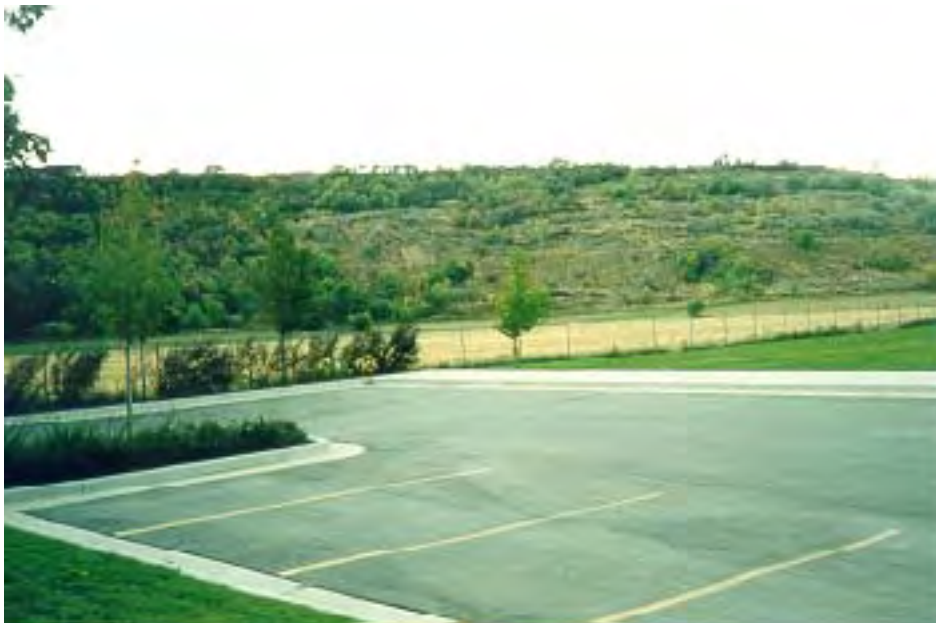
Figure 7: The South Weber Drive landslide visible as small scarps in the slope. (July 2002)

South Weber Drive. The 1998 landslide occurred on the eastern edge of South Weber landslide complex which is a zone of prehistorical and historical landsliding (Figure 7). The entire slope moved in spring 1984. The 1998 slide occurred in a zone of slumps and slides about 75 m long and 360 m wide. The scarp was up to 1.8 m high and all movement appeared to be shallow and did not affect the Davis-Weber canal (Black, 1998). Black noted that landsliding began due to marginal slope stability and elevated groundwater levels, but the exact cause for movement is still unclear. Precipitation in the area in January and February of 1998 was 200% of normal precipitation (Giraud, 1998).

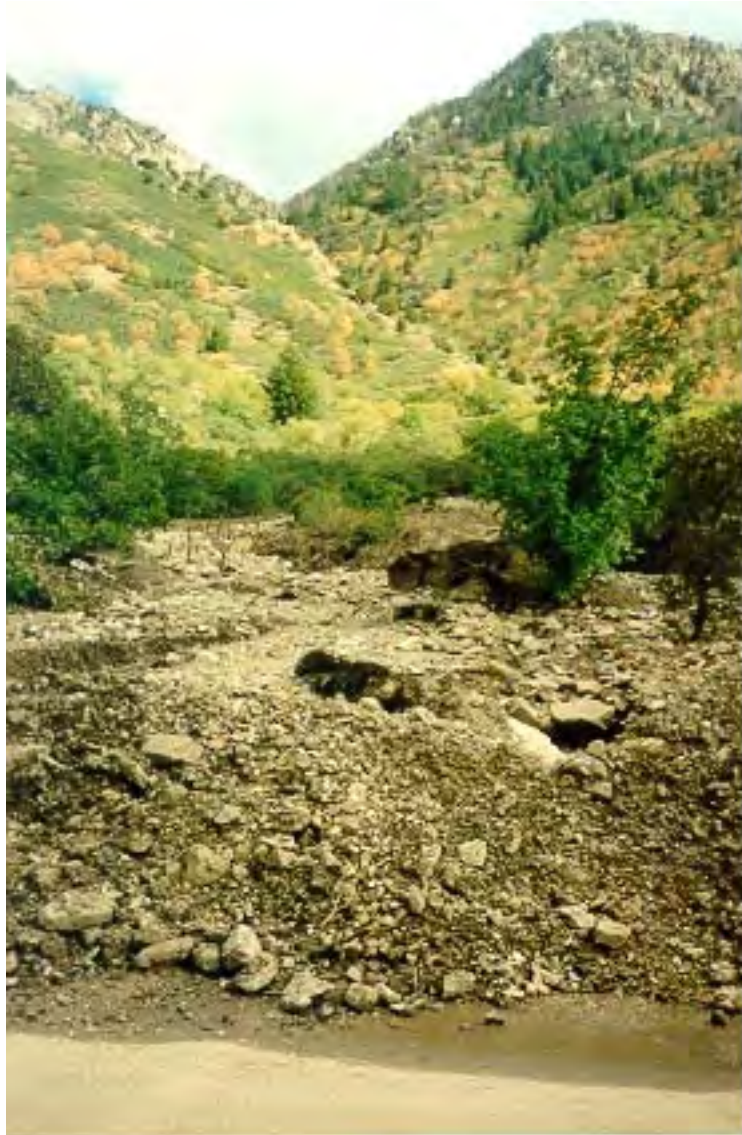
Figure 8: The September 8 Preston Canyon debris flow where it crossed Preston Canyon Drive; Preston Canyon is visible in the background. Photograph taken facing east. (September 18, 2002)

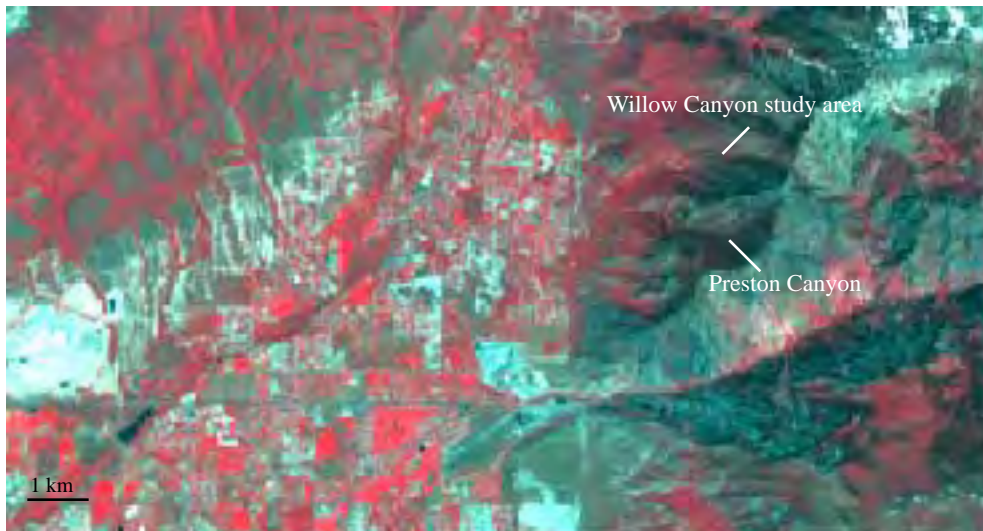
Figure 9: Locations of Preston and Willow Canyons in Alpine area; Landsat 7 scene using bands 4, 3 and 2 (May 28, 2000).

The City of Alpine in northern Utah County experienced two debris flows in an eight day period in September, 2002, both emanating from Preston Canyon (Figures 8, 9, and 10). No previous landslide or mass movement maps show debris flows emanating from this canyon. In nearby American Fork Canyon, 27 landslide/debris flow events occurred in 1983 (Brabb, Wieczorek, and Harp, 1989).

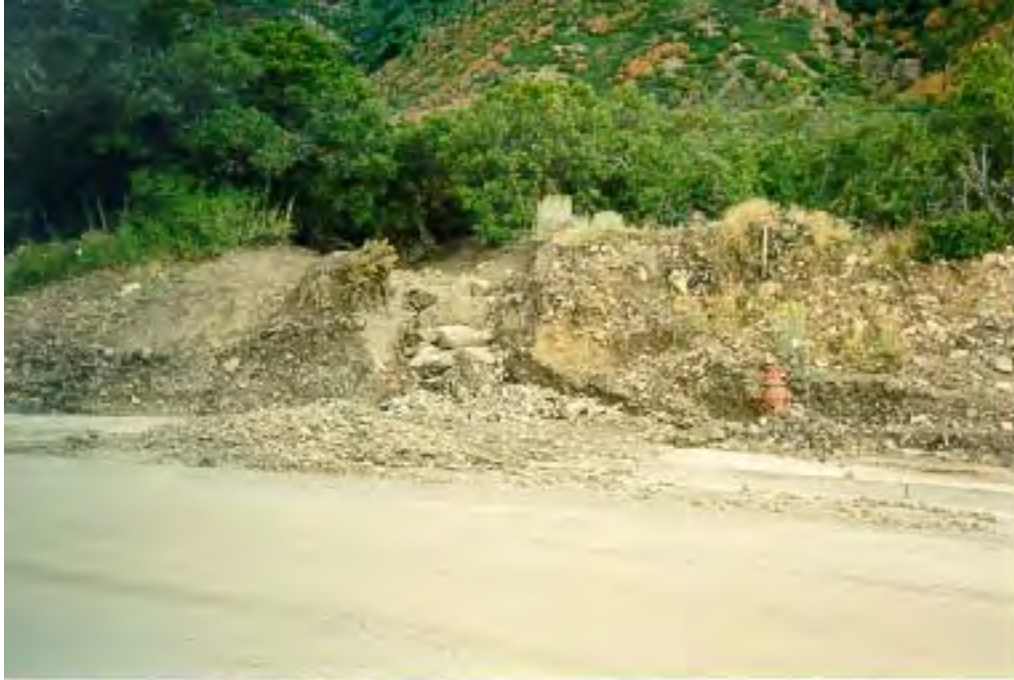
Figure 11: Preston Canyon Drive where the debris flow crossed Bald Mountain Drive, photograph taken facing east. (September 18, 2002)

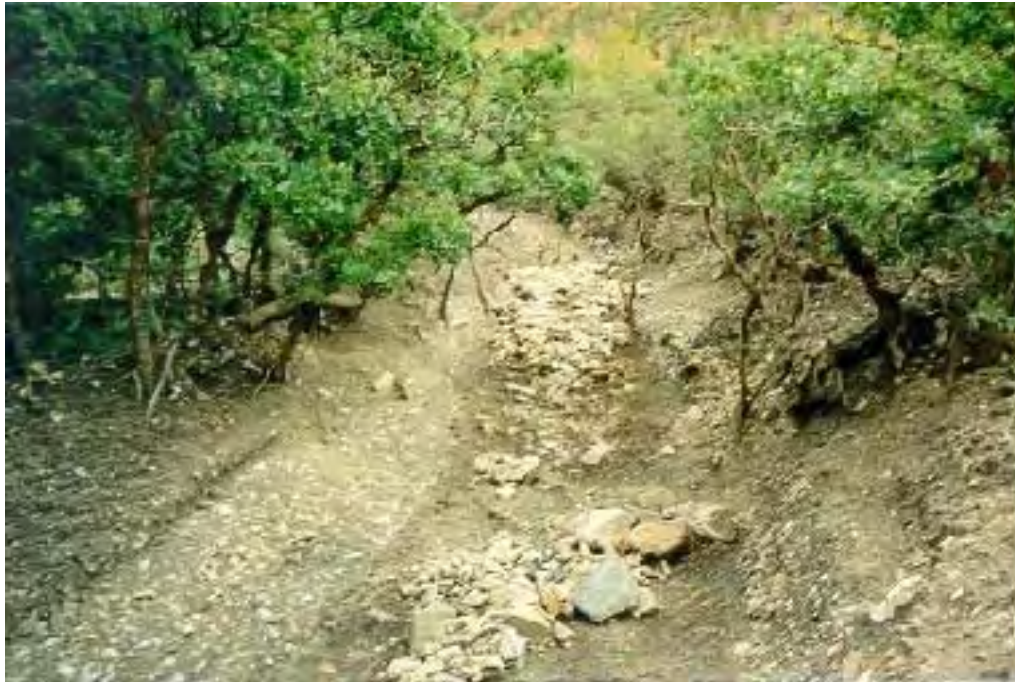
Figure 12: The channel of the Preston Canyon debris flow, photograph taken facing east. (September 18, 2002)

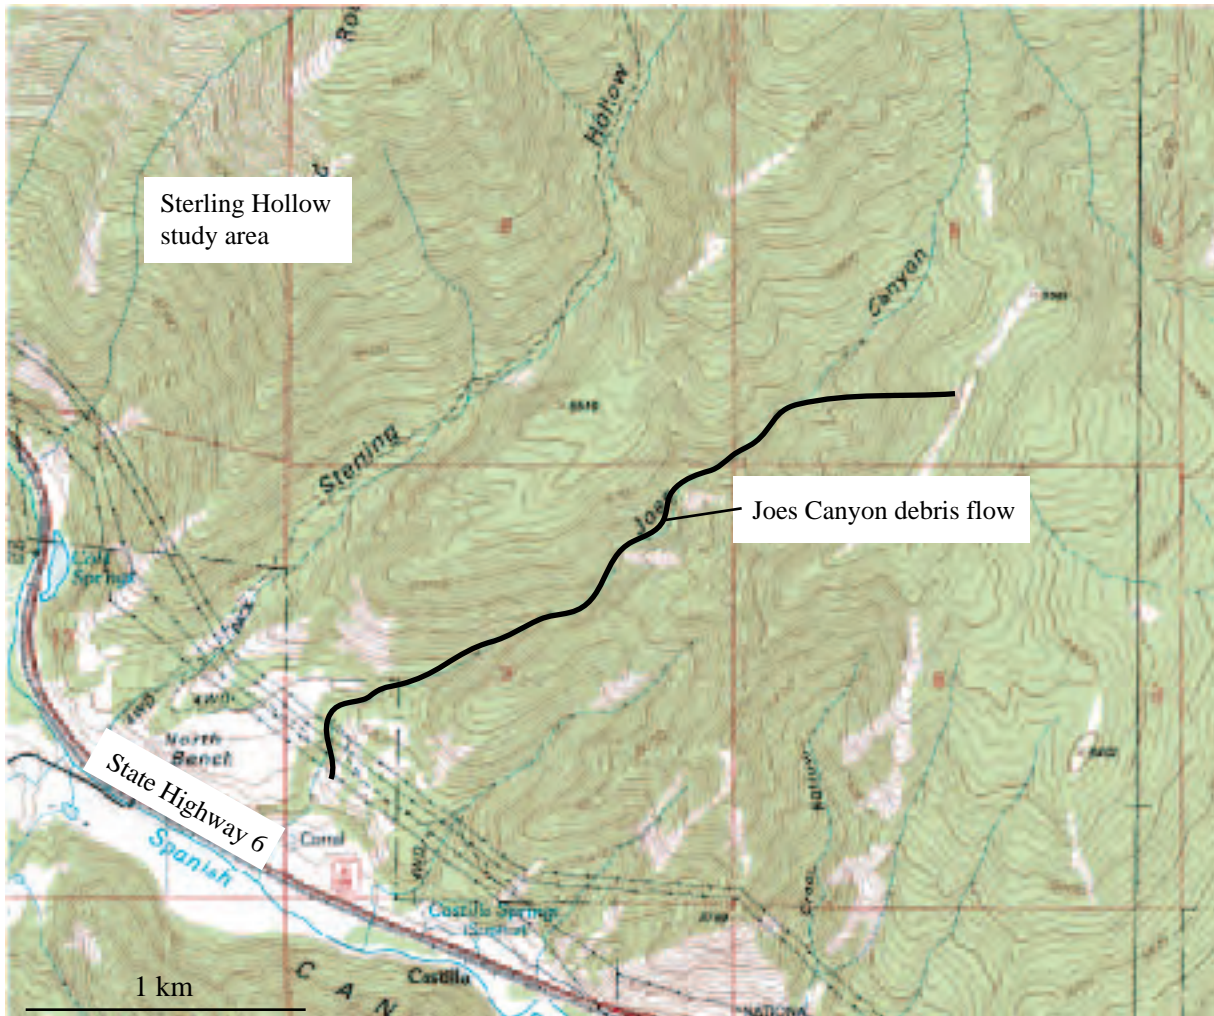
Figure 14: Topographic map of Sterling Hollow and Joes Canyon, and path of Joes Canyon debris flow.

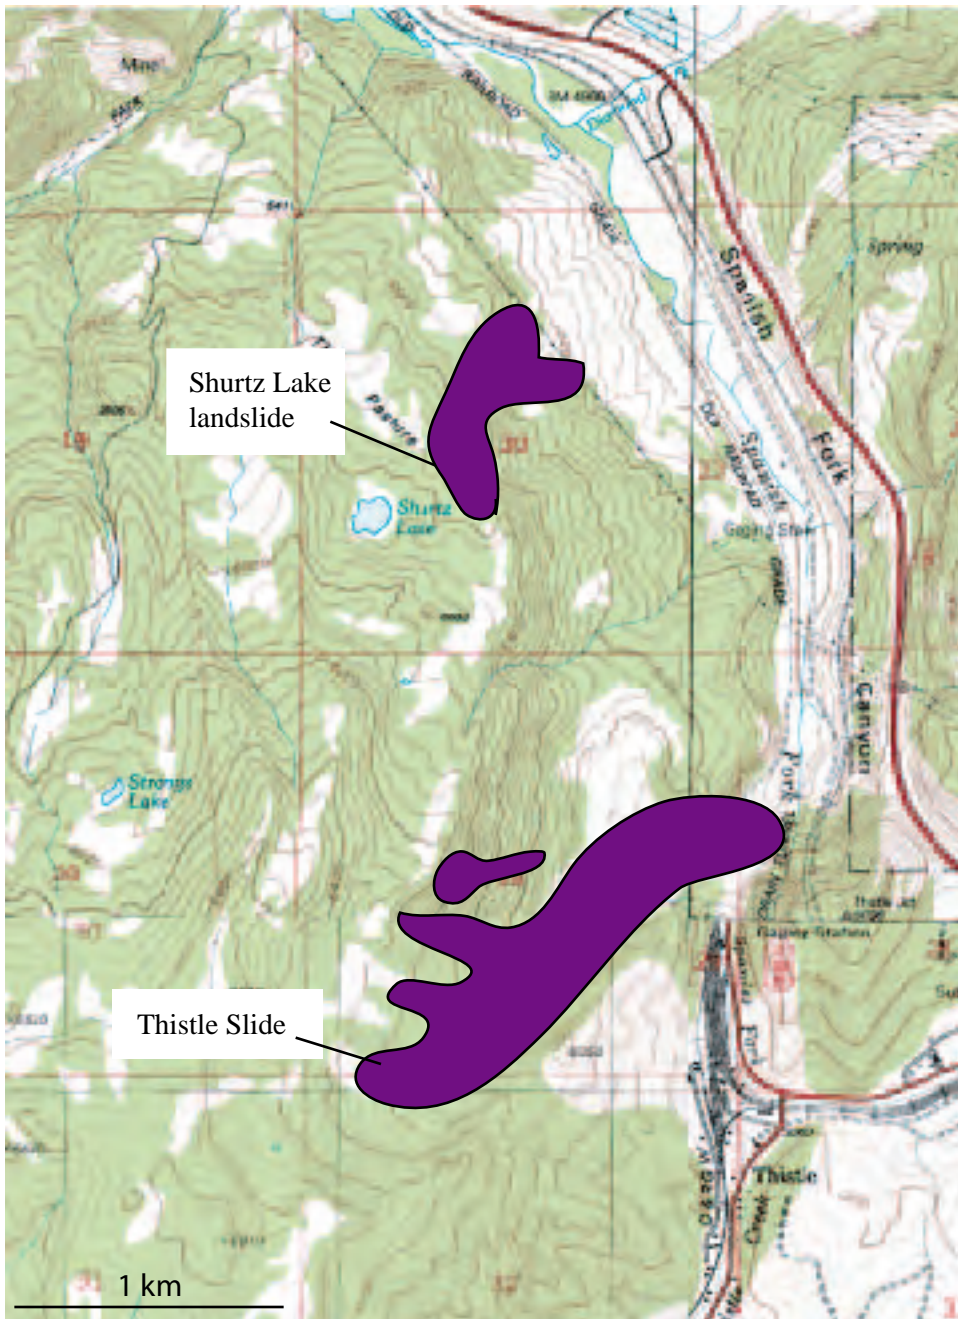
Figure 15: Topographic map of the locations and morphology of the Thistle slide and Shurtz Lake landslide.

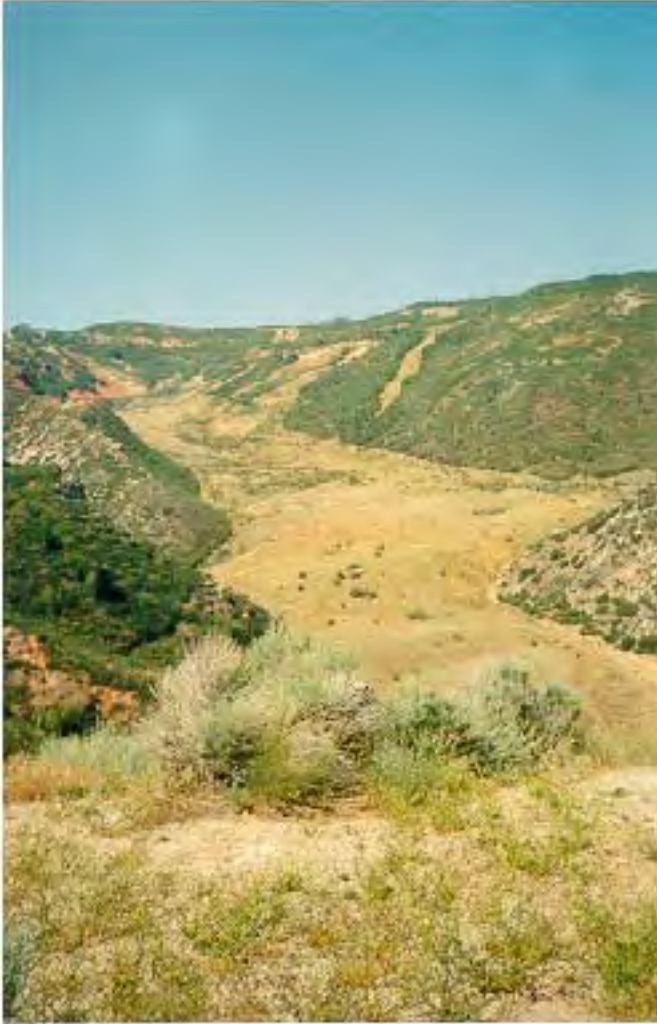
Figure 16: Thistle landslide, photograph taken facing southwest. (July 4, 2002)

Thistle. The Thistle landslide reactivated most recently in May, 1998 (Figure 16). Movement was initiated by the detachment of a large slump block at the crown of the landslide. The detachment and rotation of the slump block created a vertical scarp of nearly 30 m in height. Most movement occurred by sliding on the deep 1983 rupture. Relative displacement of casings oriented east-west suggests a minimum of approximately 48 m of movement (this value may include 1997 movement) (Christenson, 1998). Average rates of movement for years prior to 1997-8 were about 0.17 m/yr yielding about 2.4 m of movement that would have occurred from 1984-1998 (Christenson, 1998). The entire landslide, except for the dam, moved in 1998 (Christenson, 1998). The spring of 1998 was the third wettest on record for Spanish Fork Canyon and surpassed only by 1982 and 1983 (Figure 17) (Ashland, 2003).

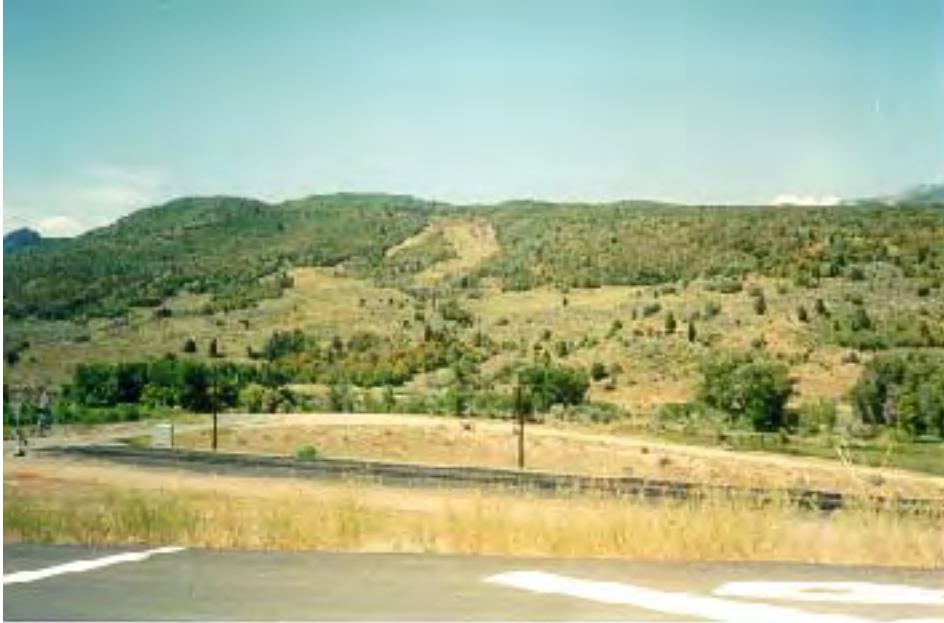
Figure 18: Shurtz landslide, photograph taken facing west. Only the two earthflows are visible, the remainder of the slide is on the plateau. (July 4, 2002)

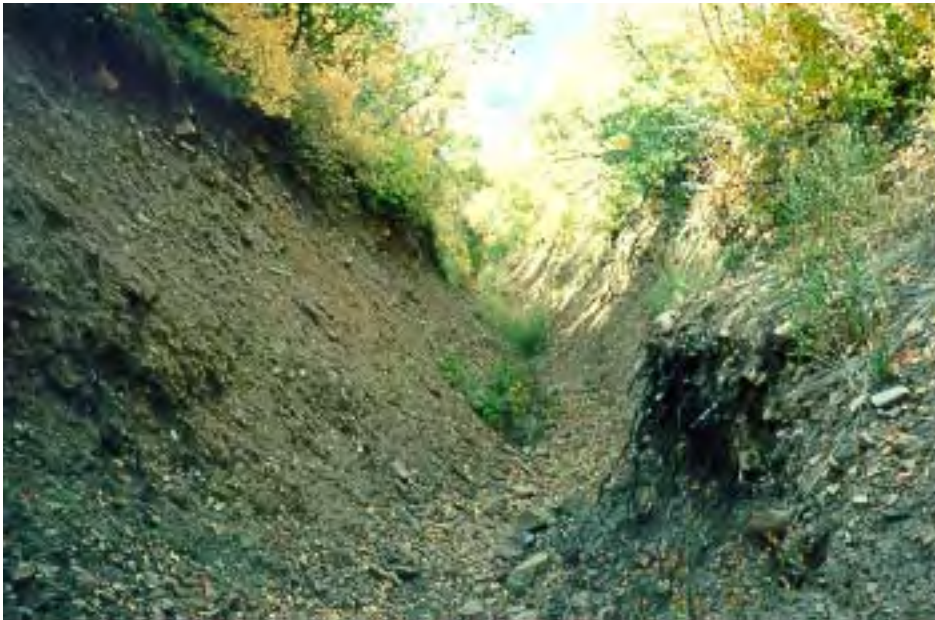
Figure 19: The channel of Joes Canyon debris flow, photograph taken facing south-southwest. (July 4, 2002)

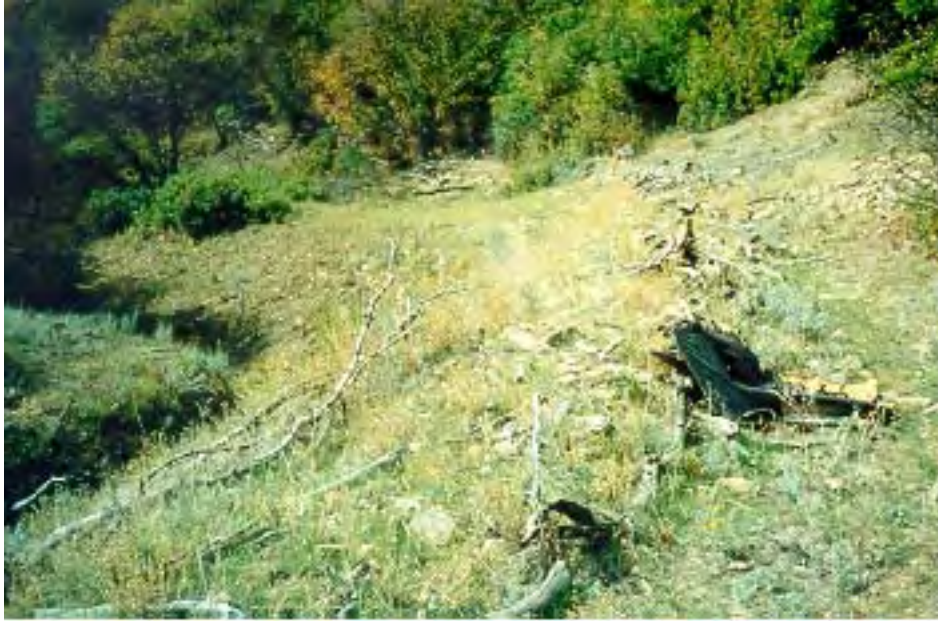
Figure 20: Levee of Joes Canyon debris flow, photograph taken facing south. (July 4, 2002)

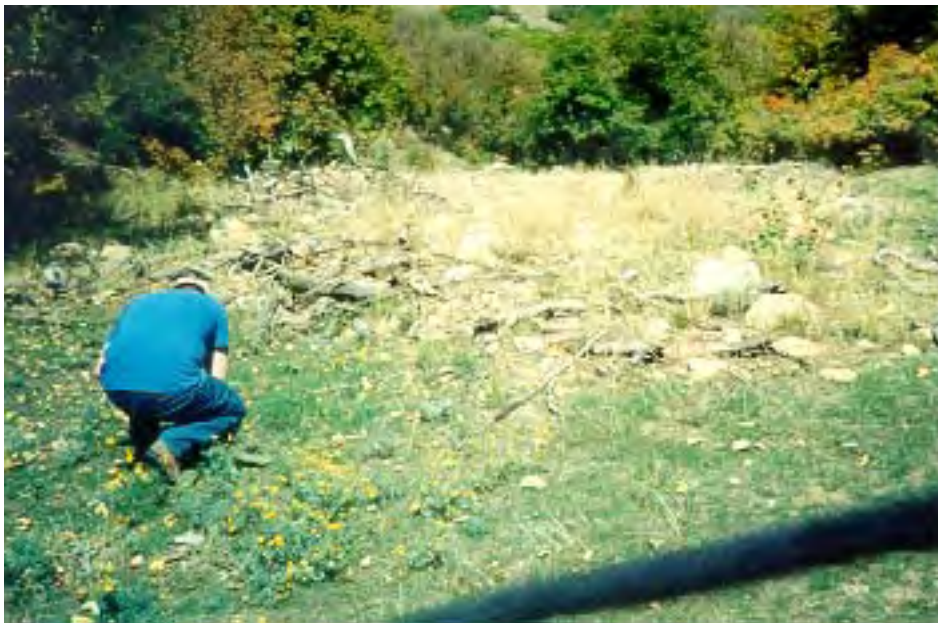
Figure 21: Toe of the Joes Canyon debris flow fan, photograph taken facing north. Jared Howland in foreground. (July 4, 2002)

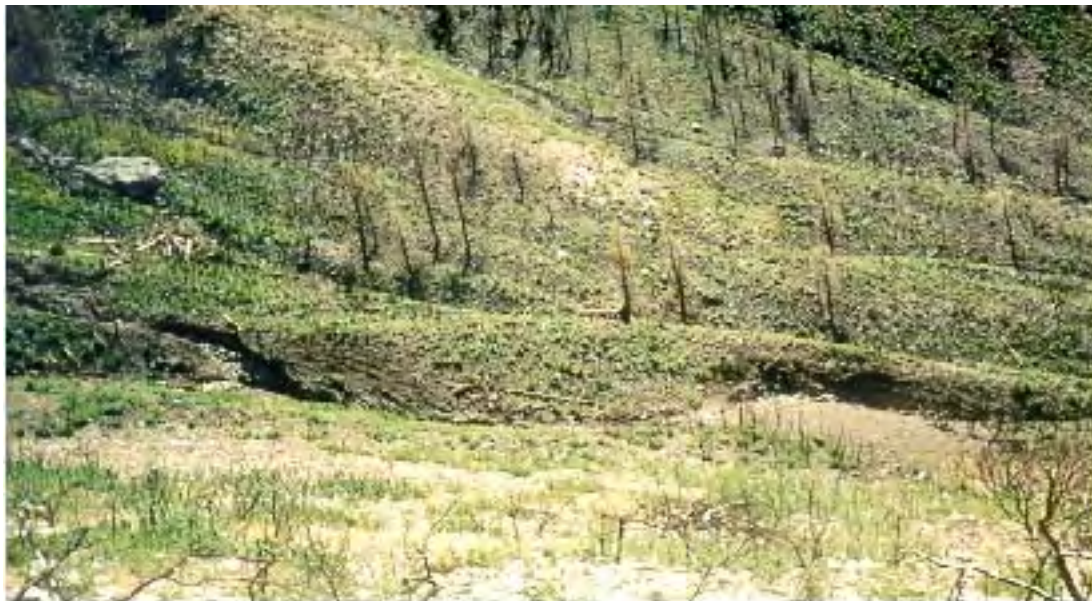
Figure 24: Source area of the Tributary 5 debris flow, photograph taken facing south. Note the burned trees from the Mollie Fire in 2001. (September 19, 2002)

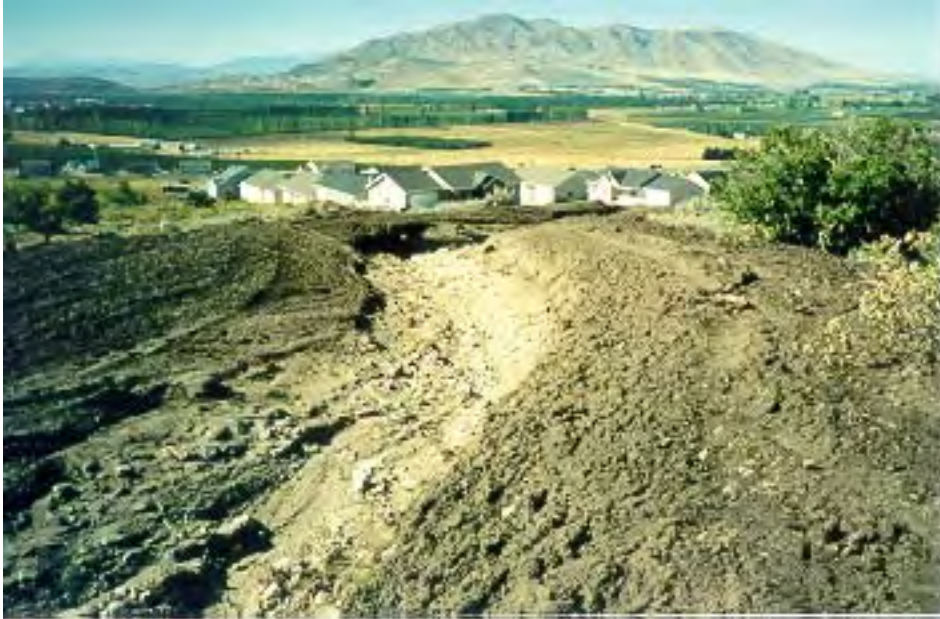
Figure 25: The Tributary 4 debris flow and the subdivision it hit, photograph taken facing northwest. (September 19, 2002)

Tributary 4 and 5 debris flows. On September 12, 2002, two large debris flows traveled west from Dry Mountain and damaged homes in Spring Lake and Santaquin,

Utah County (Figure 25). The hazard for debris flows on Dry Mountain existed prior to the fire and will exist even once the vegetation recovers (McDonald and Giraud, 2002).
