Evaluating Shallow-Flow Rock Structures as Scour Countermeasures at Bridges

EVALUATING SHALLOW-FLOW ROCK STRUCTURES AS
SCOUR COUNTERMEASURES AT BRIDGES

Master of Science

Department of Civil and Environmental Engineering

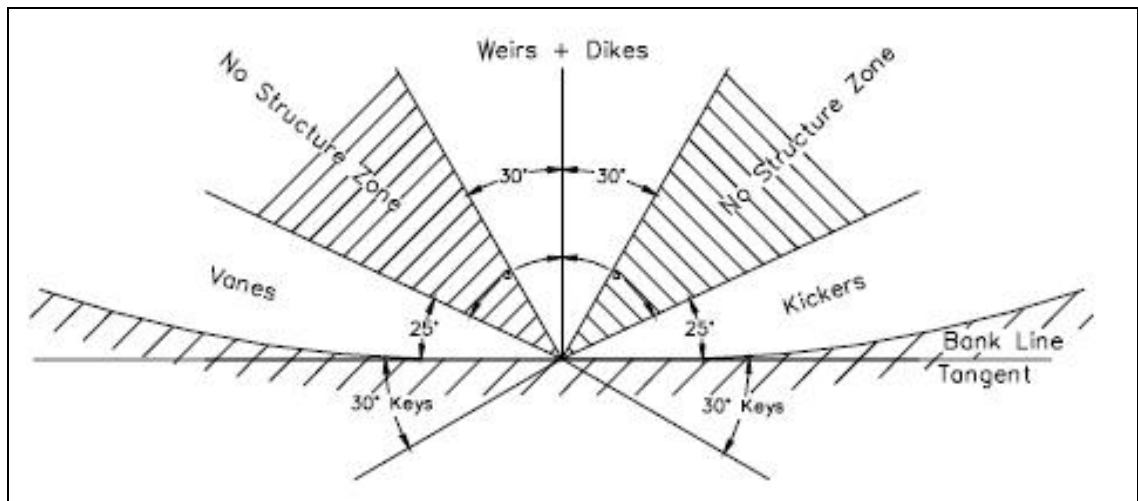
Figure 2-3. Bendway Weir and Vane Variations.

Variations of bendway weirs relate to the orientation of the structures with respect to the streambank. Bendway weir (barb) placement ranges from perpendicular to the bank or up- and downstream 30° from perpendicular. Vane orientation is always upstream as shown in Figure 2-3. Kickers are the mirror reflection of a vane from perpendicular as shown in Figure 2-3. See Figure 2-4 and Figure 2-5 for illustrations of a bendway weir and vane, respectively. Vane theory and design methodologies are found in *Stream Investigation, Stabilization and Restoration (SISR)* (Freeman 2005^{1,2}) and Johnson et al. (2001).

There are two variations with respect to bendway weirs and vanes. The variations of bendway weirs (barbs) and vanes can best be described using Figure 2-3 from *Stream Investigation, Stabilization and Restoration* (SISR) (Freeman 2005¹).

Vanes are oriented upstream 20° to 30° from the bank whereas bendway weirs are perpendicular to the bank give or take 30° (see Figure 2-3). Vanes, for the purposes of this study, have separate design criteria from bendway weirs, but by definition are the same. See the definition for bendway weir and Figure 2-9 for vane weir theory. (Freeman 2005¹). Further, Johnson et al. (2001) described the similarities between vanes and bendway weirs, “bendway weirs are low elevation stone sills similar to vane structures.”

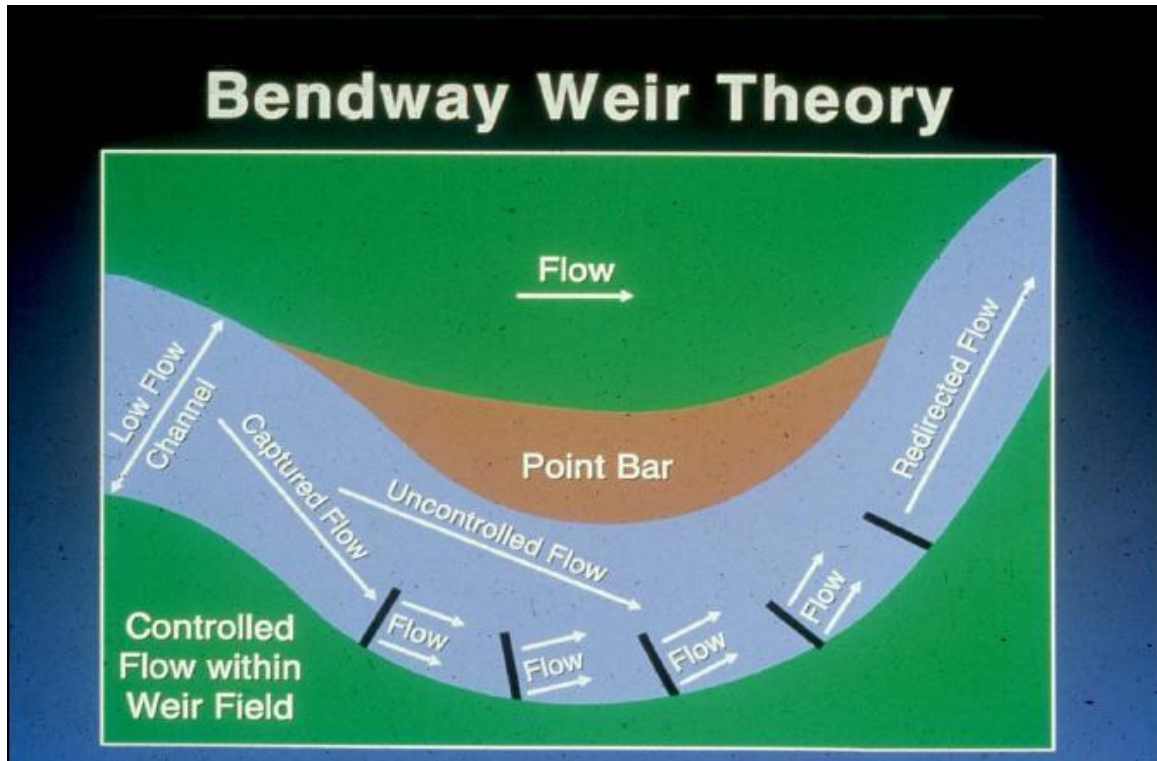
Figure 2-8. Bendway Weir Theory.

As water passes over a bendway weir, it is redirected downstream perpendicular to the structure as illustrated in Figure 2-8. (Freeman 2005²).

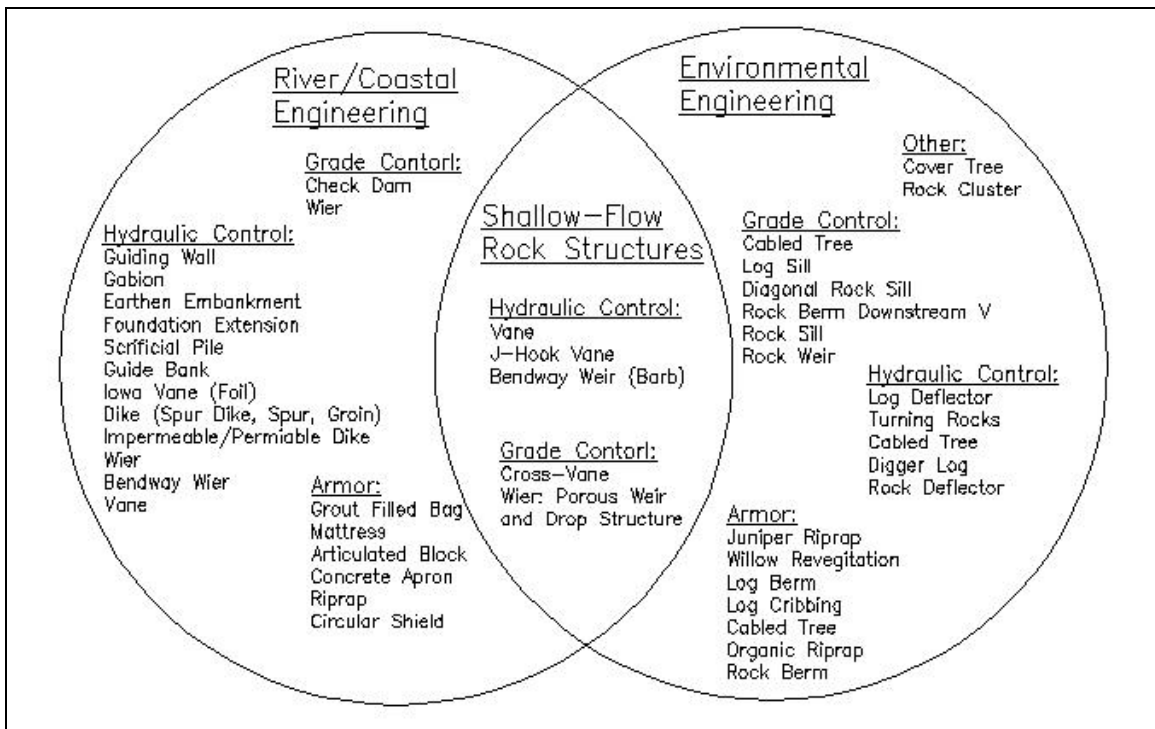
Figure 2-10. Shallow-Flow Structures and River and Environmental Engineering Structures.

In some cases environmental engineering structures are used as scour countermeasures and can be classified in a similar manner. Scour countermeasures mitigate the erosion induced by horizontal and vertical movement of waterways. Shallow-flow structures are defined in section 2.2 and can be viewed as an intersection of river and environmental structures. Shallow-flow structures include: vanes, j-hook vanes, bendway weirs, vortex weirs, and cross-vanes. See Figure 2-10 for an illustration of how shallow-flow rock structures are related to river and environmental engineering structures.

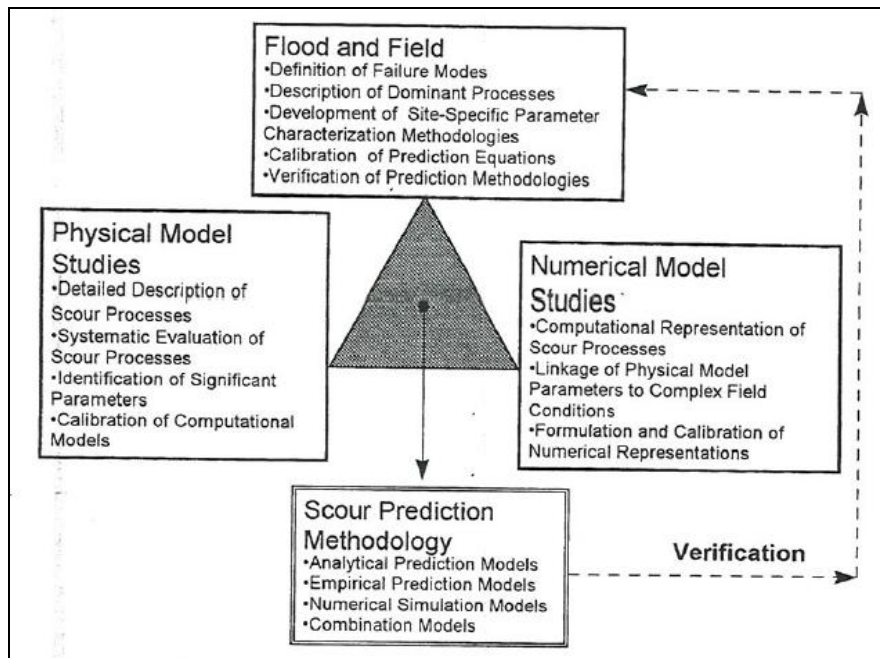
Figure 2-11. Balanced Research Approach Model.

As the literature was surveyed for studies conducted on structures comparable in composition and relative size, components of a balanced approach methodology were scattered throughout the literature. Shea and Ports (1997) asserted that a balanced approach to evaluation of scour at bridge crossings can produce cost savings with a high degree of reliability. Figure 2-11 shows an illustration of the balanced approach methodology for evaluation of scour at bridge crossings (Parola et al. 1997).

Failure modes are a key component of a balanced research approach (see Figure 2-11) for evaluating scour. Johnson et al. (2004) describes failure mode analysis:

Siting or “...structure placement relative to natural channel features and fluvial patterns...” may increase the reliability of scour countermeasures (URMCC 1995). Recommended structure siting is given in *Stream Habitat Improvement Evaluation Project* (URMCC 1995) in Table 4.48, *Bridge Scour and Stream Instability Countermeasures – Experience, Selection and Design Guidance* (Lagasse et al. 2001) in Table 2.1, *Using Technical Adaptive Management to Improve Design Guidelines for Urban Instream Structures* (Johnson et al. 2002²) in Tables 1 and 2., and class notes sections five and nine of the *2005 Stream Investigation, Stabilization and Restoration Conference* held in Niagara Falls, Ontario (Freeman 2005^{1,2}). Being familiar with common siting practices will enable more consistent monitoring during flood and field studies. See Figure 2-11 for elements of flood and field studies components.

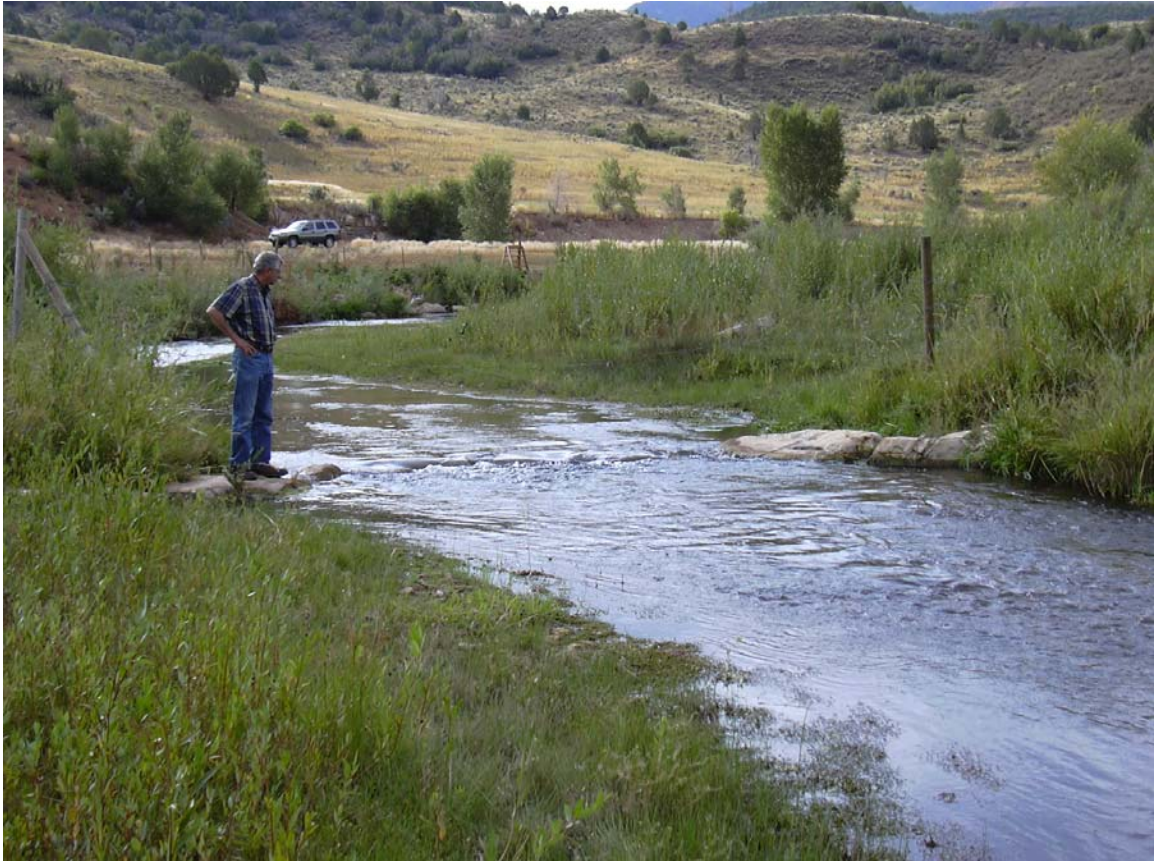
Figure 3-3. Cross-Vane Structure Observed and Modeled.

The site chosen for modeling includes many structures including: two cross-vanes, one j-hook and a number of vanes. Figure 3-3 shows the cross-vane modeled. Note the flow approaches the structure mostly on the right side of the channel and moves across the structure. This is reflected in the results of the numerical model.

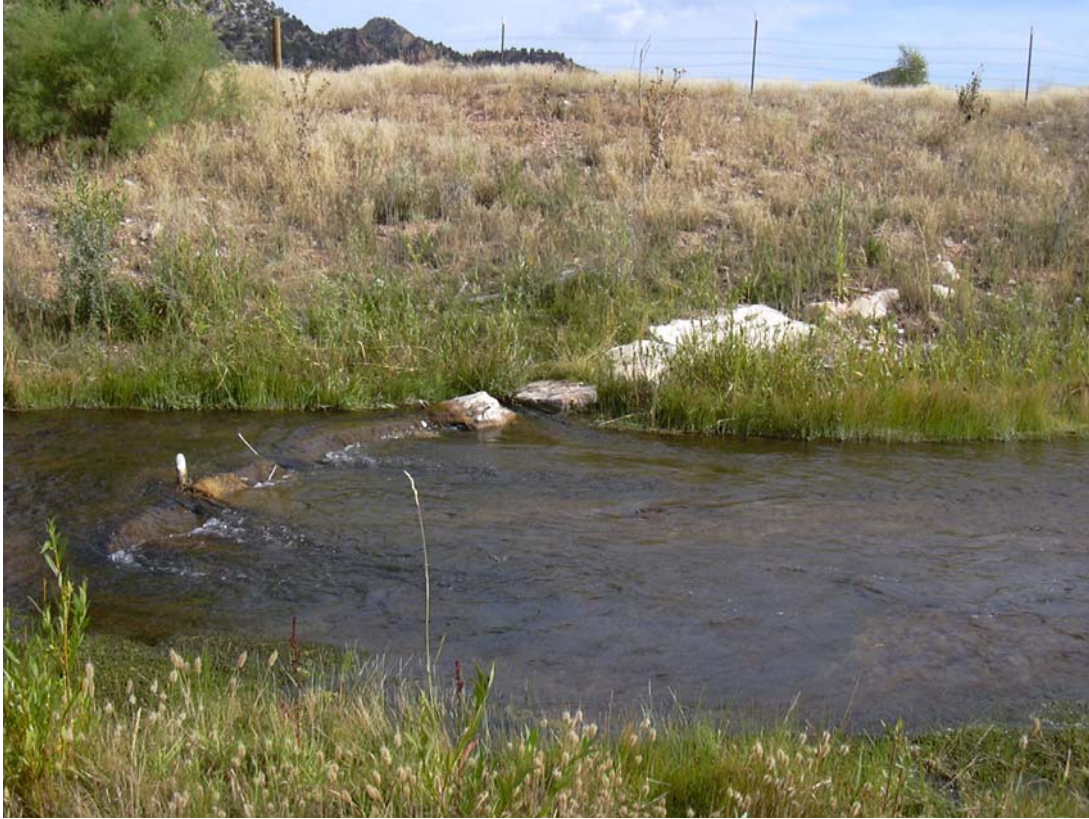
Figure 3-4. J-Hook Structure Observed and Modeled.

Figure 3-4 shows the j-hook structure modeled. Flow is from left to right in the picture. This structure is just downstream around a meander bend from the cross-vane. There is another cross-vane between these two structures on the meander bend. This is part of an ongoing restoration after the mudslide near Thistle, Utah. Also of note in this area is one of four experimental installations (in the study group for this paper) of SFS at bridges. The existing installation is located at Utah County State Park upstream of the Spanish Fork River and Diamond Fork confluence. SFS are installed upstream of a pedestrian-trafficked bridge. Figure 3-5 and Figure 3-6 show the relationship of a j-hook being constructed next to this footbridge.

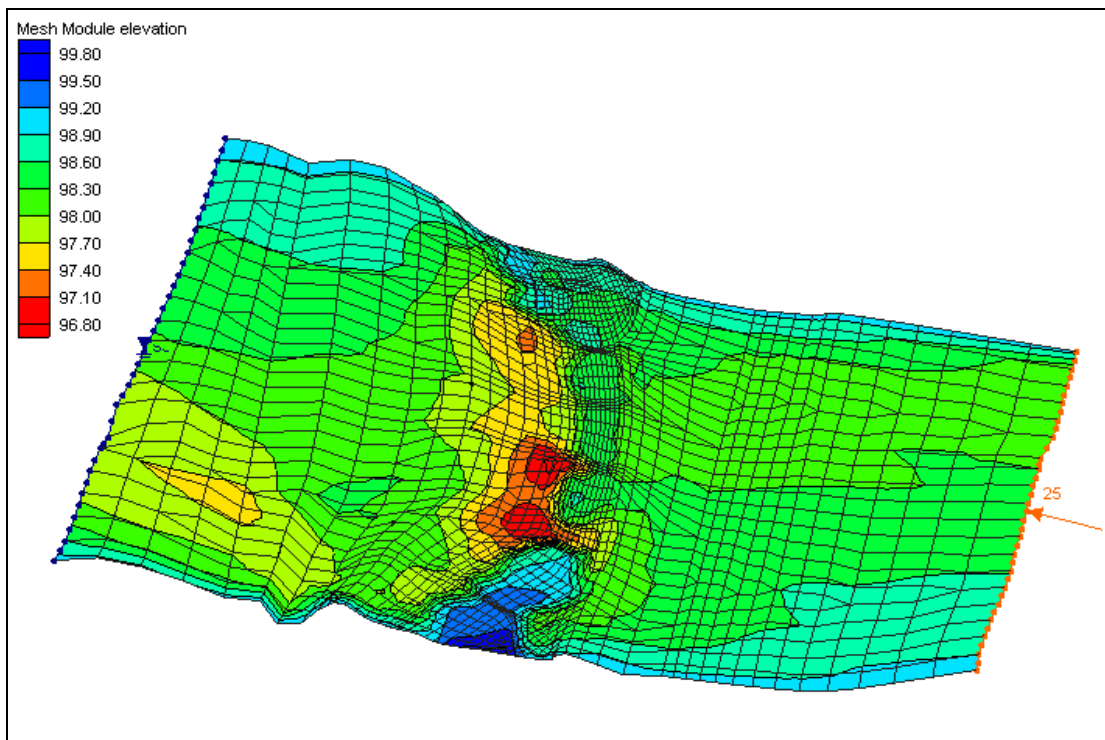
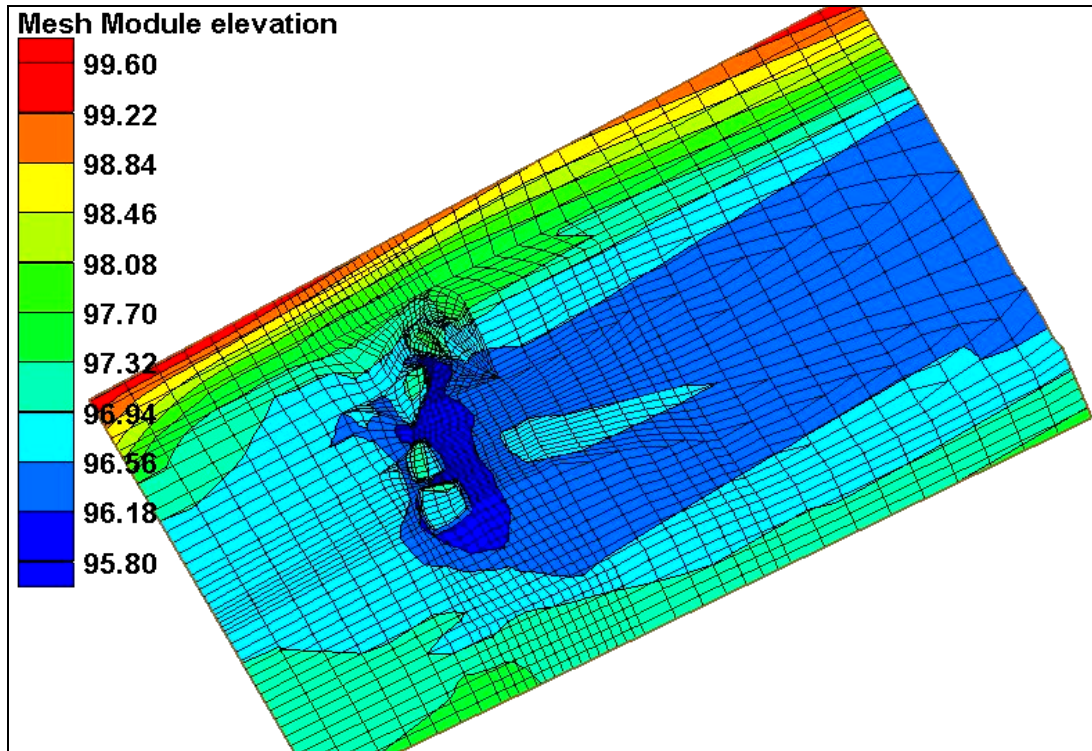
The Thistle Creek site modeled includes two separate finite element meshes. They represent two reaches of the stream that are very close together. The first includes a cross-vane structure and the second includes a j-hook. Figure 3-7 and Figure 3-8 show the meshes constructed around the cross-vane and the j-hook, respectively. The color keys in the upper left-hand corners indicate elevations. The resolution around the structure is very high, defining the elevation of each boulder, the elevation of the chutes between boulders and the pools upstream and downstream of the chutes are also illustrated.

Figure 3-7. Layout of Mesh for the Cross-Vane Model.

Figure 3-8. Layout of Mesh for the J-Hook Vane Model.

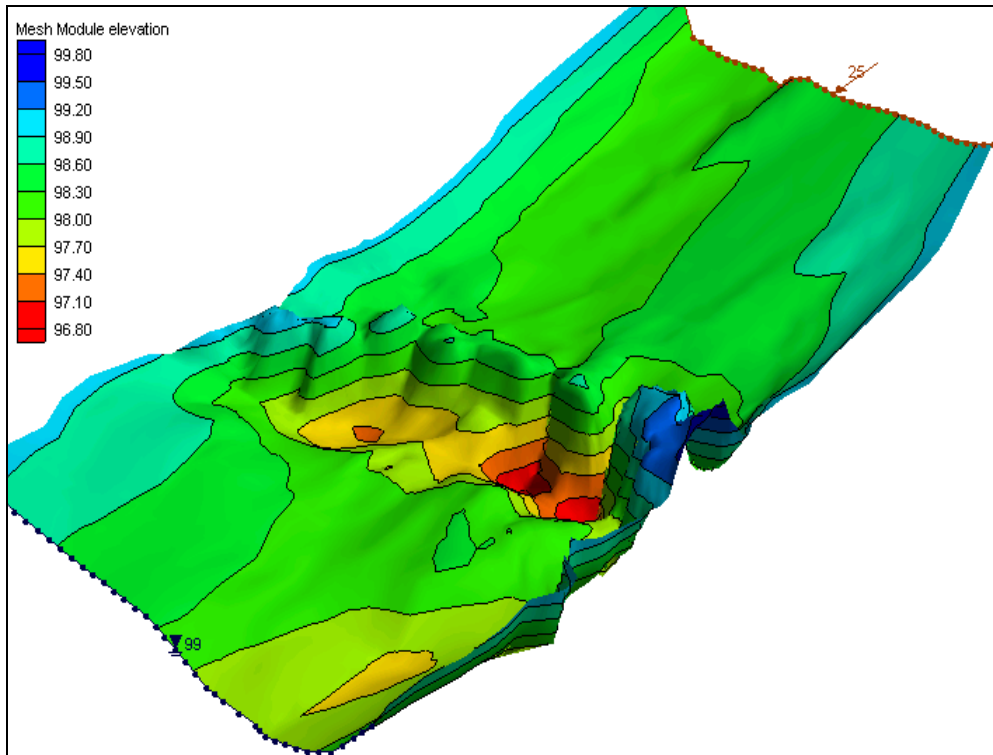
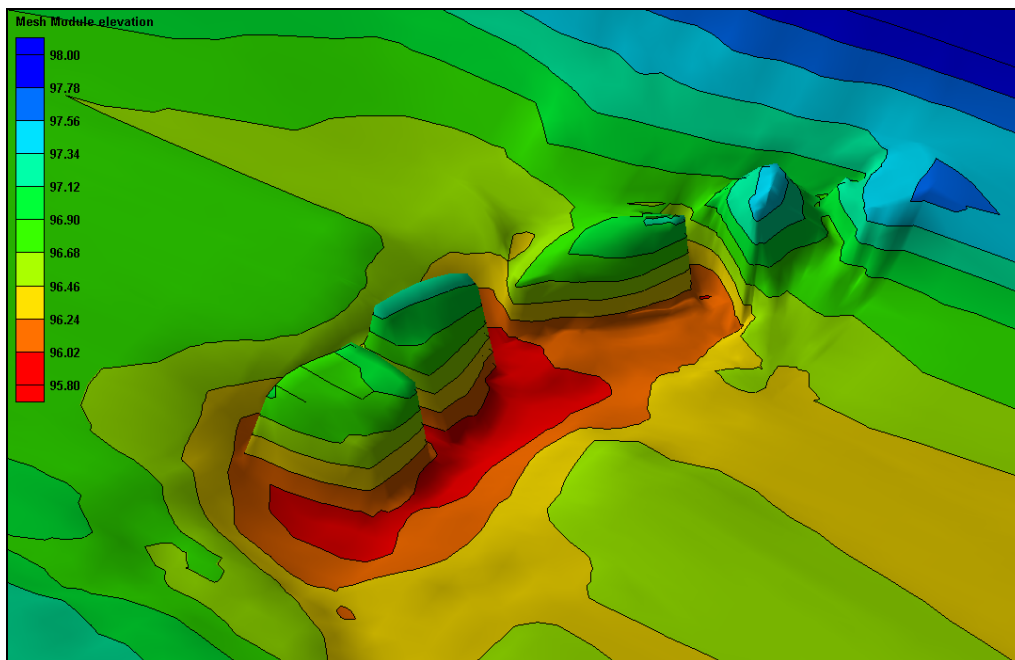
Figure 3-9 and Figure 3-10 show the geometry of the meshes from an oblique view. This view accentuates the scour holes that are developing downstream of the structures. Results shown later in this chapter illustrate additional scour has occurred during the year of phase one monitoring. Also note the scour occurring upstream on the j-hook. Field observations support that failure of SFS occurs not only by downstream scour, but also by an upstream erosion mechanism. The initial elevations came from the survey data that are displayed along with contours of the survey points in Figure 3-11 and Figure 3-12.

Figure 3-9. Oblique View of Geometry of the Cross-Vane Structure.

Figure 3-10. Oblique View of Geometry of the J-Hook Structure.

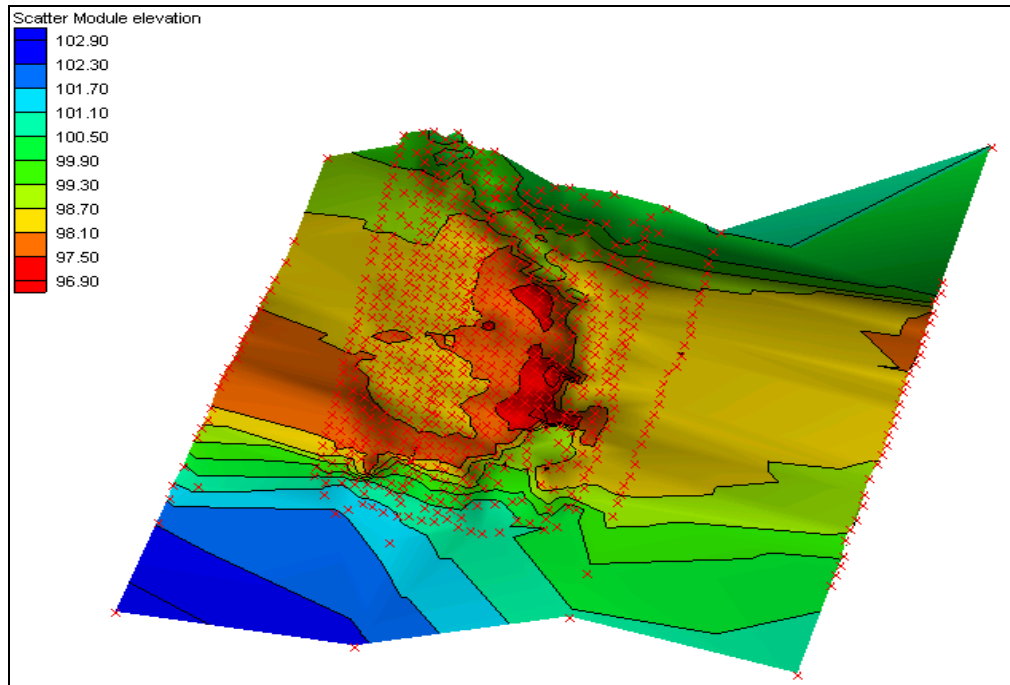
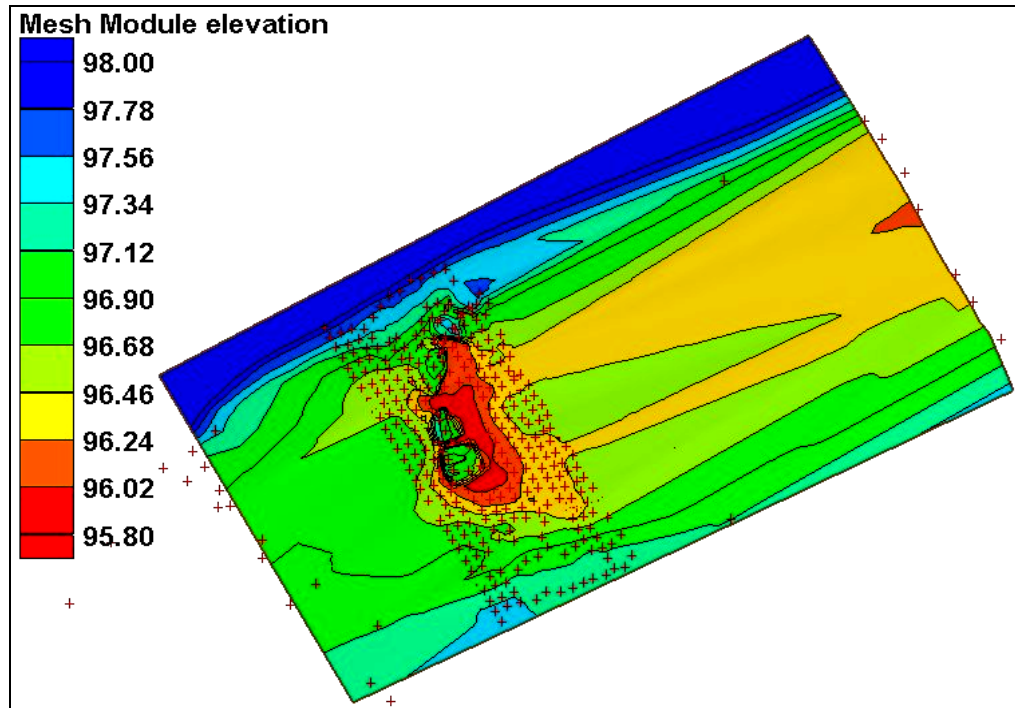
Figure 3-11. Survey Data of Cross-Vane.

Figure 3-12. Survey Data of J-Hook.

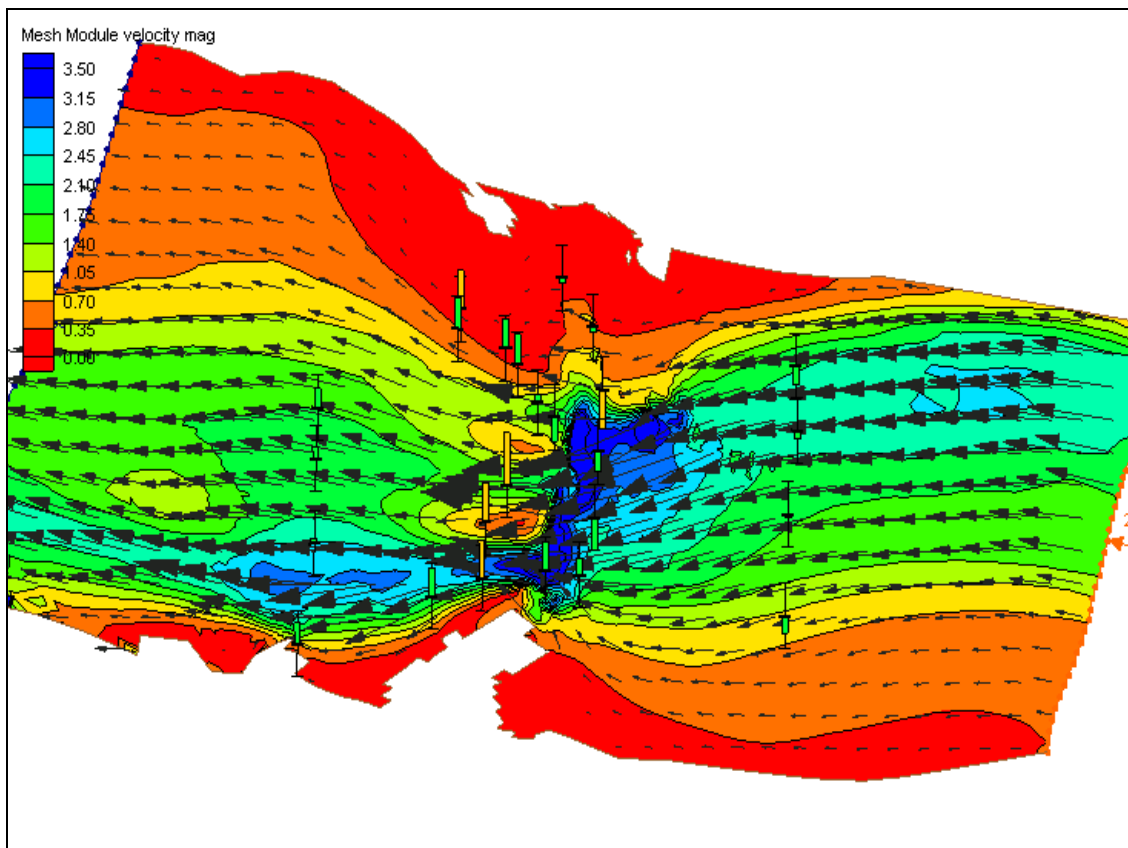
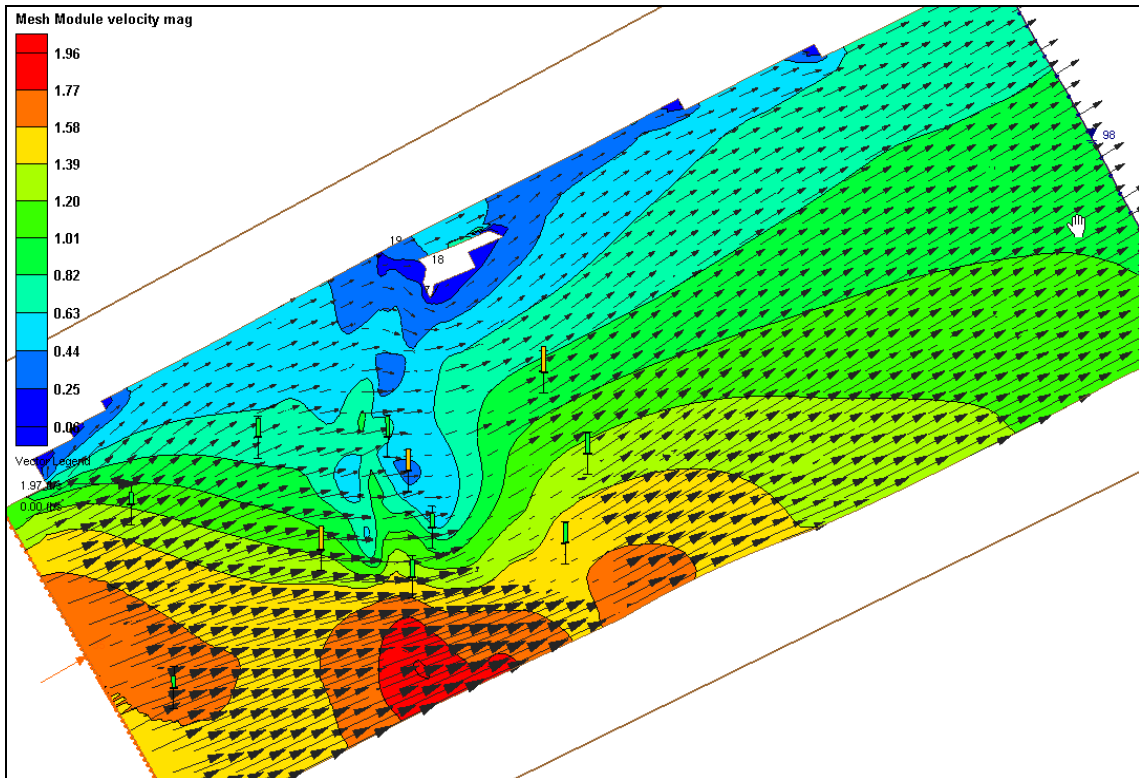
Initially, a flow of 25 cfs was simulated through the two meshes. This corresponds to the flow rate computed from the date when the original survey data was gathered. In addition to bathymetric data at 1-foot intervals, velocity samples were obtained across the cross section and at several points around the structure. The following images display the computed flow directions and magnitudes computed by the model. Note that the model has dried out portions of the rocks and reproduced the flow conditions coming from the right side of the channel and crossing over to the left at the structure.

Figure 3-13. Velocity Magnitudes Computed for Cross-Vane.

Figure 3-14. Velocity Magnitudes Computed for J-Hook.

Figure 3-13 and Figure 3-14 also show the calibration targets at various sample points. Any target showing a green staff indicates a computed velocity magnitude within .26 ft/sec of the measured value. A yellow staff indicates a computed value within .52 ft/sec of the measured value. The data sets were calibrated using the measured velocities and depths gathered at the site. Based on the calibration results and flow conditions observed during data gathering, it appears that the models are performing reasonably well to predict flow conditions. This includes water depths and flow velocities from which scour forces can easily be computed.

The asymmetrical cross-vane also has erosion problems illustrated in the photos taken in the fall of 2003 and the summer of 2004 during spring runoff (Figure 3-16 and Figure 3-17). In Figure 3-16, two large boulders are visible on the far bank. Figure 3-17 illustrates that due to erosion around the boulder, the left of the two boulders on the bank has shifted and broken. That is why the boulder is not visible in this figure. The erosion is caused by the water moving across the structure from the upstream (north) to the downstream (south) side. The velocity of the water is increased as it runs over the structure and is redirected to the south bank as seen in Figure 3-13.

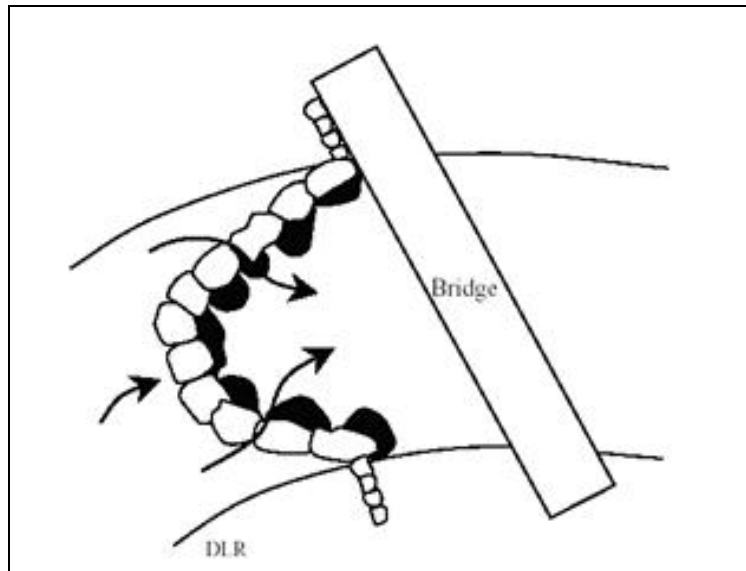
Figure 3-15. Proposed Design Methodology for Cross-Vane Installation at a Bridge.

See Figure 3-15 for Rosgen’s (2001) proposed cross-vane installation upstream of bridges.

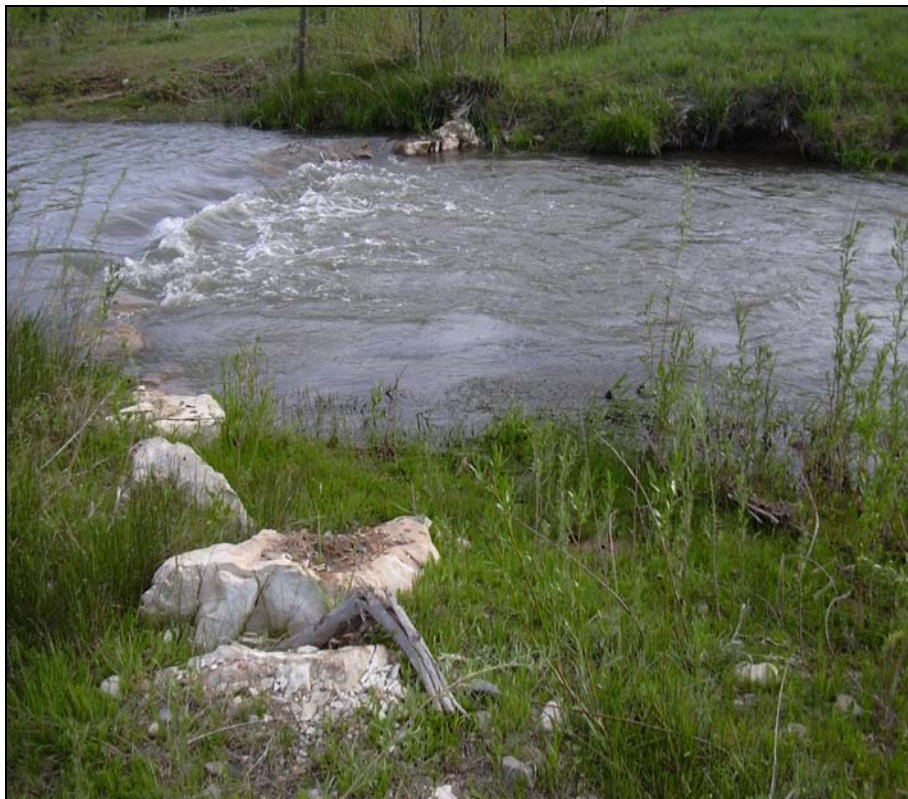
Figure 3-17. Cross-Vane Photo Taken During Spring Runoff 2004.

Rock decay was also observed during the study. As noted above, one of the main boulders broke after shifting due to erosion. The crumbling rock in the foreground of Figure 3-17 illustrates the inferior quality of these materials.

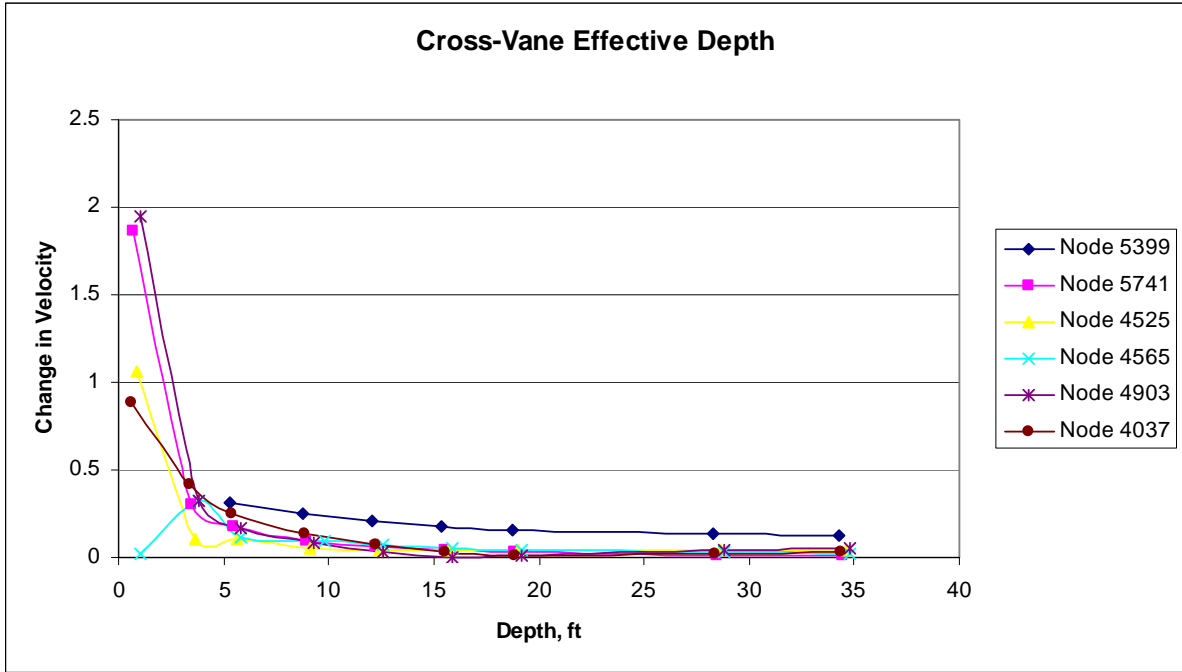
To view the depth verses flow direction, data points were selected across the structure. The depths and directions at that point were recorded for each flow rate. The results are presented in Figure 3-19 and Figure 3-21. To view the change in velocity versus depth, an additional data point was chosen just upstream to correspond with each of the points along the structure. The depth of the upstream point was plotted against the change of velocity between the upstream and downstream points. The results for the second set of data are illustrated in Figure 3-18 and Figure 3-20.

Figure 3-18. Cross-Vane Effective Depth from Change in Velocity Magnitude.

Figure 3-19. Cross-Vane Effective Depth from Change in Flow Direction.

Figure 3-20. J-Hook Effective Depth from Change in Velocity Magnitude.

Figure 3-21. J-Hook Effective Depth from Change in Flow Direction.

With that observation made, it is important to qualify it. This is for a stream whose base flow is less than one foot deep. It is recommended that these results not be extended to larger rivers without direct evaluation of such situation. As stated in section 3.4.2, these structures have proven to be very sensitive and therefore results cannot be easily extracted. Also of import, is that the model was not calibrated for larger flows. The spring runoff of 2004 was far smaller than a typical spring runoff. Based on the preceding statement, extending the calibration of this model to larger flows also requires caution and judgment.

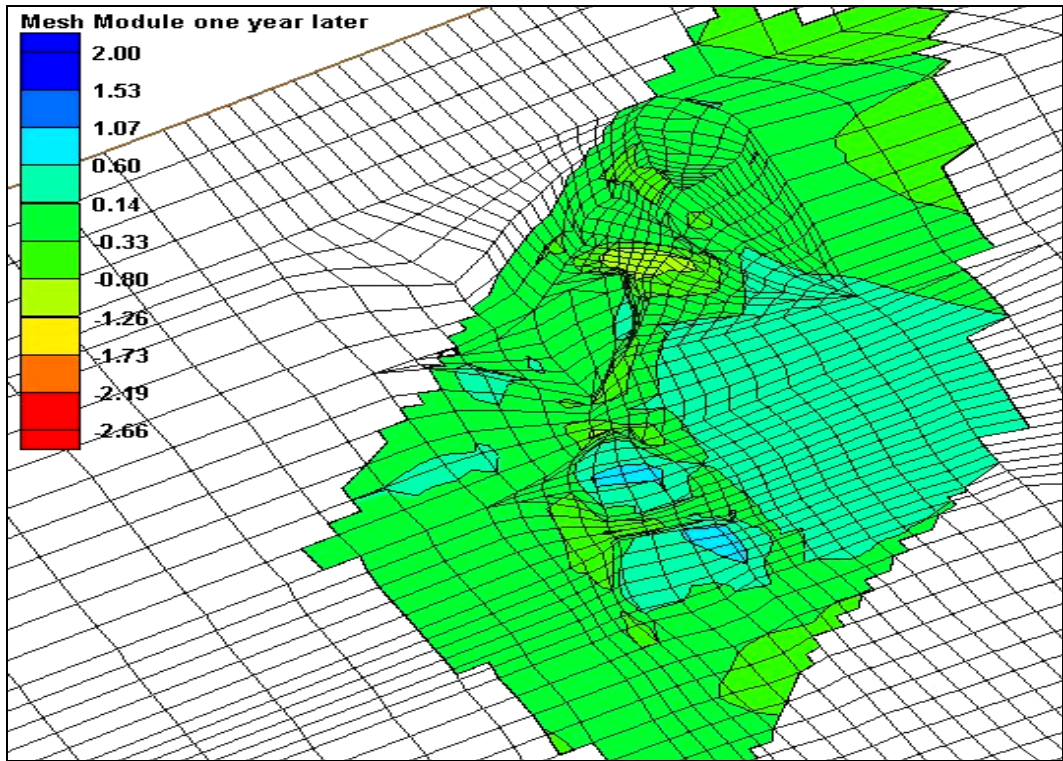
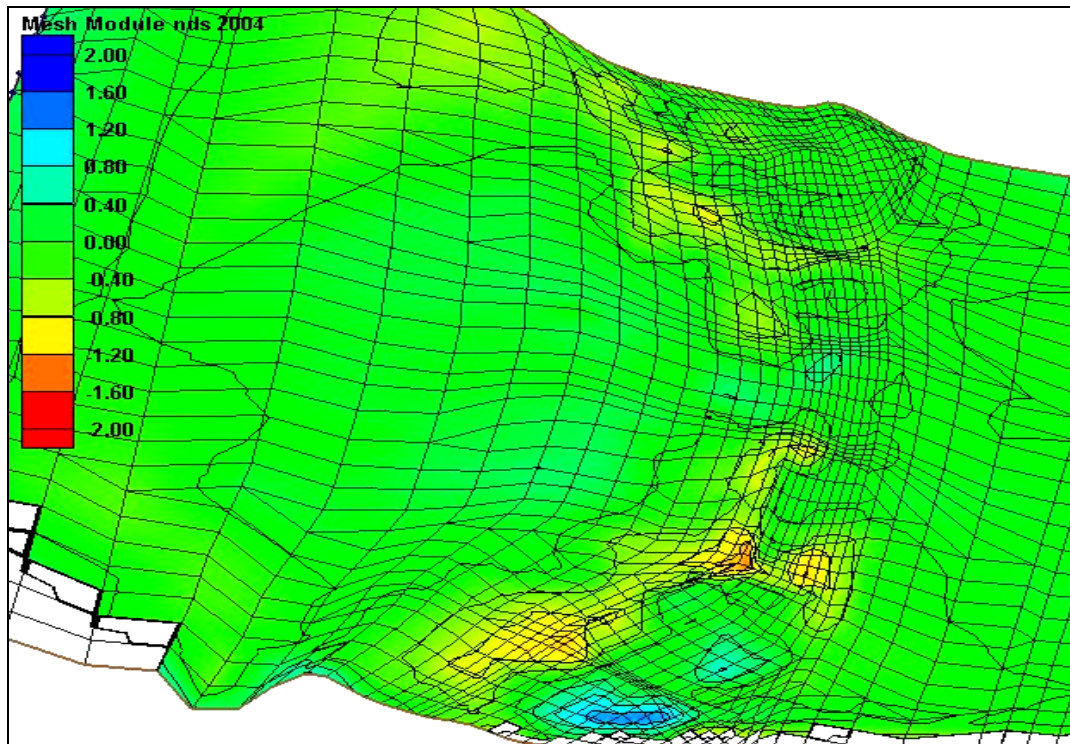
A fourth observation can be made by evaluating the erosion that took place over the year of monitoring at this site (2003-2004). To do this, bathymetric data from the fall of 2003 is compared to post spring runoff measurements in 2004. The results are shown around the vicinity of the structures themselves.

Figure 3-22. Erosion of J-Hook at Thistle Creek Site Between 2003-2004.

Figure 3-23. Erosion of Cross-Vane at Thistle Creek Site Between 2003-2004.

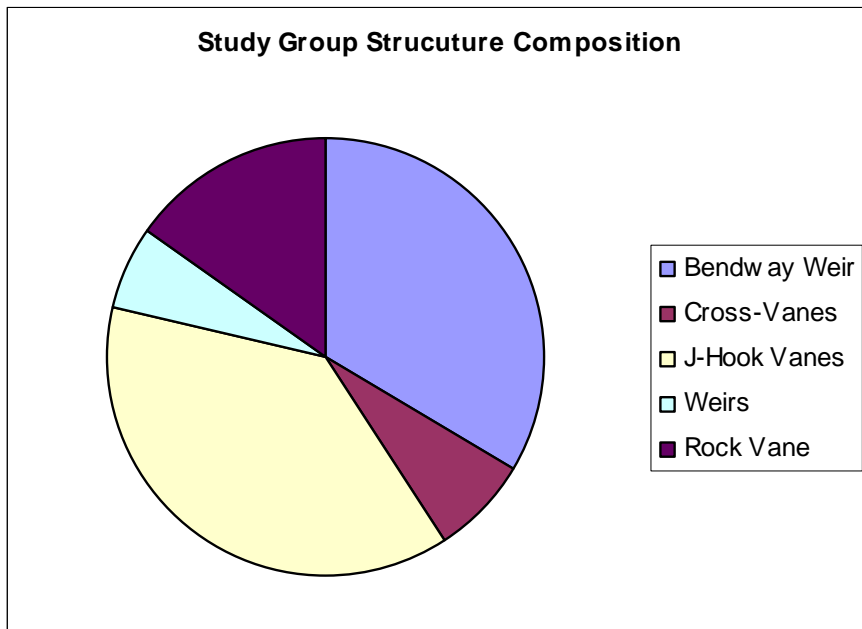
Figure 4-1. Study Group Structure Composition.

There are six rock weirs and seven cross-vanes in the study group. These structures have profiles that start from just above the bankful river stage and slope down into the streambed and usually have the lowest elevation at the location of the thalweg. Their length or distance into the streambed varies depending on what type of structure it is. Rock weirs extend from one bank to the other.

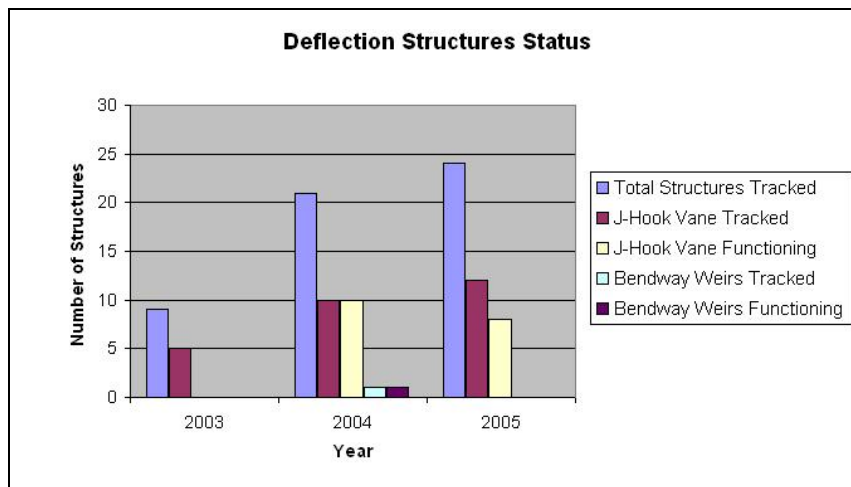
Figure 4-16. River Training Structure Status.

The year 2005 was an average-water year and mixed results were found for the 24.5% of the monitored structures. In 2005, a total of seven cross-vanes were monitored. Only four were still functioning as designed after spring runoff for a 57.1% success rate. There were a total of 12 j-hook vanes, of which eight were still functioning as designed after spring runoff for a 66.7% success rate. There were a total of five weirs of which one was still functioning as designed after spring runoff for a 20.0% success rate. Overall 54.2% of the structures monitored in 2005 had not failed during that year.

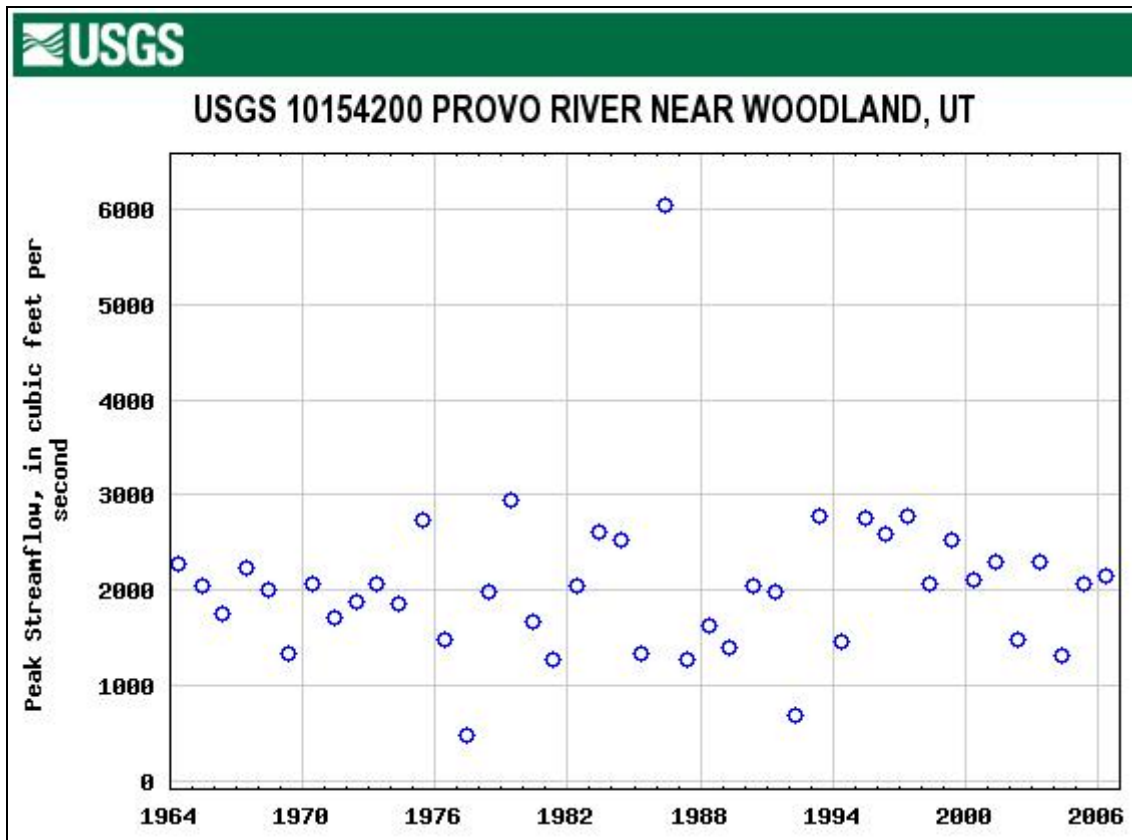
Figure 4-20. Stream Gauge Data for North Fork of the Provo River Site.

Spring runoff in 2005 was an average event based on data from the U.S. Geological Survey (USGS). The closest monitoring gauge is approximately 9,100 meters downstream (obtained from ArcView in the database) of the site. June gauge records indicate that the peak flow was 2,070 cfs and the mean monthly discharge for the same month was 1,052 cfs. See Figure 4-20 for peak stream flows downstream of the site and Flow Data Record No. 3 in Table 4-2 for stream characterization data.

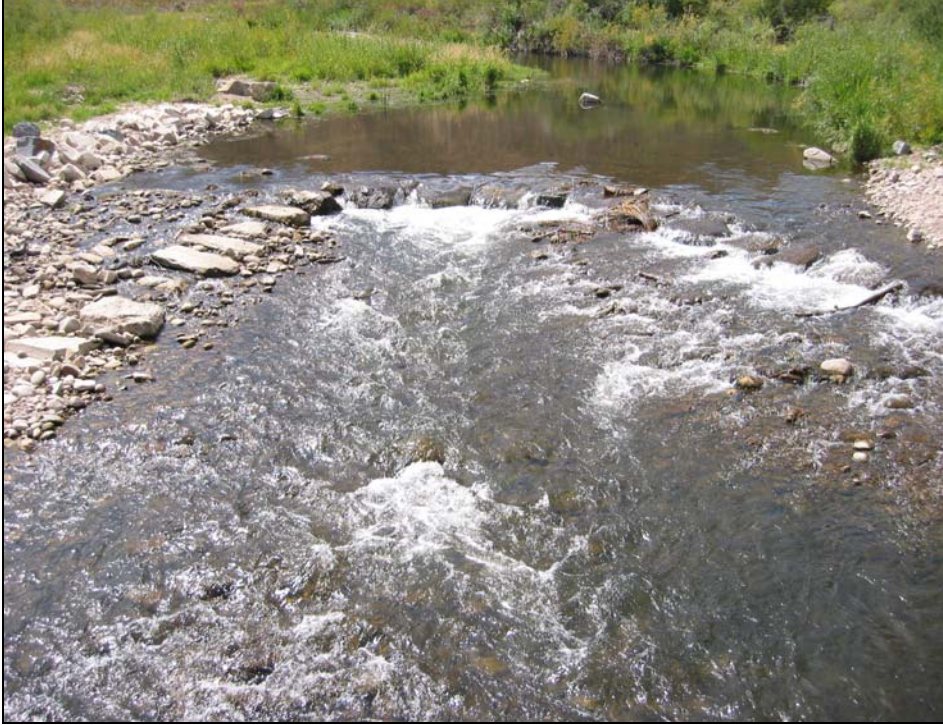
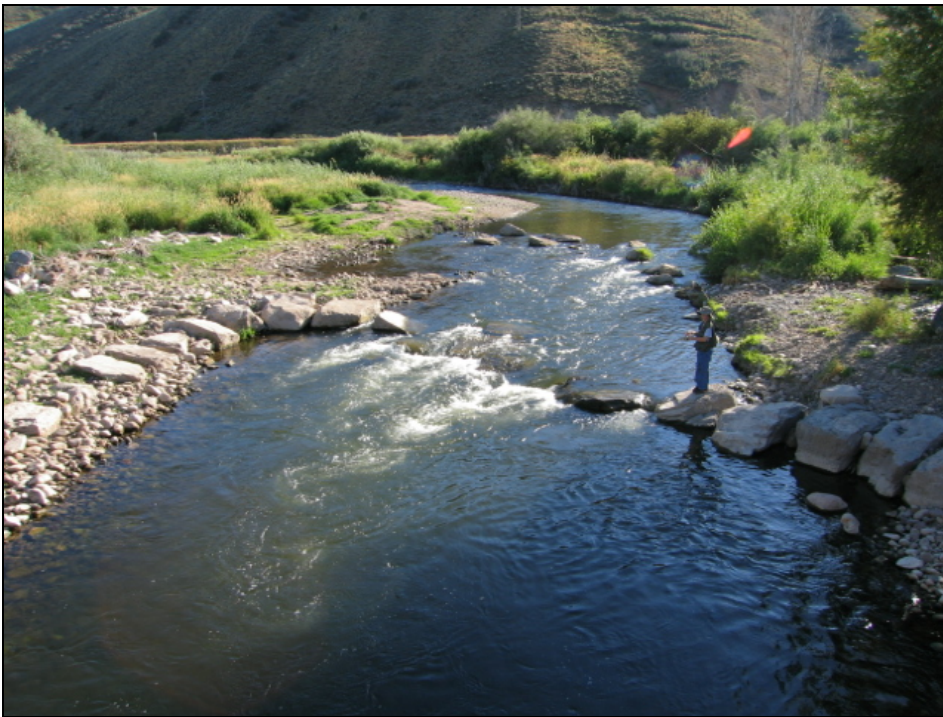
One structure was placed upstream of the bridge at Rockport State Park on the Weber River as shown in Figure 4-25 and Figure 4-26. The structure is a cross-vane placed just upstream of the bridge. The installation did not conform to Rosgen Design Methodology, which dictates the vane arms slope down at a slight angle upstream. In this installation, the vane arms were installed at a slight upstream angle.

Figure 4-25. Rockport Before Runoff.

Figure 4-26. Rockport After Runoff.
