Evaluating Shallow-Flow Rock Structures as Scour Countermeasures at Bridges

EVALUATING SHALLOW-FLOW ROCK STRUCTURES AS
SCOUR COUNTERMEASURES AT BRIDGES

Master of Science

Department of Civil and Environmental Engineering

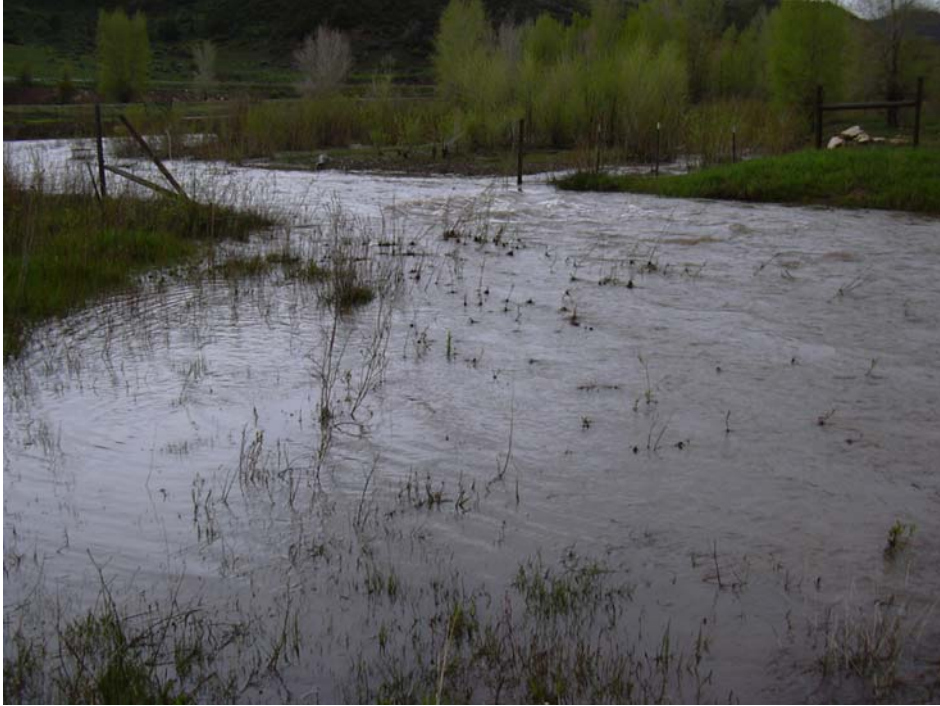
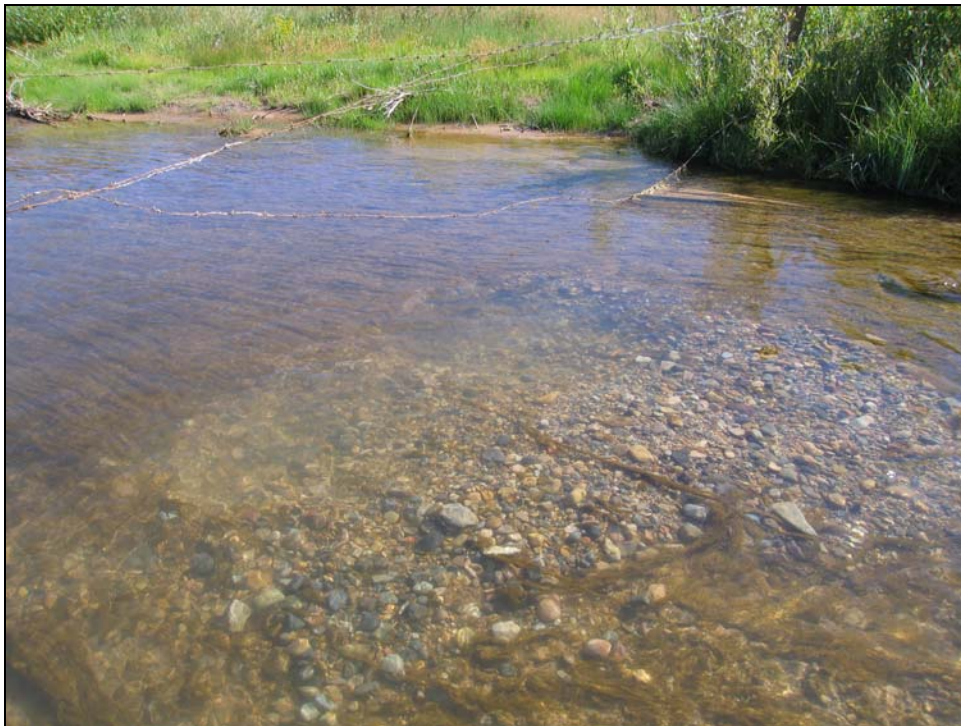
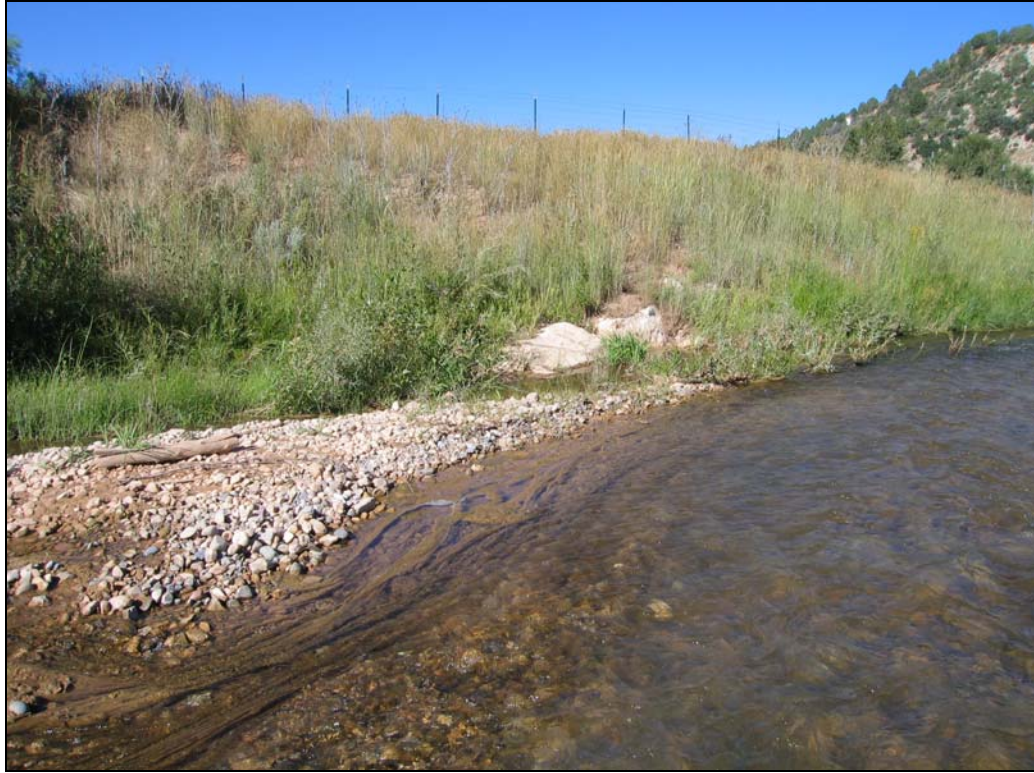
The response of the j-hook and cross-vane was unremarkable under normal flow conditions as compared to spring flows of 2005. In 2005, under average spring flows, both structures were active as water was breaking over the top of them. See Figure 4-27 for cross-vane during 2005 spring runoff. Figure 4-28 and Figure 4-29 were photos taken after 2005 spring runoff.

Figure 4-27. Cross-Vane at Thistle Creek During 2005 Runoff.

Figure 4-28. Cross-Vane at Thistle Creek After Runoff.

Figure 4-29. J-Hook at Thistle Creek After Runoff.
