Pile Downdrag During Construction of Two Bridge Abutments

PILE DOWNDRAW DURING CONSTRUCTION OF
TWO BRIDGE ABUTMENTS

A thesis submitted to the faculty of

Master of Science

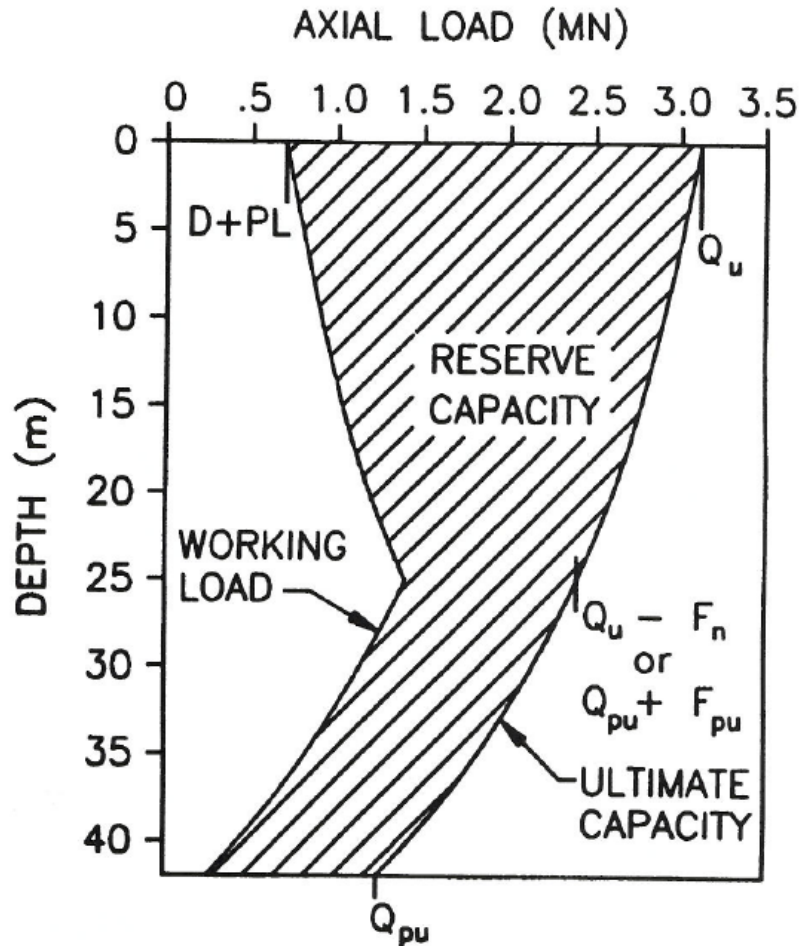
Figure 1-2 Illustration of Potential Reserve Capacity at the Ultimate State due to Reversal of Skin Friction from Positive to Negative after Initial Development of Dragload due to Negative Skin Friction (Briaud and Tucker, 1997)

The load distribution along the length of the pile after the development of dragload and at the ultimate state is illustrated in Figure 1-2. This figure highlights the concept that at the ultimate state, an increased amount of reserve capacity (remaining capacity before failure of the pile) could be developed due to negative skin friction changing to positive and toe resistance becoming fully developed. In Figure 1-2, D is the applied dead load, PL is the permanent live load, Q_u is the ultimate soil capacity, F_n is the

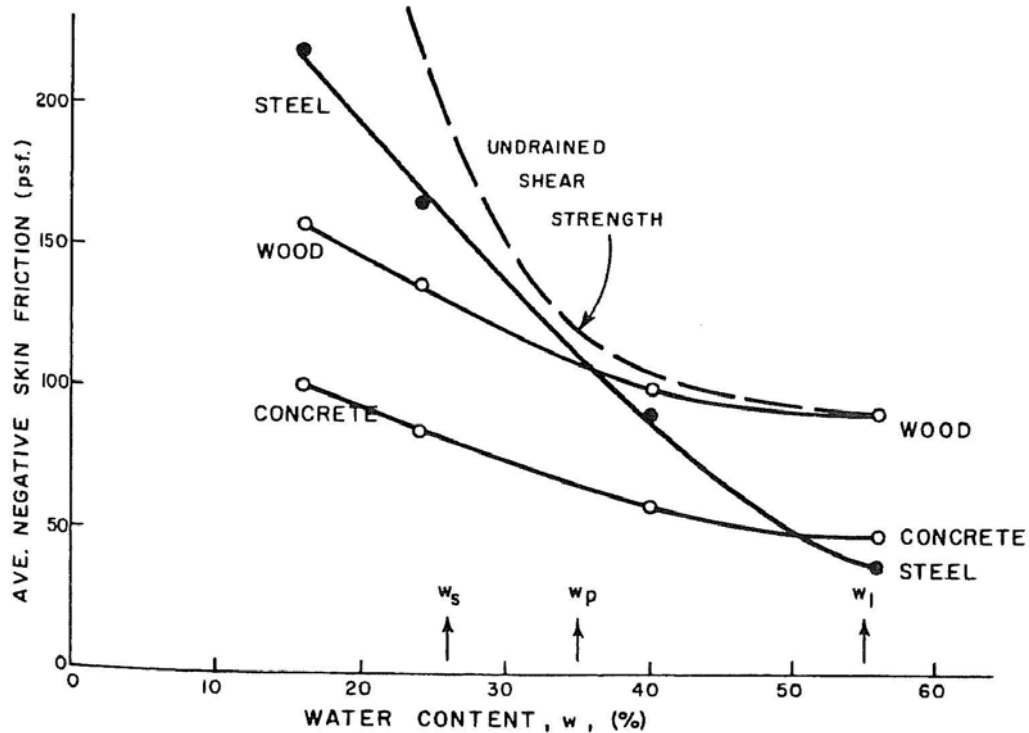
Figure 2-9 Plot to Show Relationship between Water Content, Pile Material and Downdrag Force (Koerner and Mukhopadhyay, 1972)

Tests on pile material were inconclusive, although tests showed that steel tends to follow the undrained shear strength curve until the water content becomes greater than the plastic limit. Concrete and wood begin lower, but tend to become parallel to the undrained shear strength curve with wood developing the full shear strength at the liquid limit. As was expected, the downdrag decreased as the water content increased due to the soil becoming less stiff as shown in Figure 2-9. This is expected because the soil loses shear strength as the water content increases.

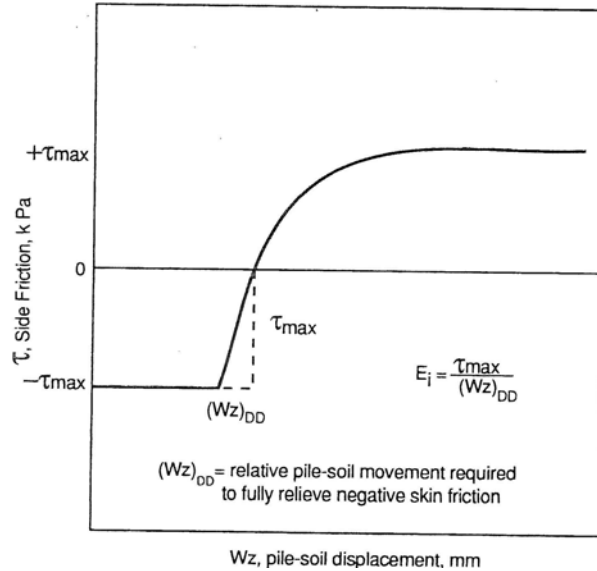
Figure 2-10 Depiction to Show Process of Obtaining E_i as Used in Method by Leifer (1994)

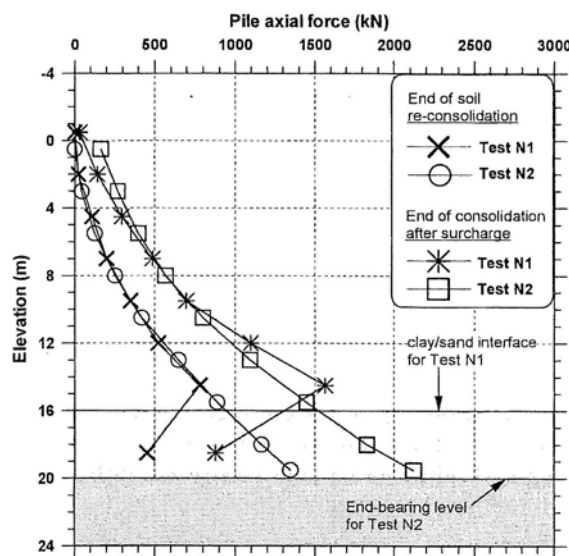
Figure 2-13 Comparison of Downdrag Loads Due to End-Bearing (from Leung et al. 2004)

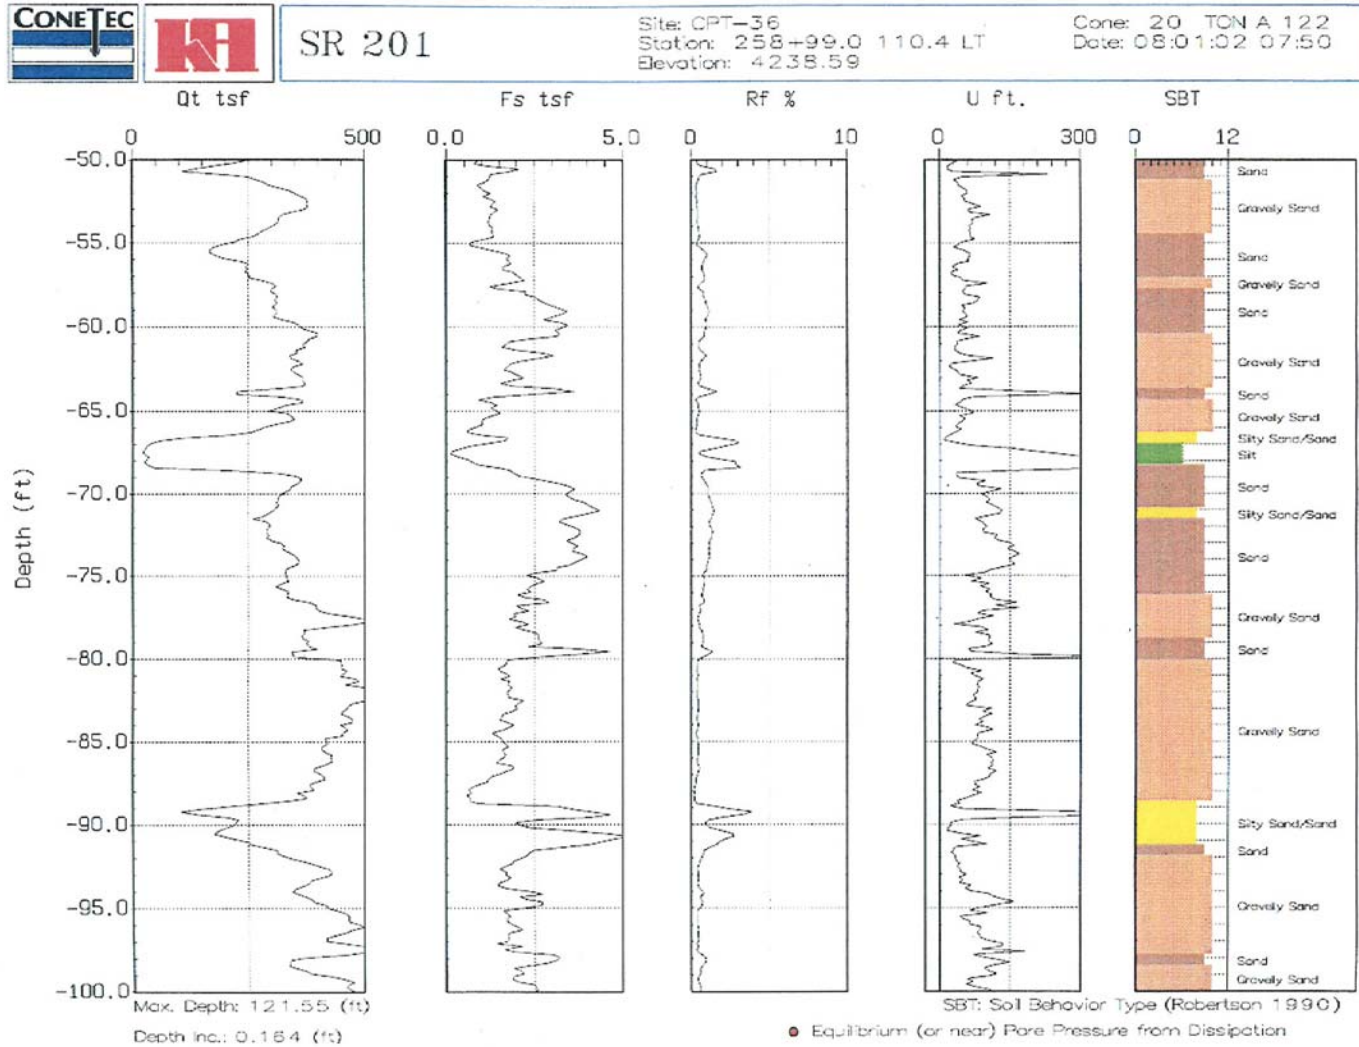
Figure 3-10 Log of CPT Sounding for CPT-36 at Redwood Road and SR-201 Site

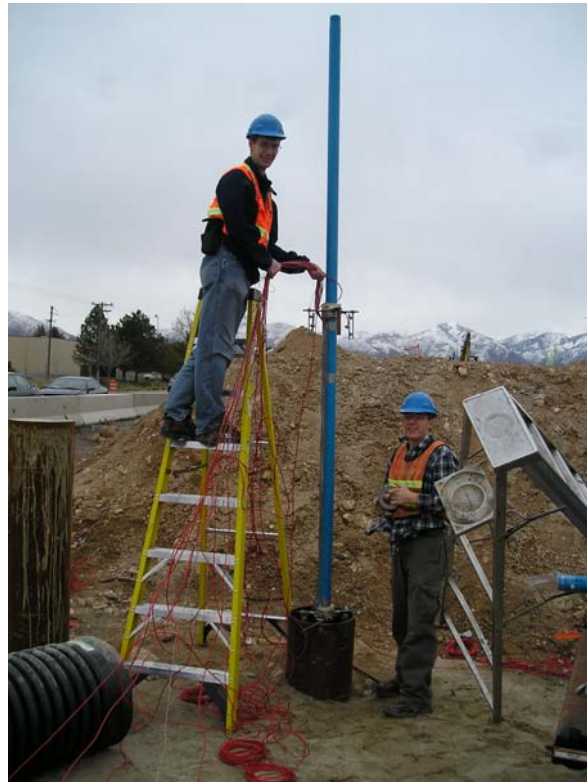
Figure 4-8 Installing Pipe Sections One at a Time at Redwood Road and SR-201 (author photo)

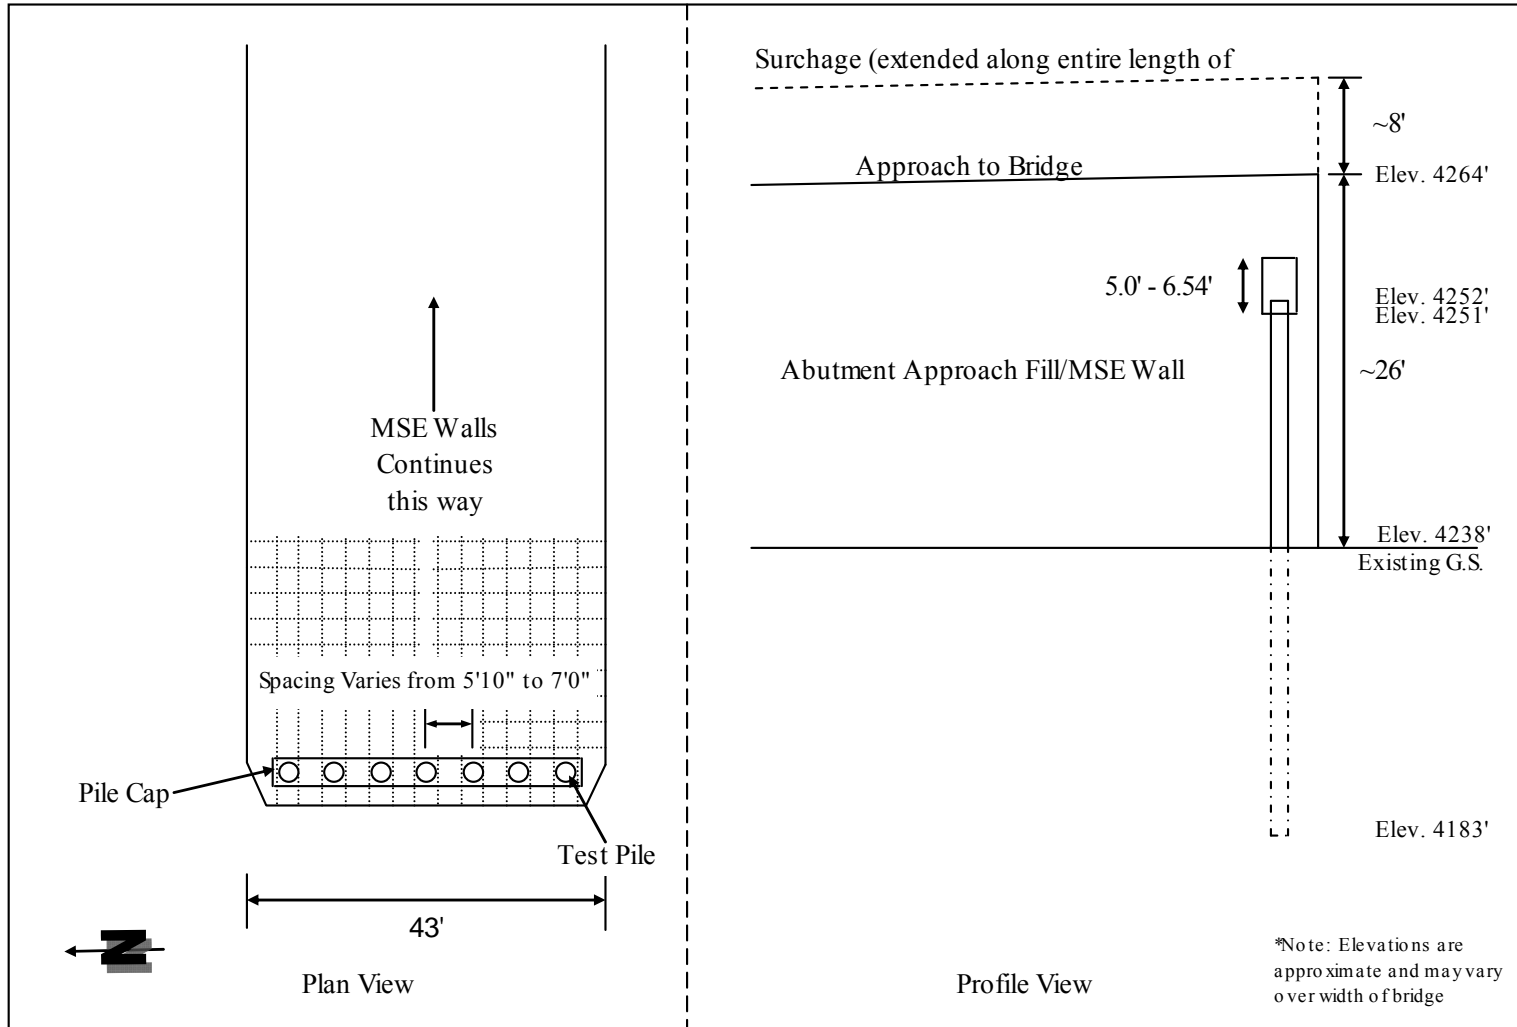
Figure 5-1 Schematic of East Abutment and Approach Fill at Redwood Road and SR-201 Site

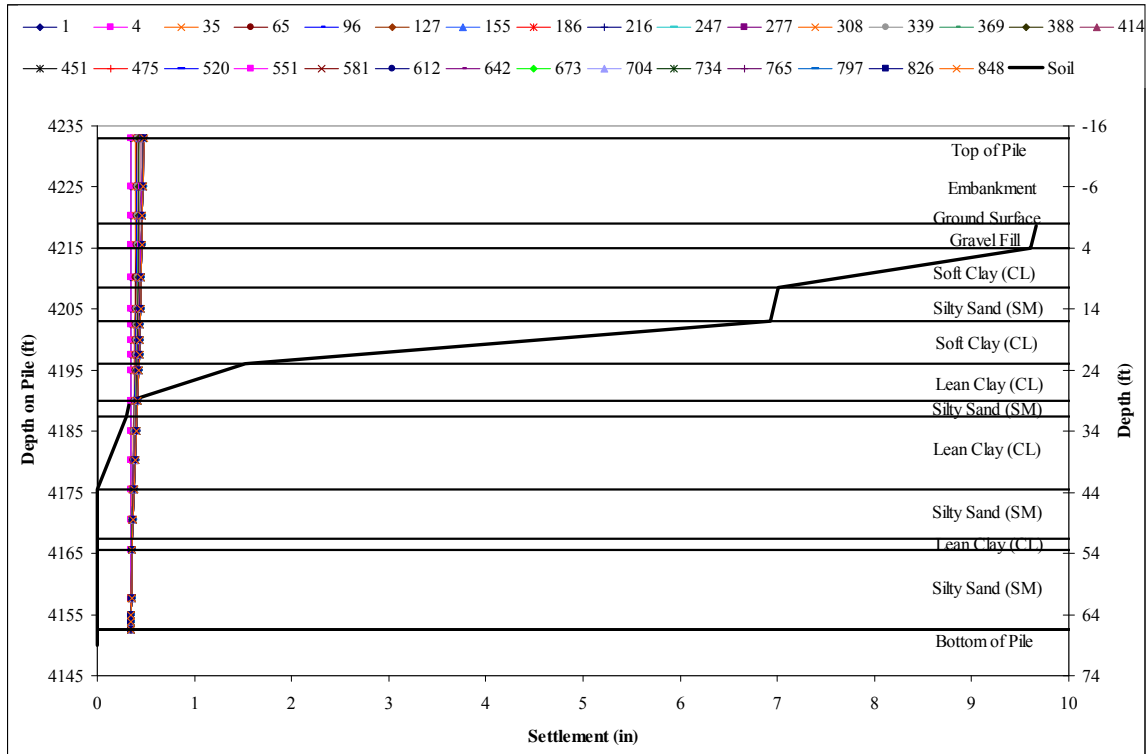
Figure 6-19 Settlement of Soil and Pile for SLCIA Site
