Effectiveness of Compacted Fill and Rammed Aggregate Piers for Increasing Lateral Resistance of Pile Foundations

A thesis submitted to the faculty of
Brigham Young University
in partial fulfillment of the requirements for the degree of
Master of Science

Department of Civil and Environmental Engineering

December 2010

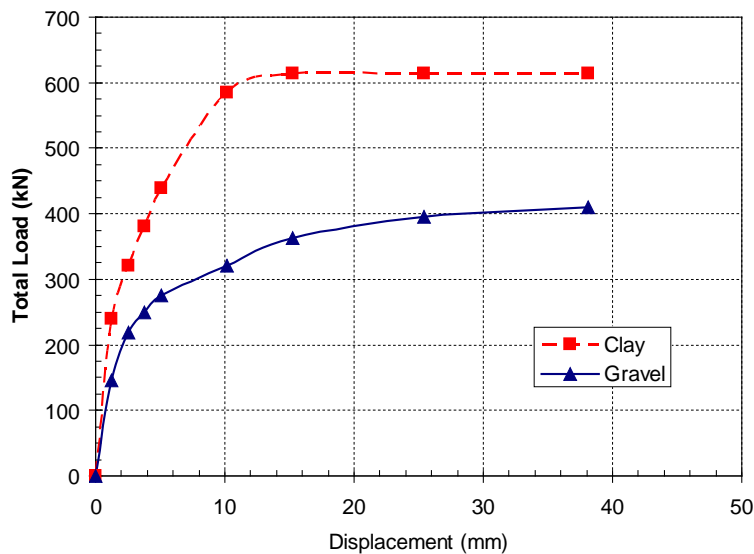
Figure 2-4 Comparison of passive force provided by stiff partially saturated clay and compacted sandy gravel against 1.1m deep x 1.9 m wide cap block (Mokwa and Duncan 2001)

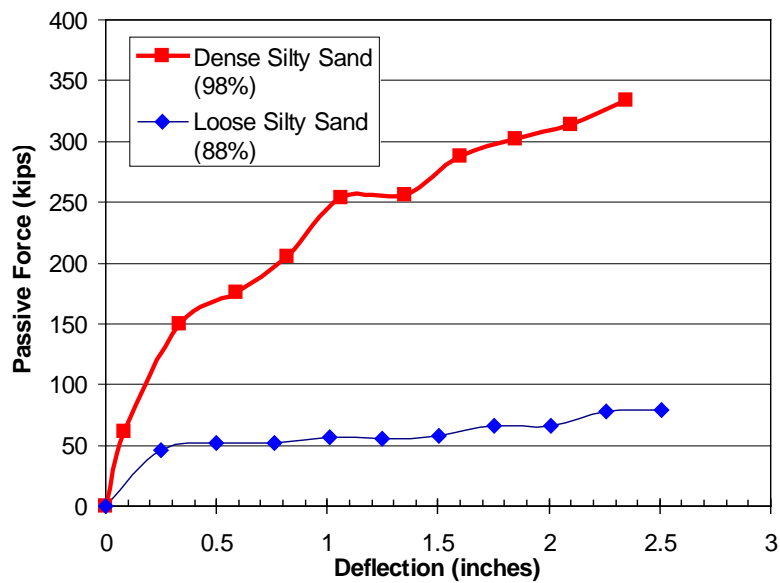
Figure 2-5 Measured passive force versus deflection relationships for two full-scale tests with silty sand compacted to 88 percent and 98 percent of the modified Proctor maximum unit weight (Rollins, Kwon, and Gerber 2008)

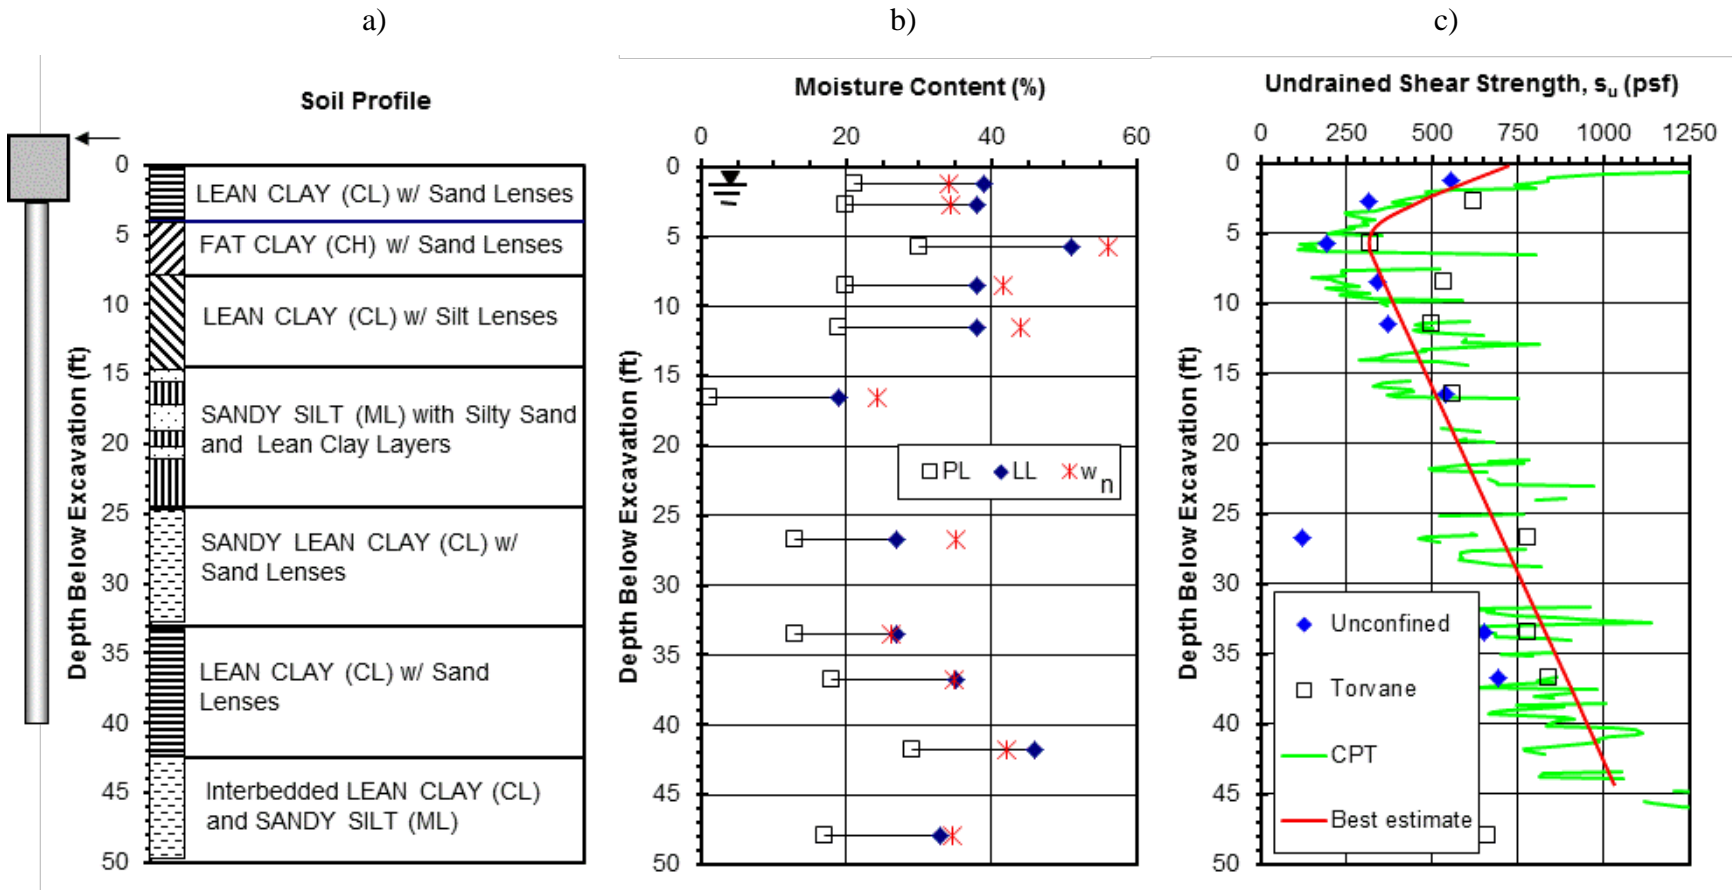
Figure 3-3 Plot of (a) soil profile, (b) Atterberg limits and natural water content versus depth, and (c) undrained shear strength versus depth

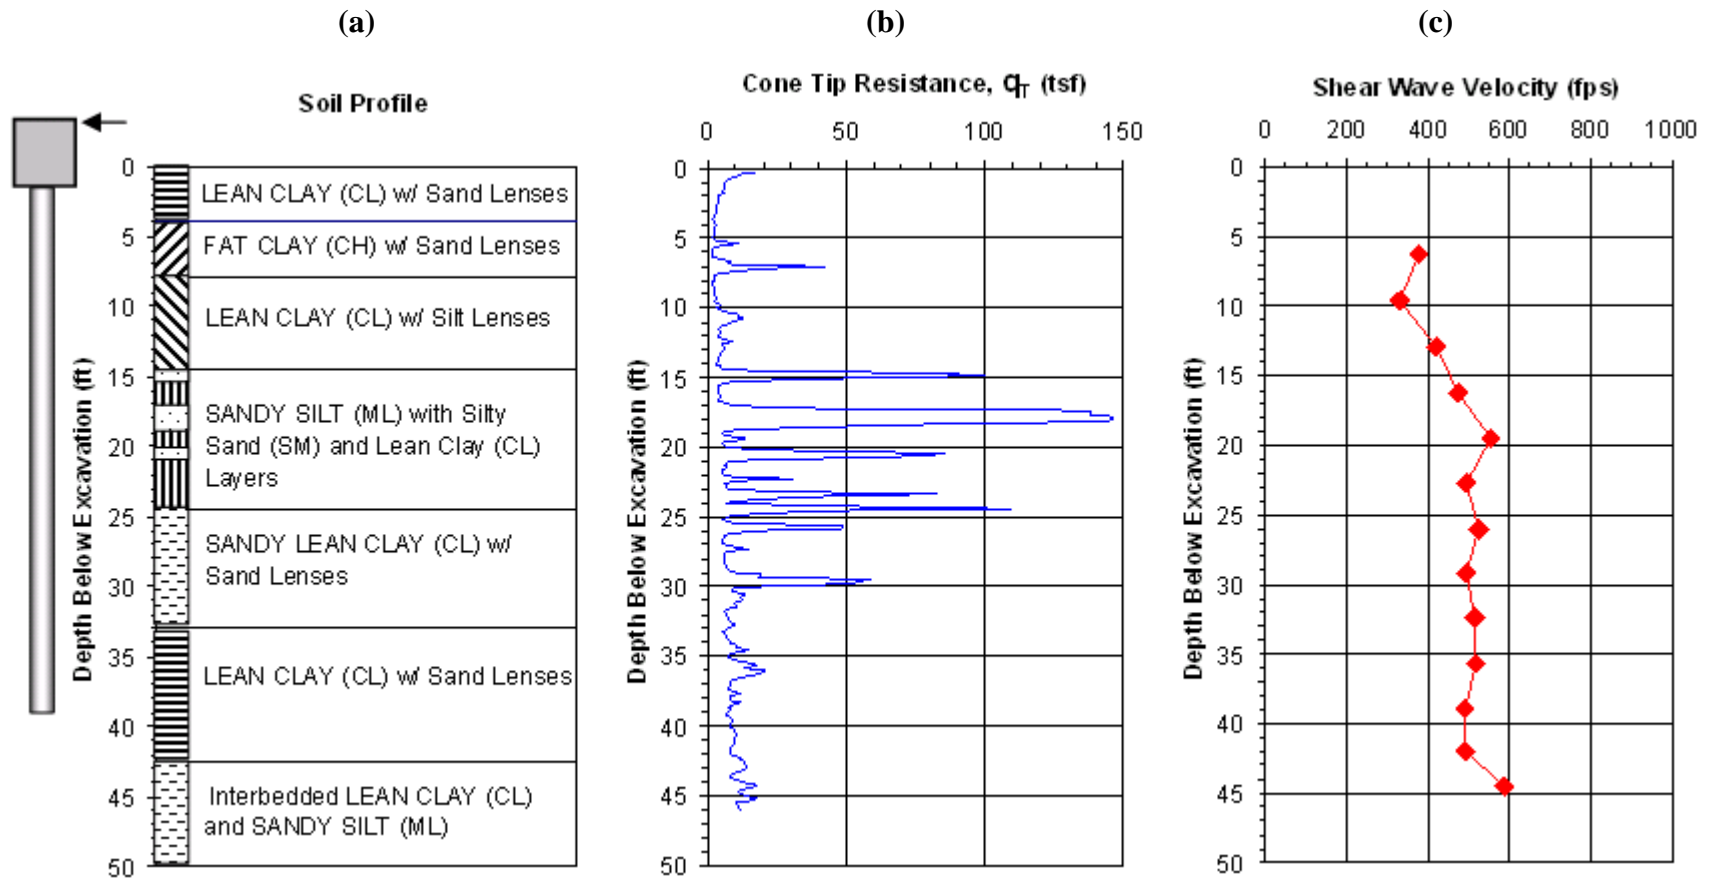
Figure 3-6 Plot of (a) soil profile, (b) cone tip resistance versus depth, and (c) shear wave velocity versus depth from seismic cone testing

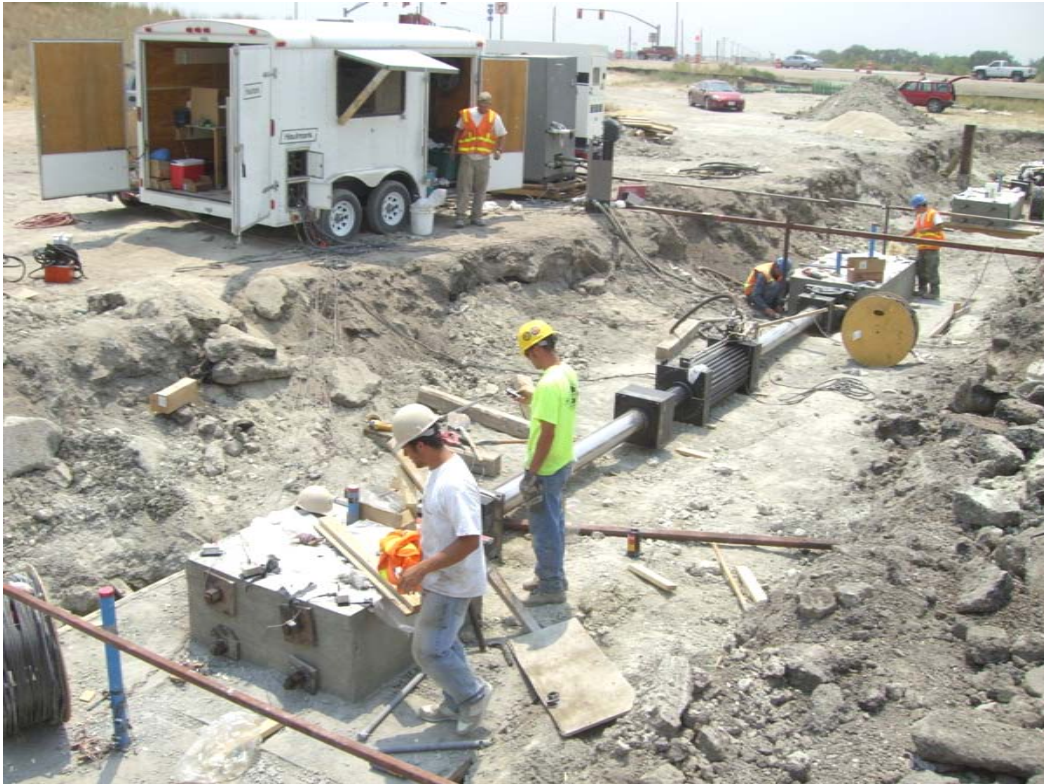
Figure 4-9 Photo of actuator setup between caps 1 & 2

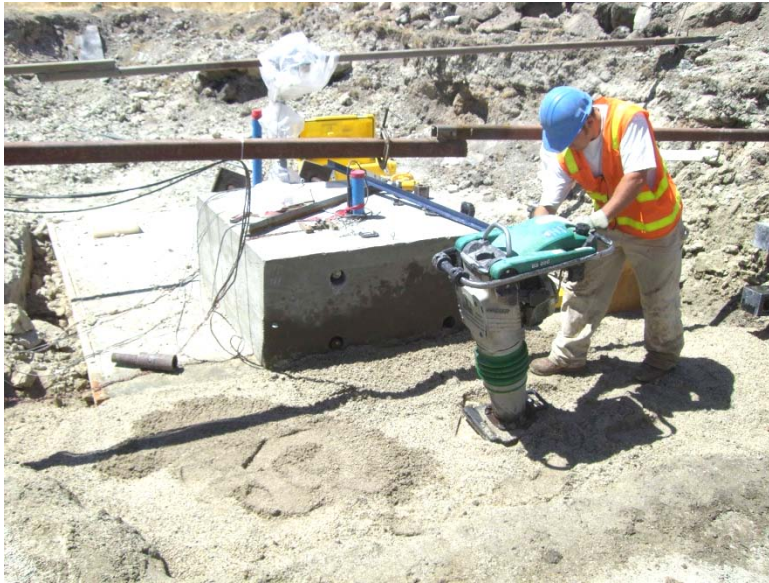
Figure 5-3 Passive resistance region of compacted sand fill being compacted

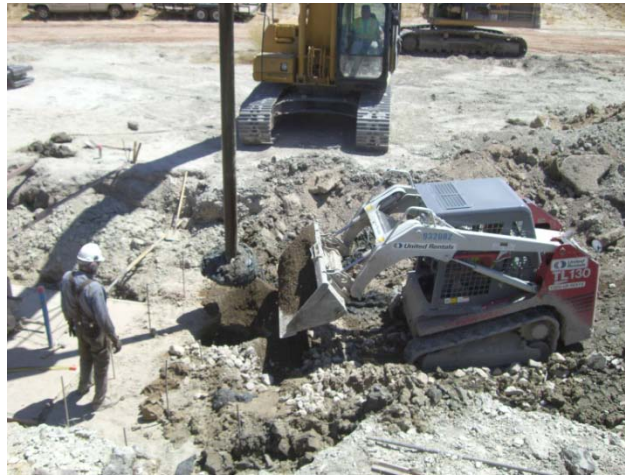
Figure 5-1 Placement of 1 ft lift for compaction of main body of RAP

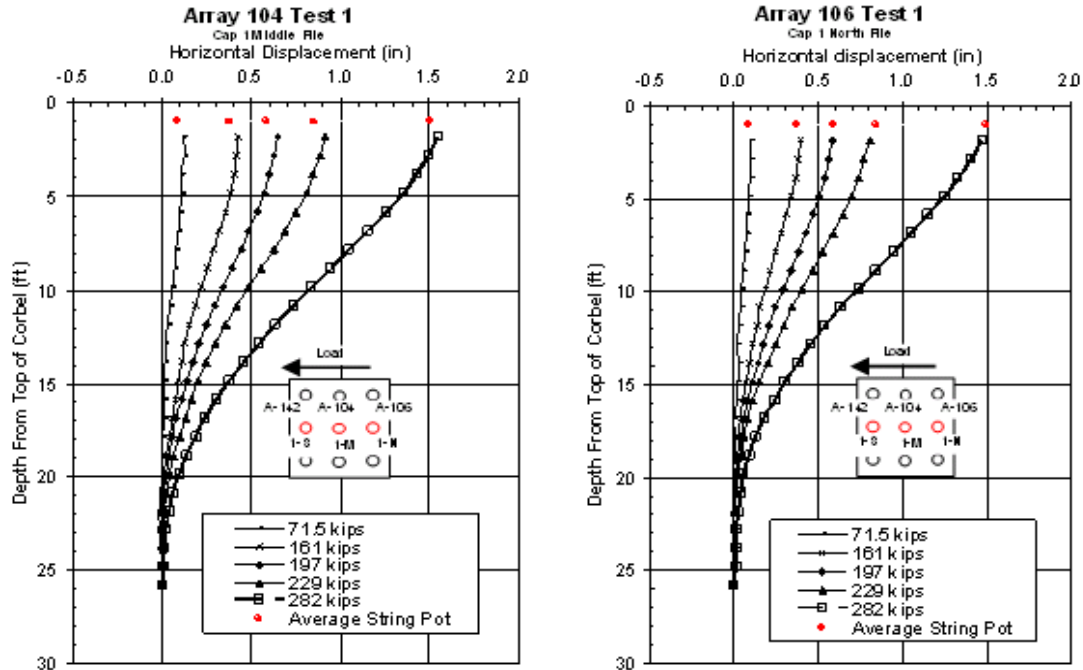
Figure 7-7 Deflection versus depth curves for pile cap 1 for each increment of the virgin clay test (Test 1), with pile head displacements from the string potentiometers also shown

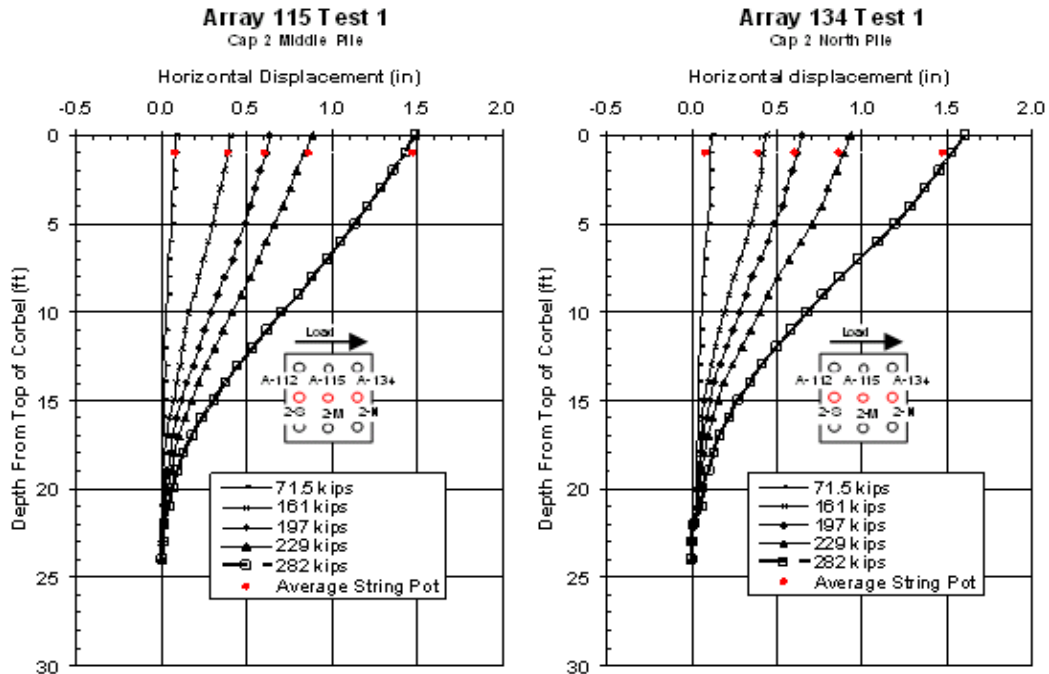
Figure 7-8 Deflection versus depth curves for pile cap 2 for each increment of the virgin clay test (Test 1), with pile head displacements from the string potentiometers also shown

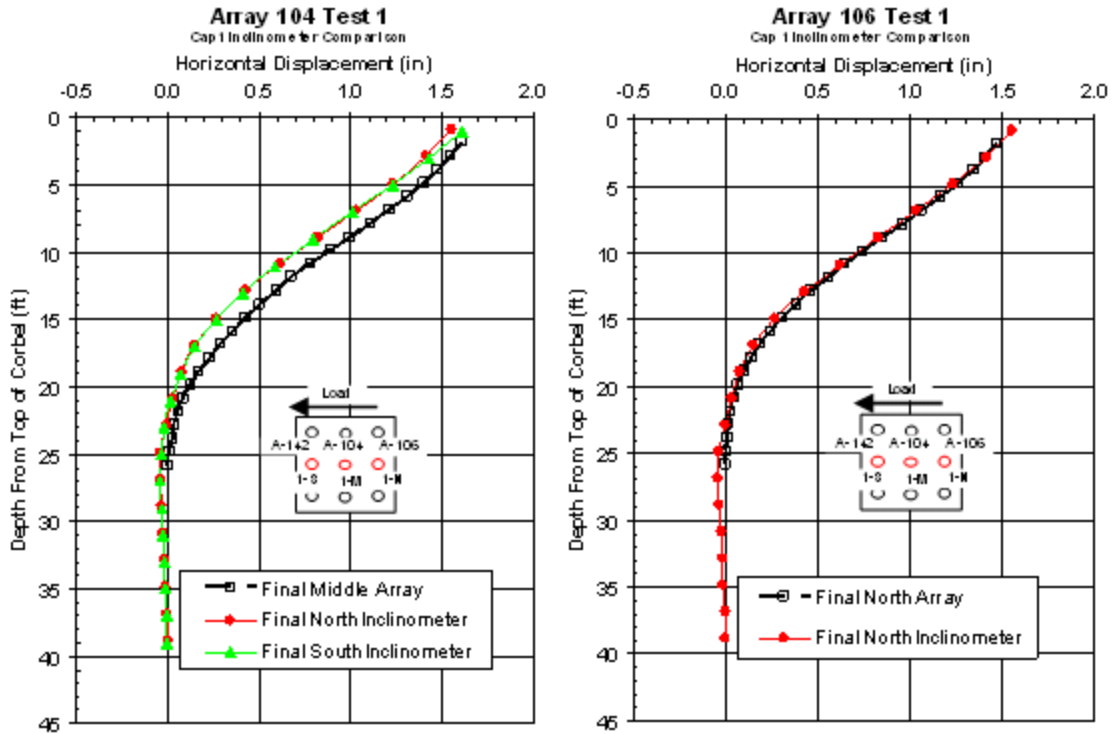
Figure 7-9 Comparison of depth versus deflection curves for the piles in pile cap 1 from the north and south inclinometers, and shape array 104 and shape array 106 in the virgin clay test (Test 1)

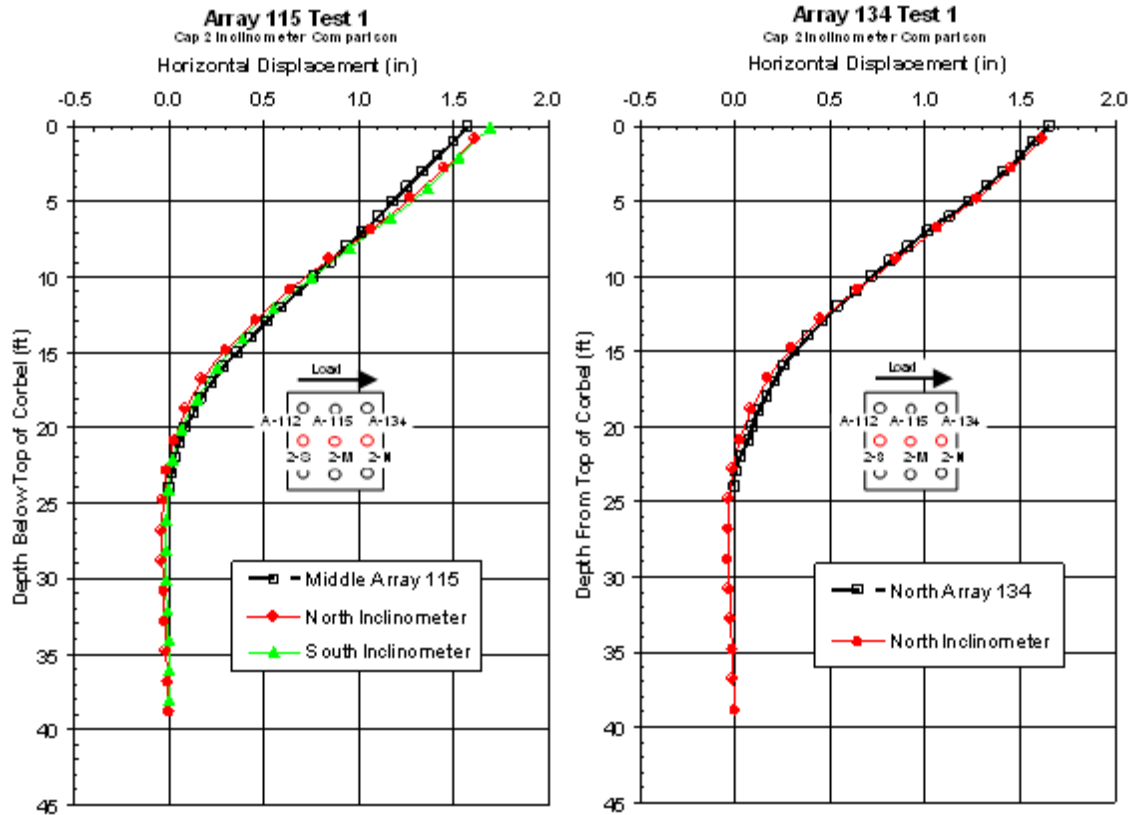
Figure 7-10 Comparison of depth versus deflection curves for the piles in pile cap 2 from the north and south inclinometers, and shape array 115 and shape array 134 in the virgin clay test (Test 1)

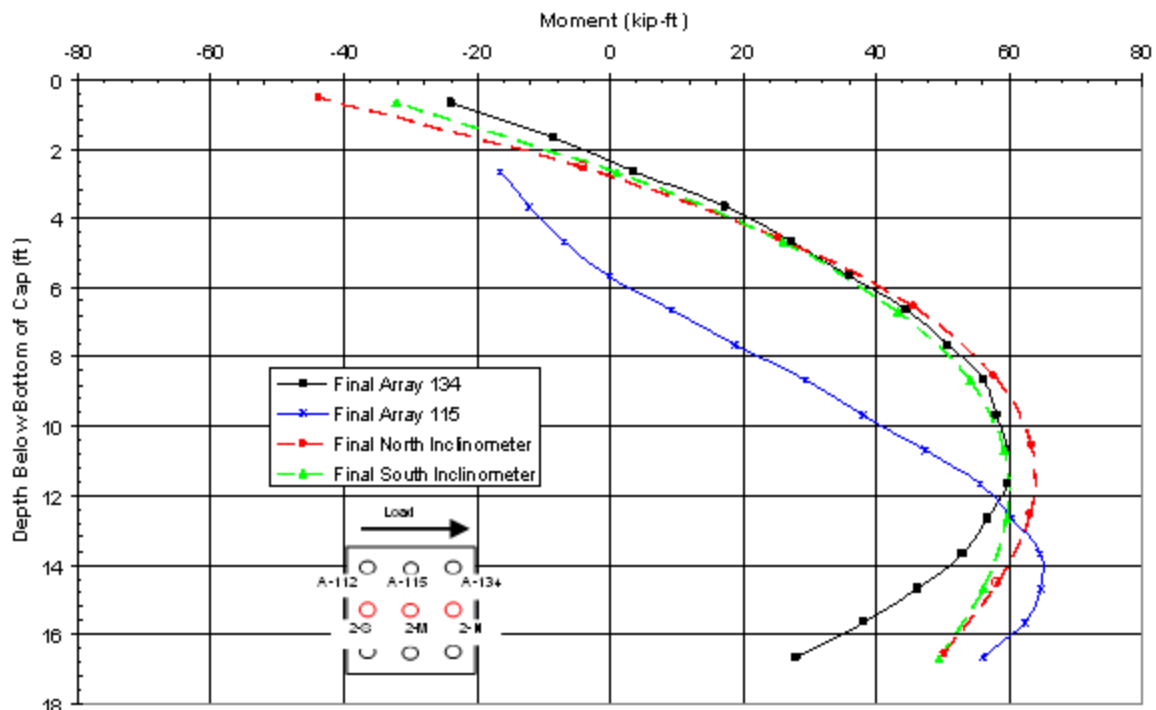
Figure 7-16 Moment versus depth comparison for the piles in pile cap 2 based on deflections measured from the north and south inclinometers, shape array 104 and shape array 134 during the virgin clay test (Test 1)

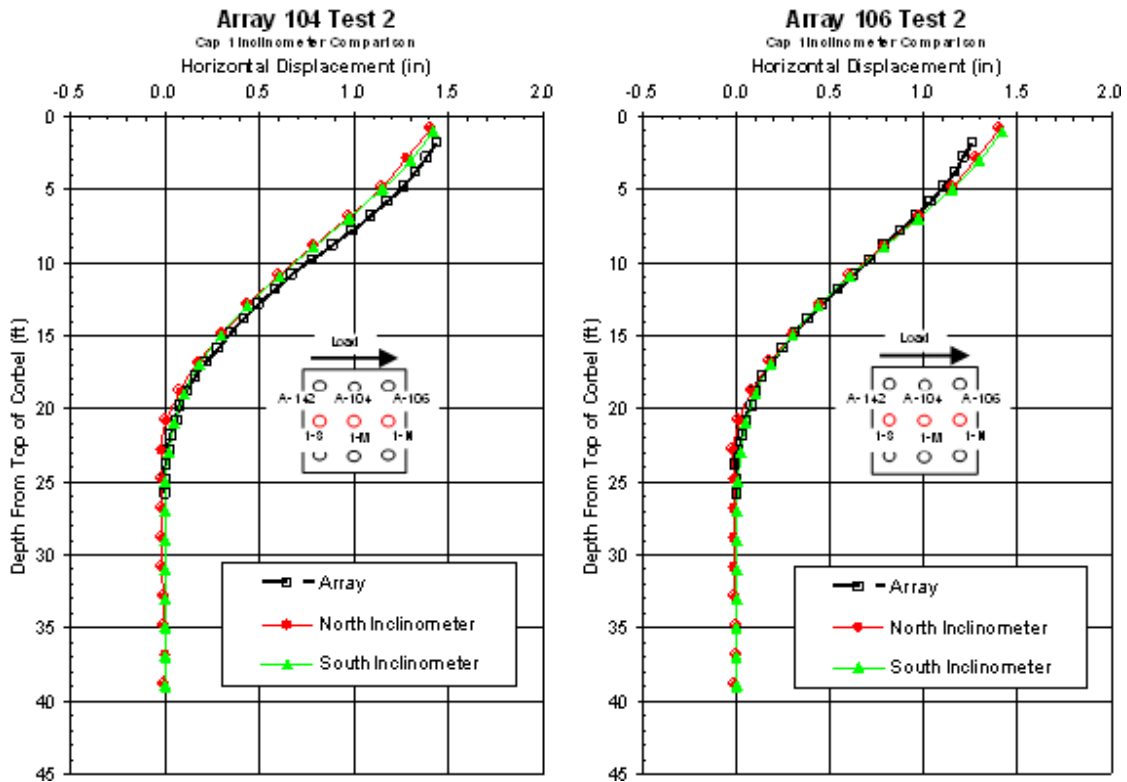
Figure 7-27 Comparison of depth versus deflection curves for the piles in pile cap 1 from the north and south inclinometers, and shape array 104 and shape array 106 in the virgin clay test after excavation (Test 2)

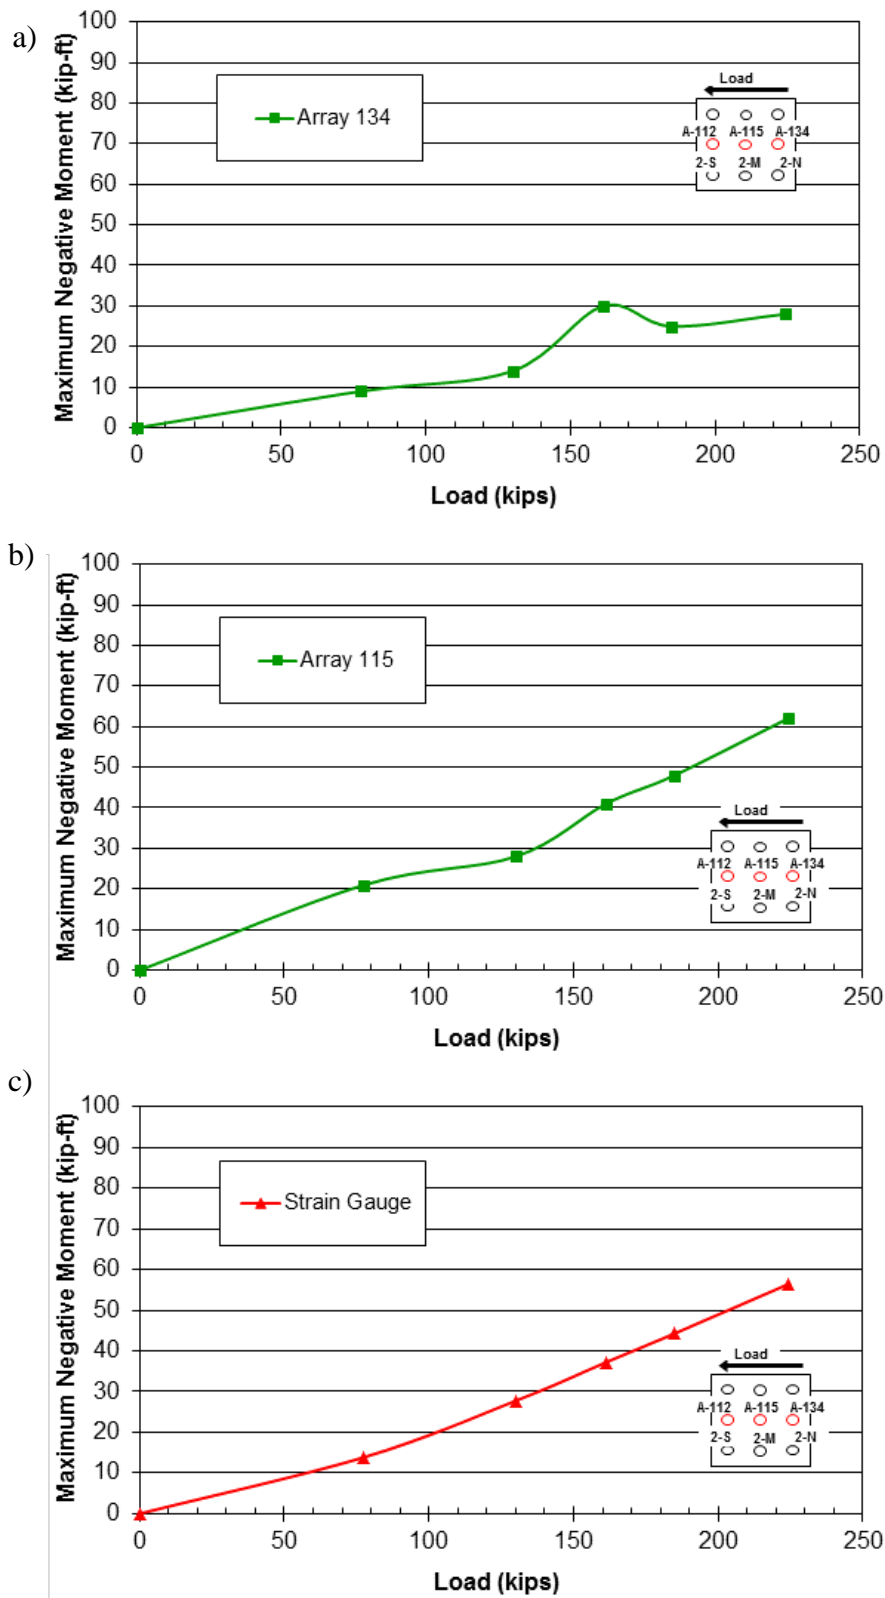
Figure 7-34 Maximum negative moment versus total pile cap load for piles (a) 2-N, (b) 2-M, and (c) 2-S in cap 2 during the virgin clay test (Test 2)

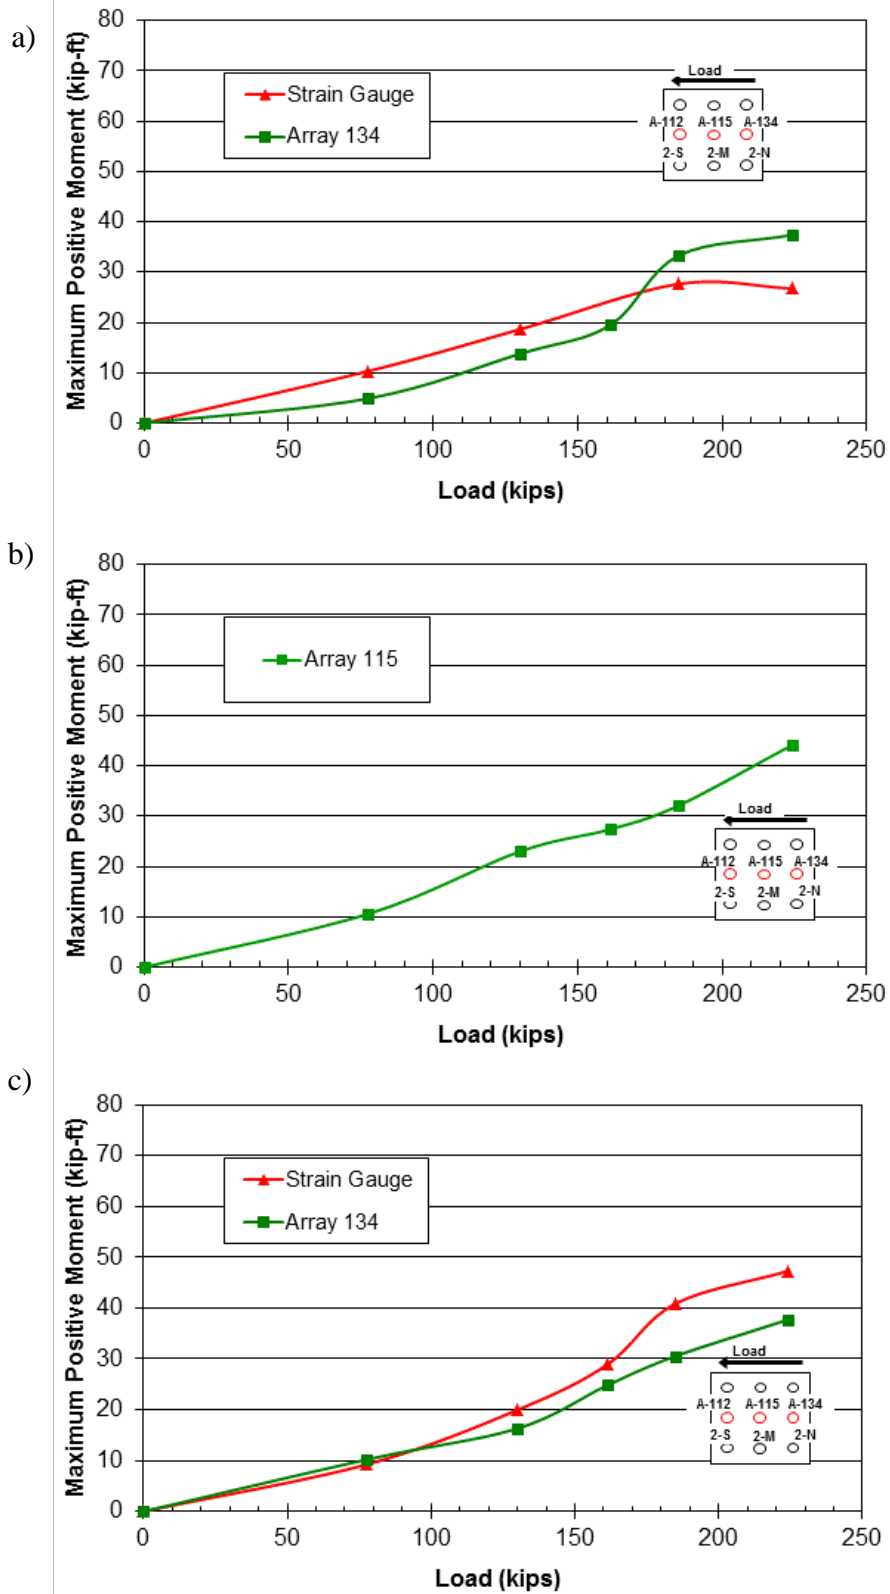
Figure 7-35 Maximum positive moment versus total pile cap load for piles (a) 2-N, (b) 2-M, and (c) 2-S in cap 2 during the virgin clay test (Test 2)

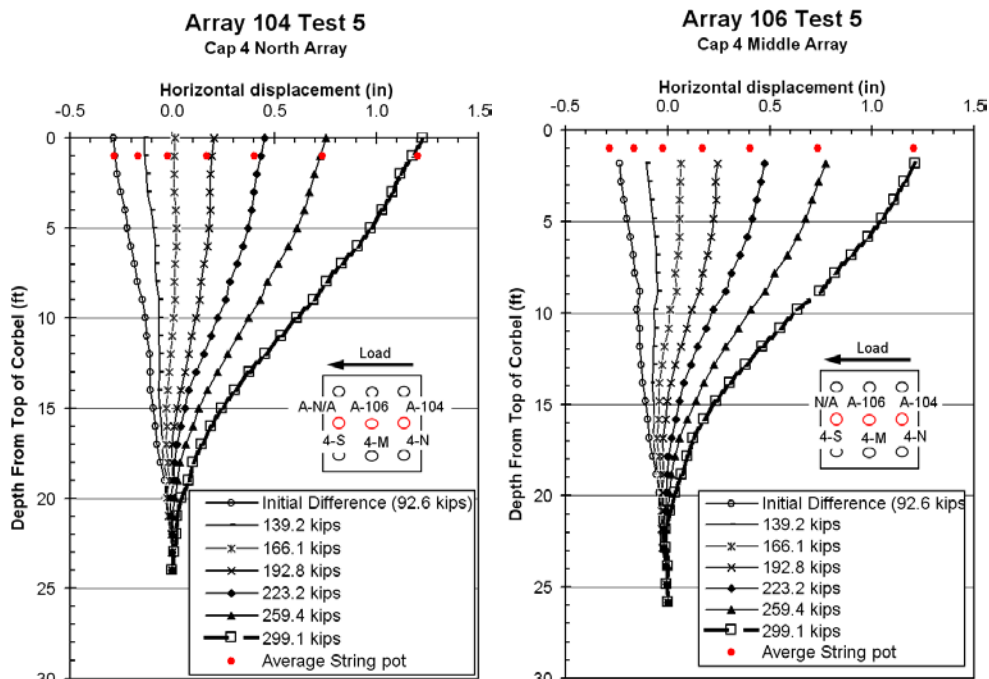
Figure 8-6 Deflection versus depth curves for pile cap 4 for each increment of testing of compacted fill under the cap (Test 5), with pile head displacements from the string potentiometers also shown

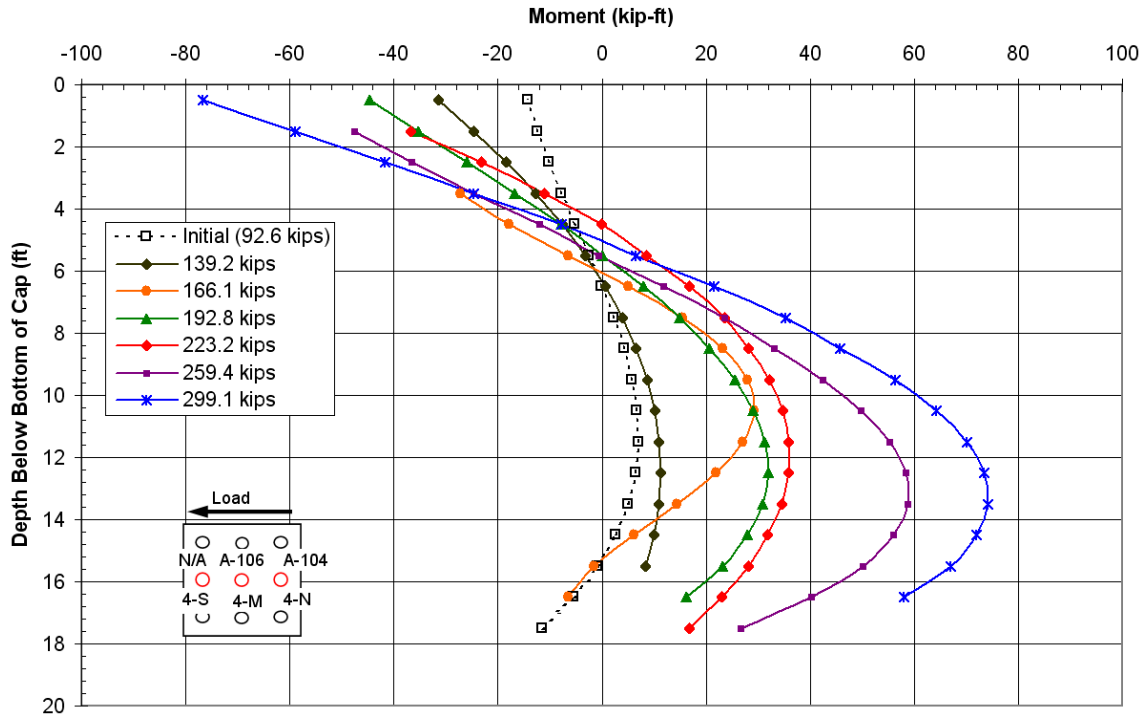
Figure 8-8 Moment versus depth curve for the center pile of pile cap 4 (4-M) based on incremental deflection versus depth curves measured from shape array 106 during testing of compacted fill under the cap (Test 5)

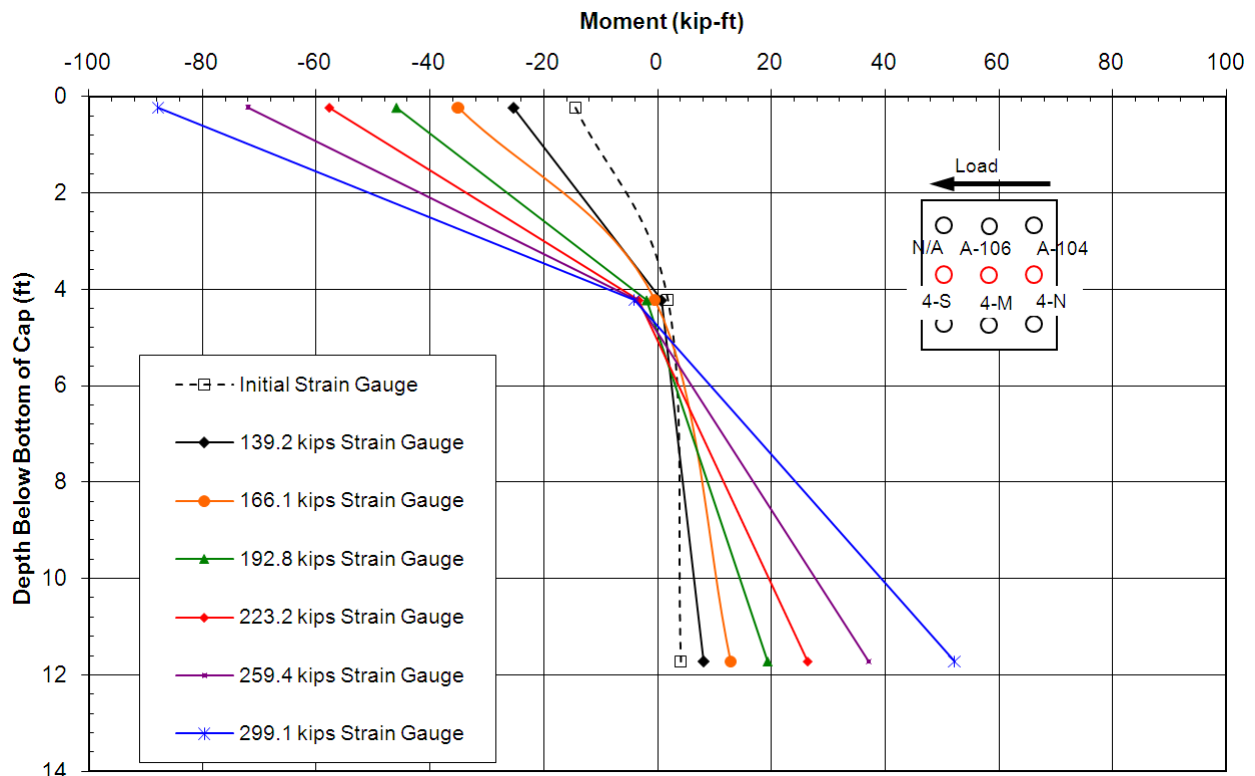
Figure 8-9 Moment versus depth curve for the south pile of pile cap 4 (4-S) based on incremental deflection versus depth curves measured from strain gauges during testing of compacted fill under the cap (Test 5)

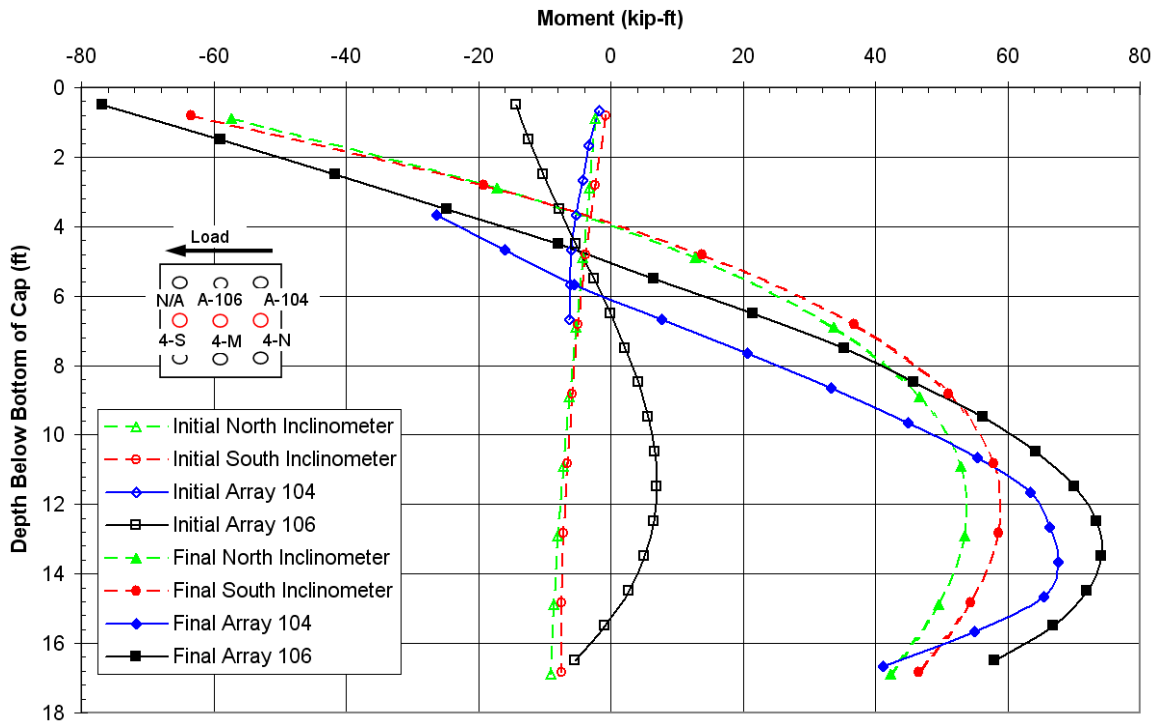
Figure 8-10 Moment versus depth comparison for the piles in pile cap 4 based on deflections measured from the north and south inclinometers, shape array 104 and shape array 106 during testing of compacted fill under the cap (Test 5)

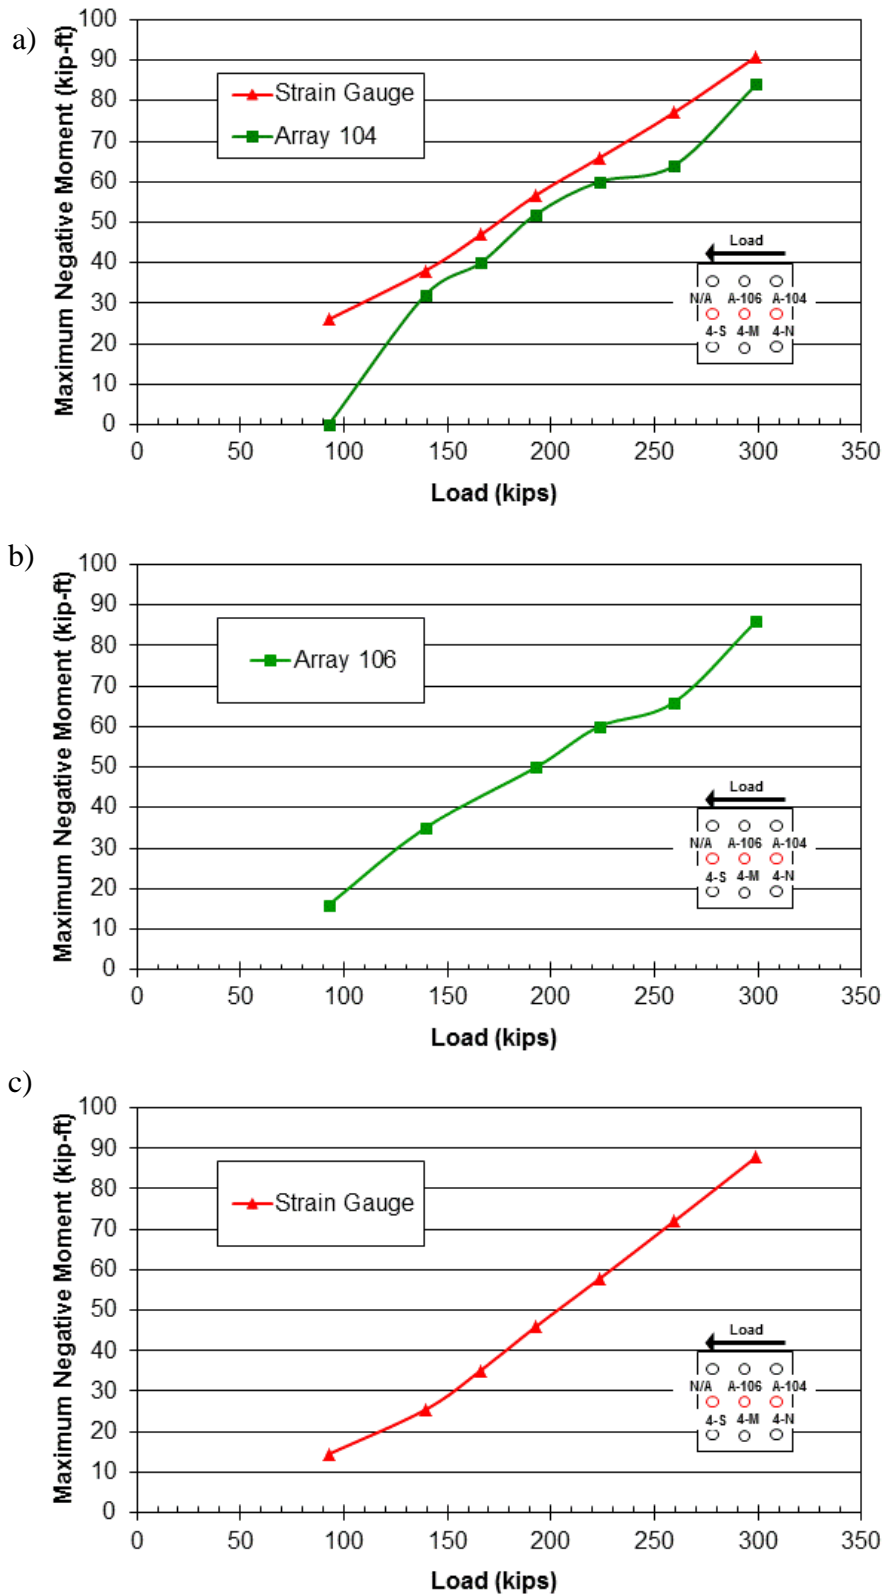
Figure 8-11 Maximum negative moment (base of cap) versus total pile cap load for piles (a) 4-N, (b) 4-M, and (c) 4-S in cap 4 during testing of compacted fill under the cap (Test 5)

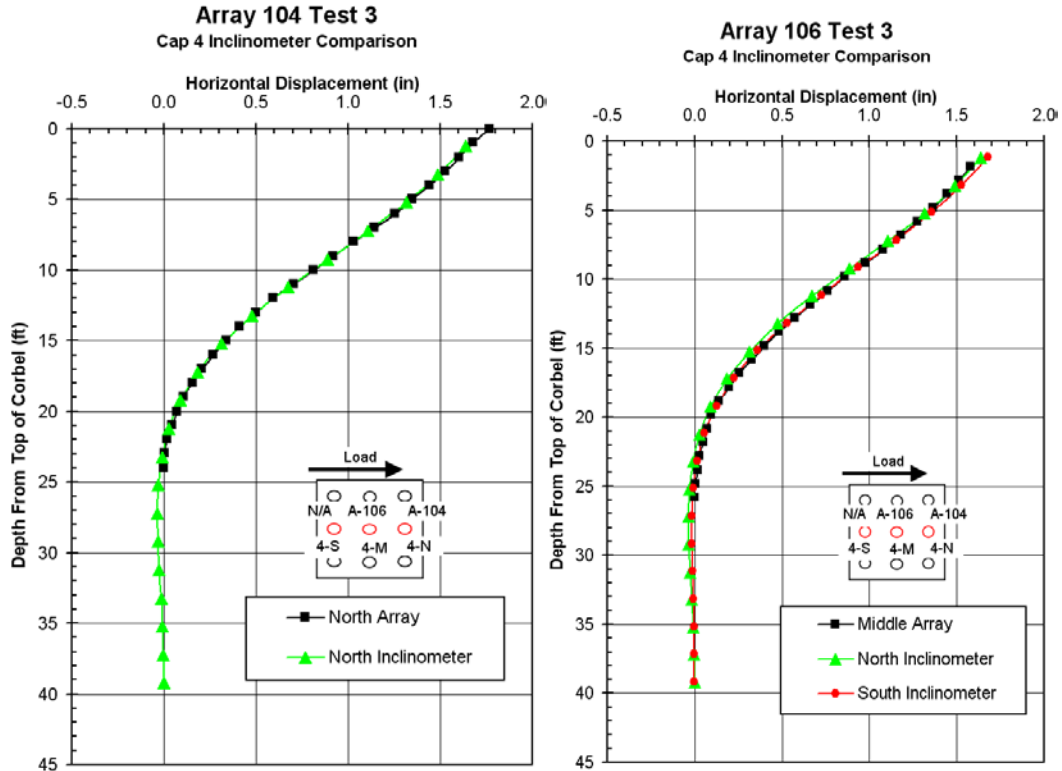
Figure 8-17 Comparison of depth versus deflection curves for the piles in pile cap 4 from the north inclinometer with shape array 104 and the north and south inclinometers with shape array 106 for the compacted fill test with no soil adjacent to the cap (Test 3)

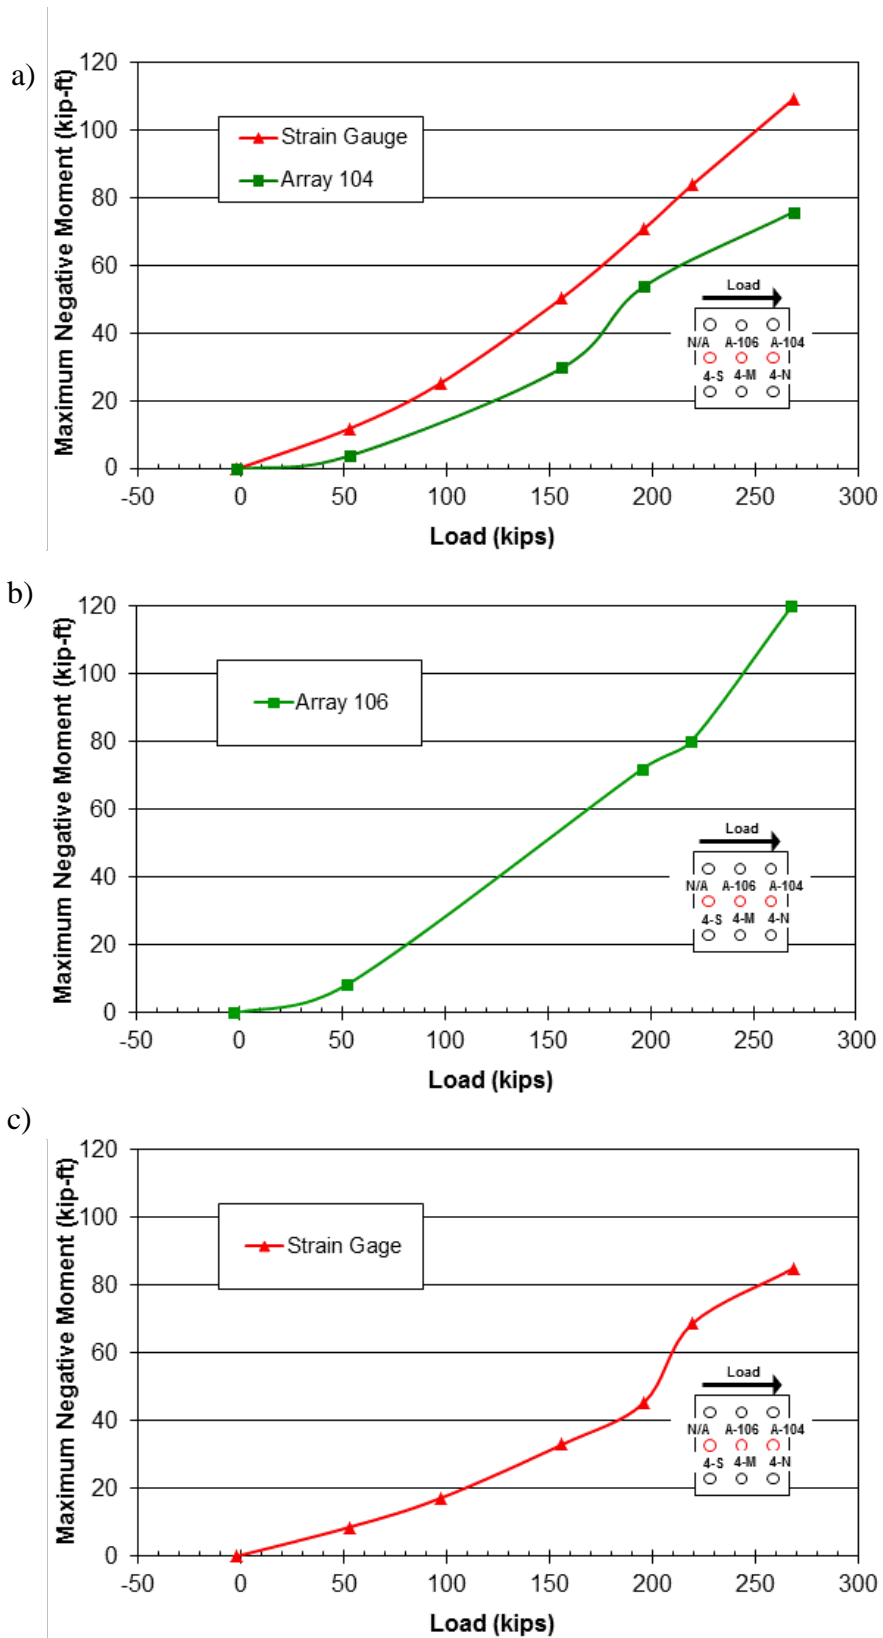
Figure 8-23 Maximum negative moment (base of cap) versus total pile cap load for piles (a) 4-N, (b) 4-M, and (c) 4-S in cap 4 during the compacted fill test with no soil adjacent to the cap (Test 3)

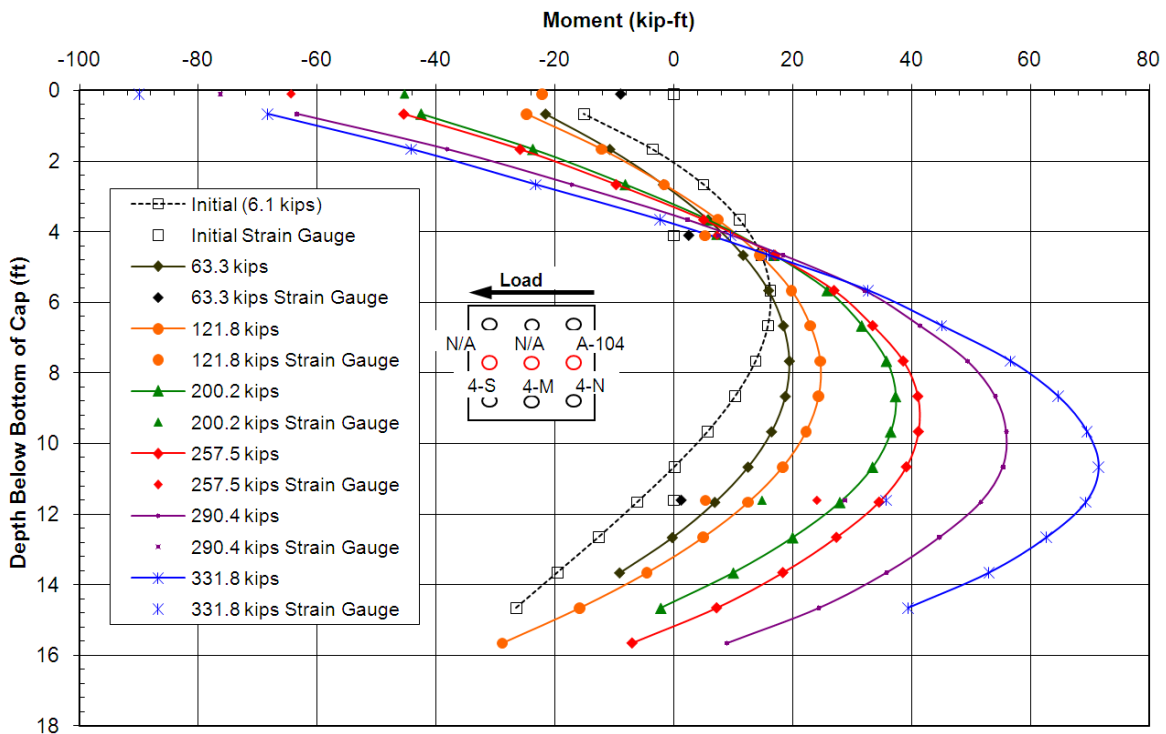
Figure 9-7 Moment versus depth curve for the north center pile of pile cap 4 (4-N) based on incremental deflection versus depth curves measured from shape array 104 during the RAP test (Test 6), with point moments measured from strain gauges at various depths also shown
