Effectiveness of Compacted Fill and Rammed Aggregate Piers for Increasing Lateral Resistance of Pile Foundations

A thesis submitted to the faculty of
Brigham Young University
in partial fulfillment of the requirements for the degree of
Master of Science

Department of Civil and Environmental Engineering

December 2010

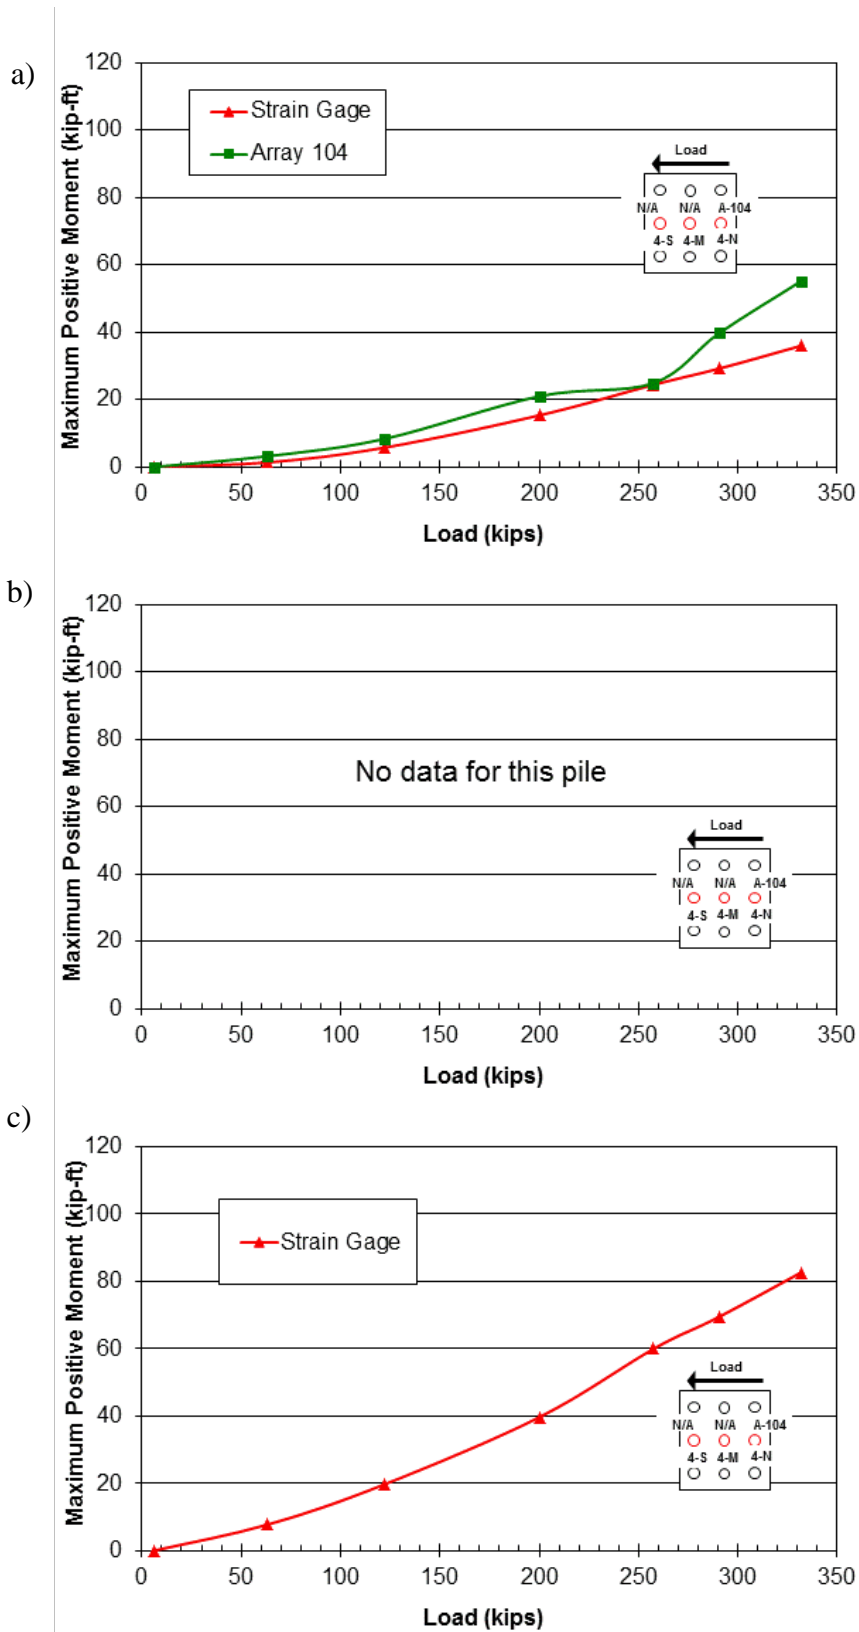
Figure 9-11 Maximum positive moment versus total pile cap load for piles (a) 4-N, (b) 4-M, and (c) 4-S in cap 1 during the RAP test (Test 6)

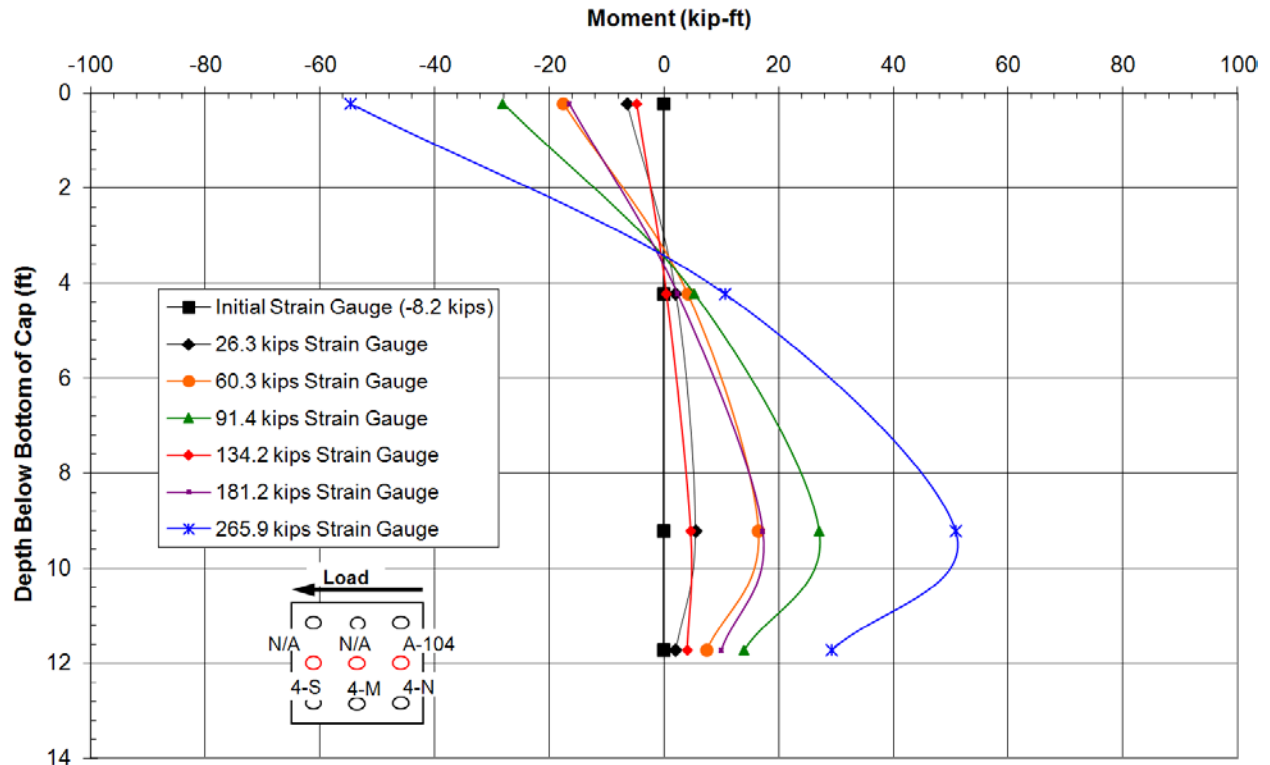
Figure 9-19 Moment versus depth curve for the south center pile of pile cap 4 (4-S) based on strain gauge readings at various depths for the RAP test after excavation (Test 7)

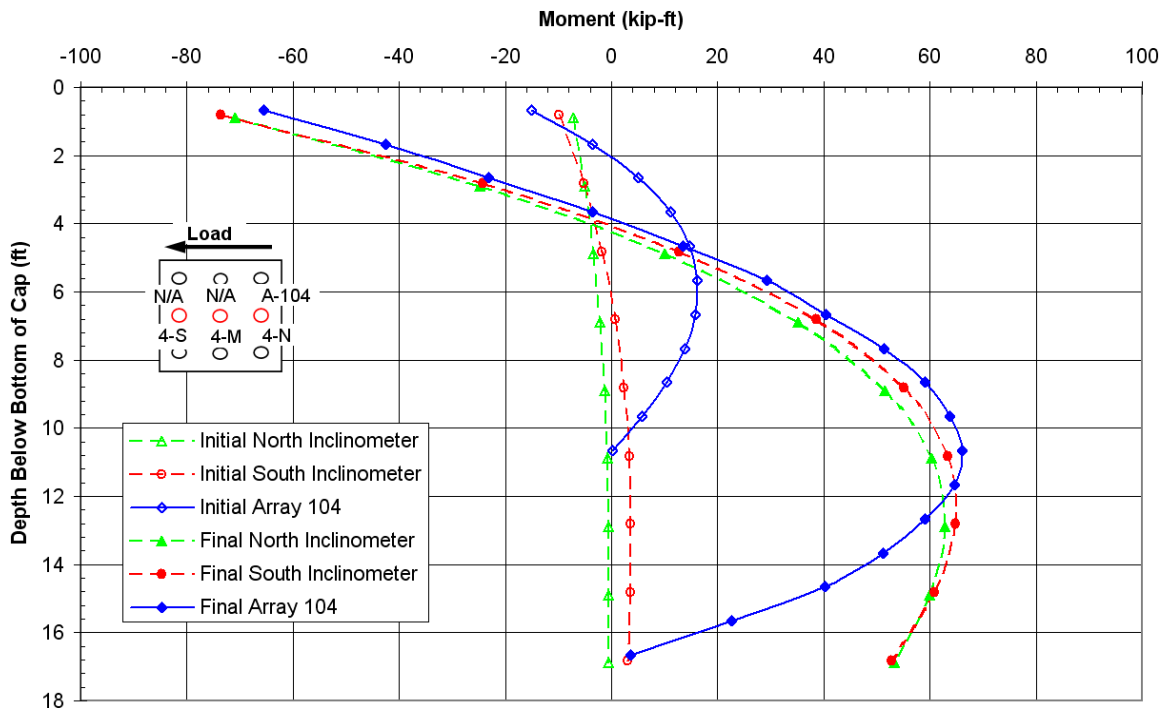
Figure 9-20 Moment versus depth comparison for the piles in pile cap 4 based on deflections measured from the north and south inclinometers and shape array 104 during the RAP test after excavation (Test 7)

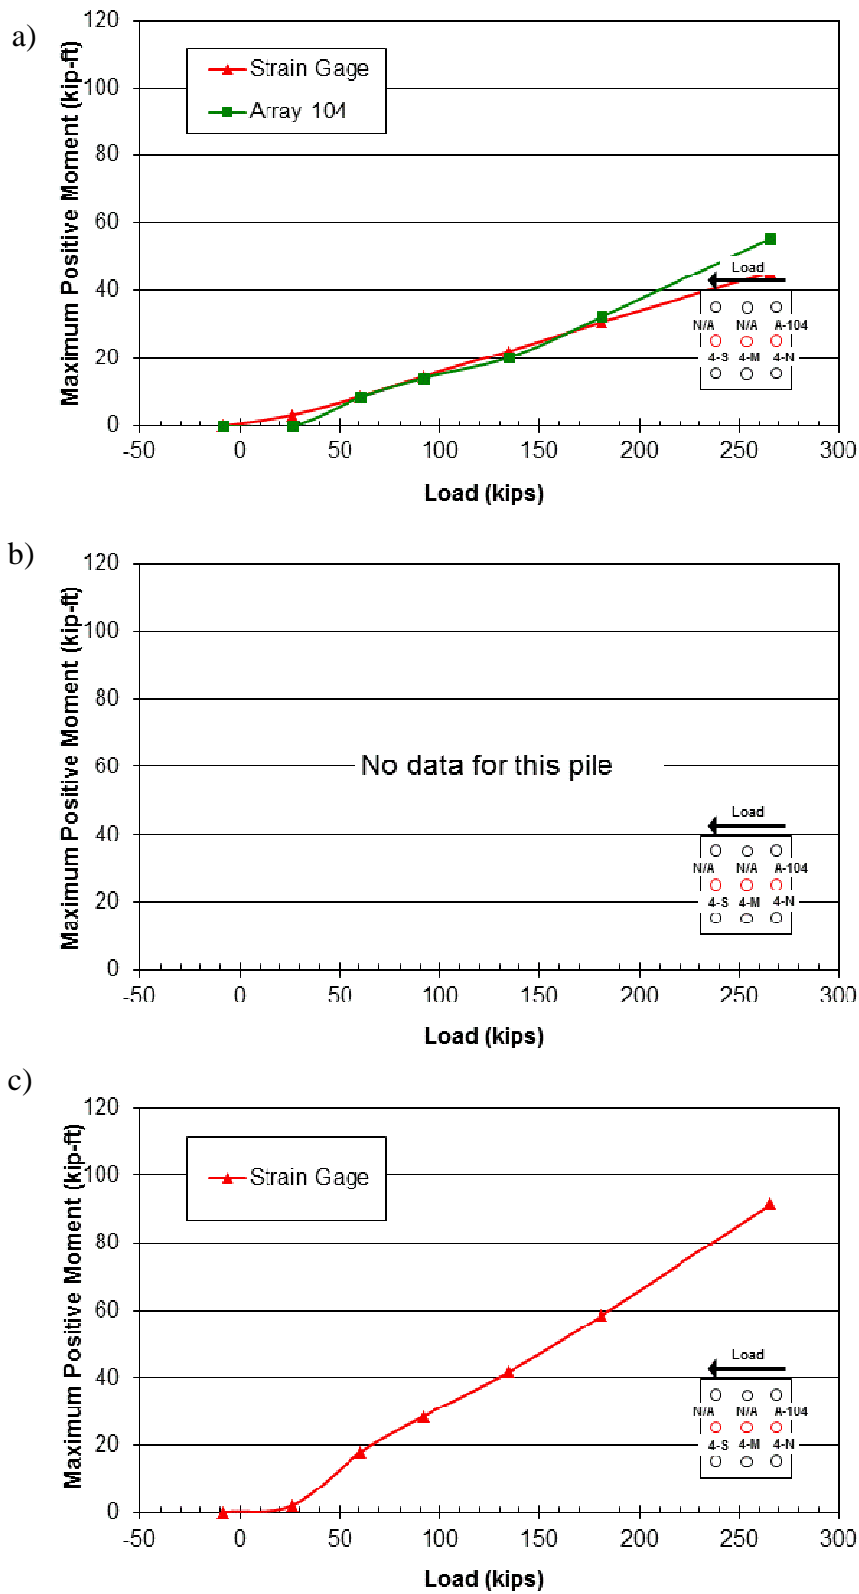
Figure 9-22 Maximum positive moment versus total pile cap load for piles (a) 4-N, (b) 4-M, and (c) 4-S in cap 1 during the RAP test after excavation (Test 7)

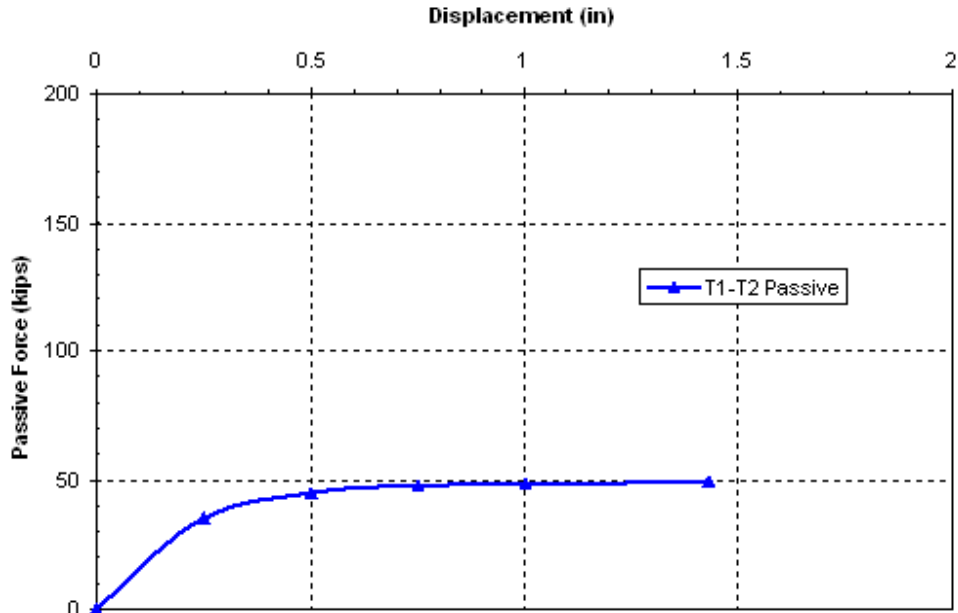
Figure 10-2 Development of passive force for virgin clay around pile cap 1

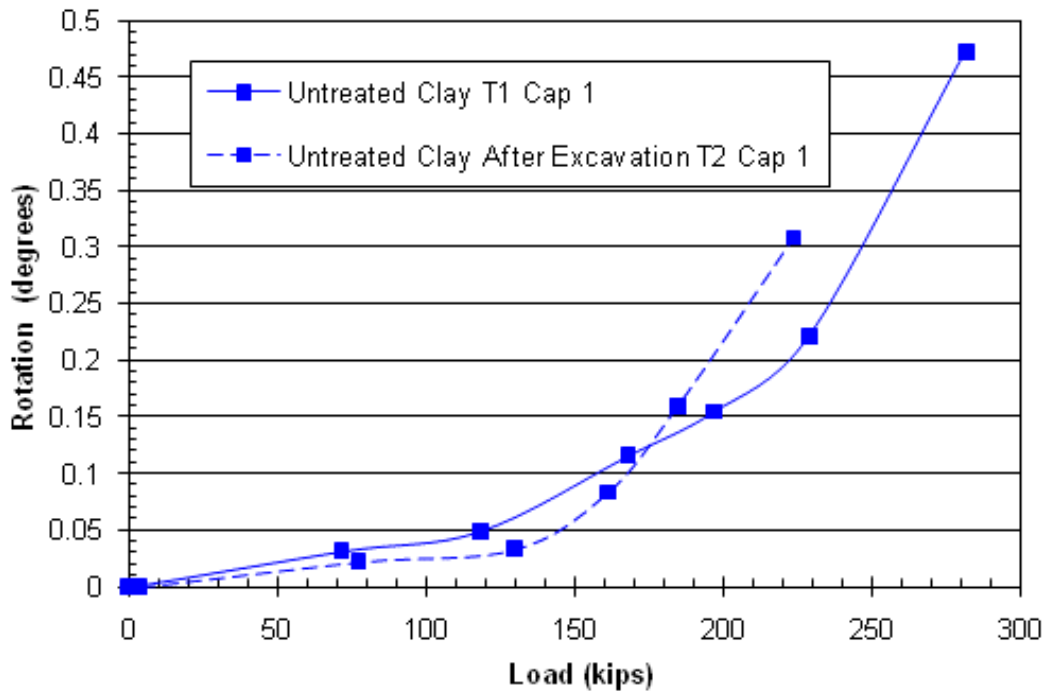
Figure 10-3 Load versus rotation curves for virgin clay tests before (Test 1) and after excavation (Test 2)

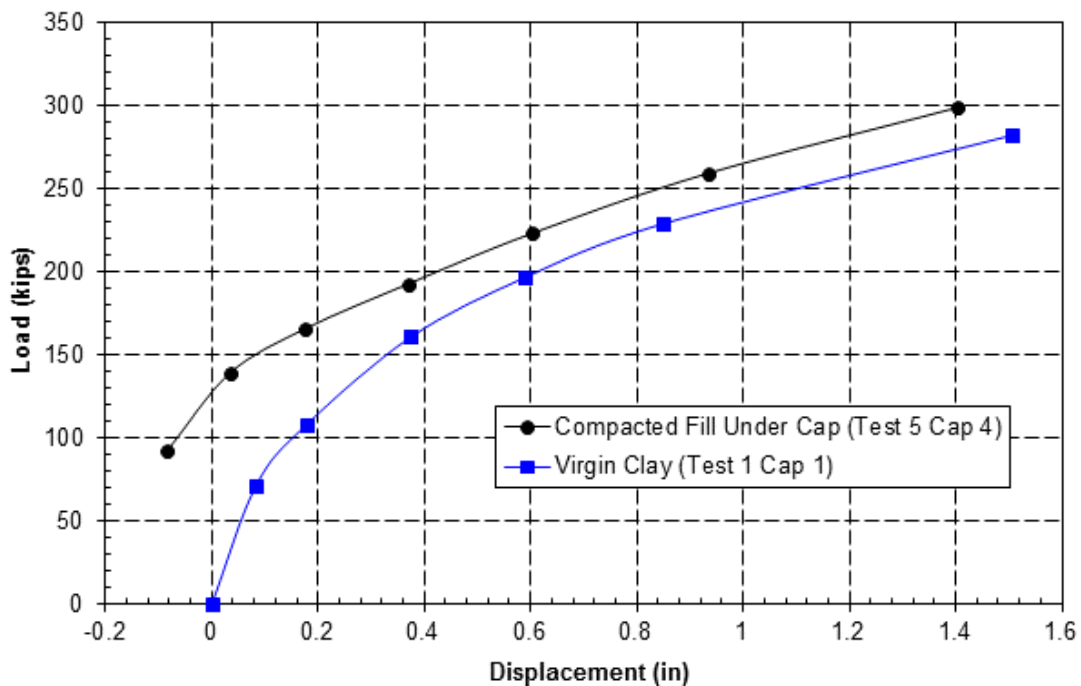
Figure 10-8 Load displacement comparison of virgin clay and compacted fill under the pile cap with clay against the cap face

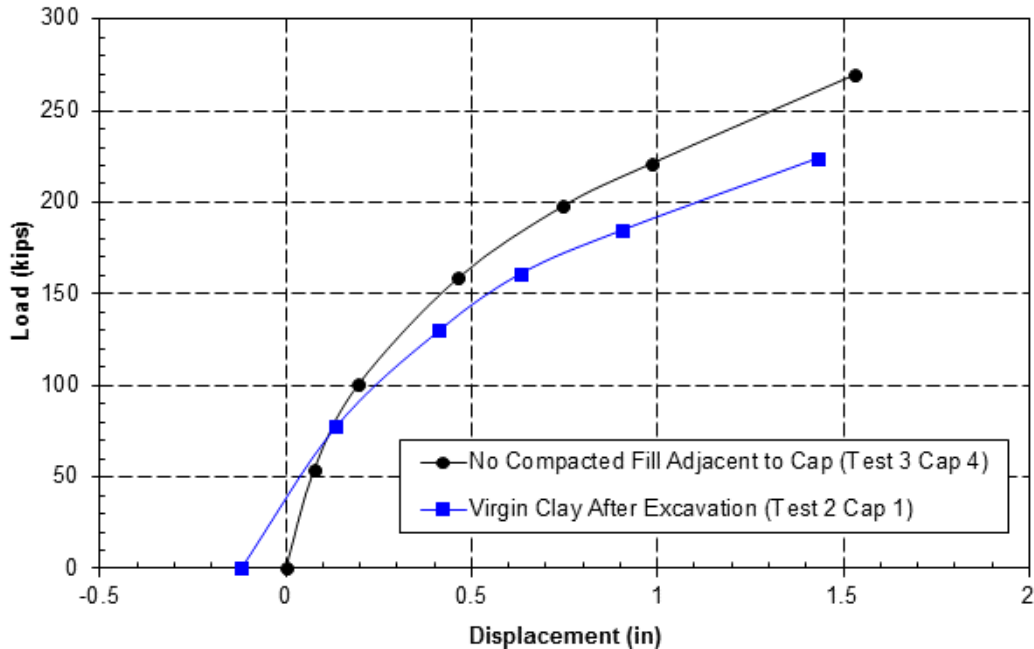
Figure 10-9 Comparison of load-displacement curves for compacted sand extending 5 ft beyond the cap and native clay without soil against the cap face

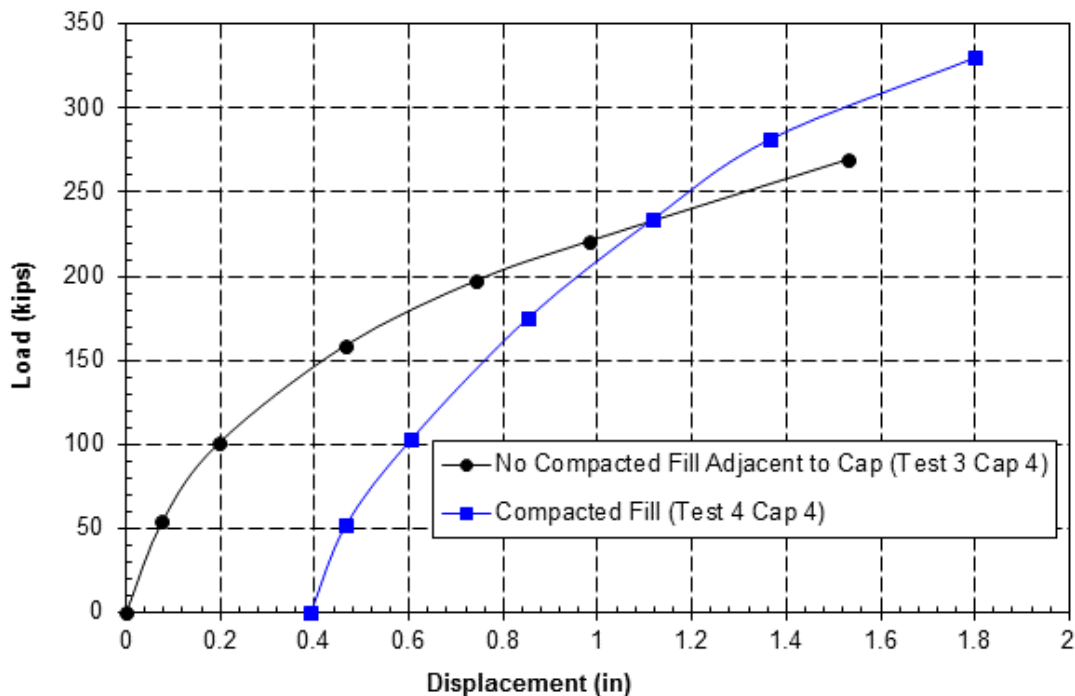
Figure 10-10 Comparison of load-displacement curves for pile cap 4 with and without fill adjacent to the pile cap
