An Integrated Geophysical and Geologic Study of the Paleogene-Age Volcanic Body and Possible Landslide Deposit on the South Slope of the Traverse Mountains, Utah

A thesis submitted to the faculty of
Brigham Young University
in partial fulfillment of the requirements for the degree of
Master of Science

Department of Geological Sciences
Brigham Young University

December 2011

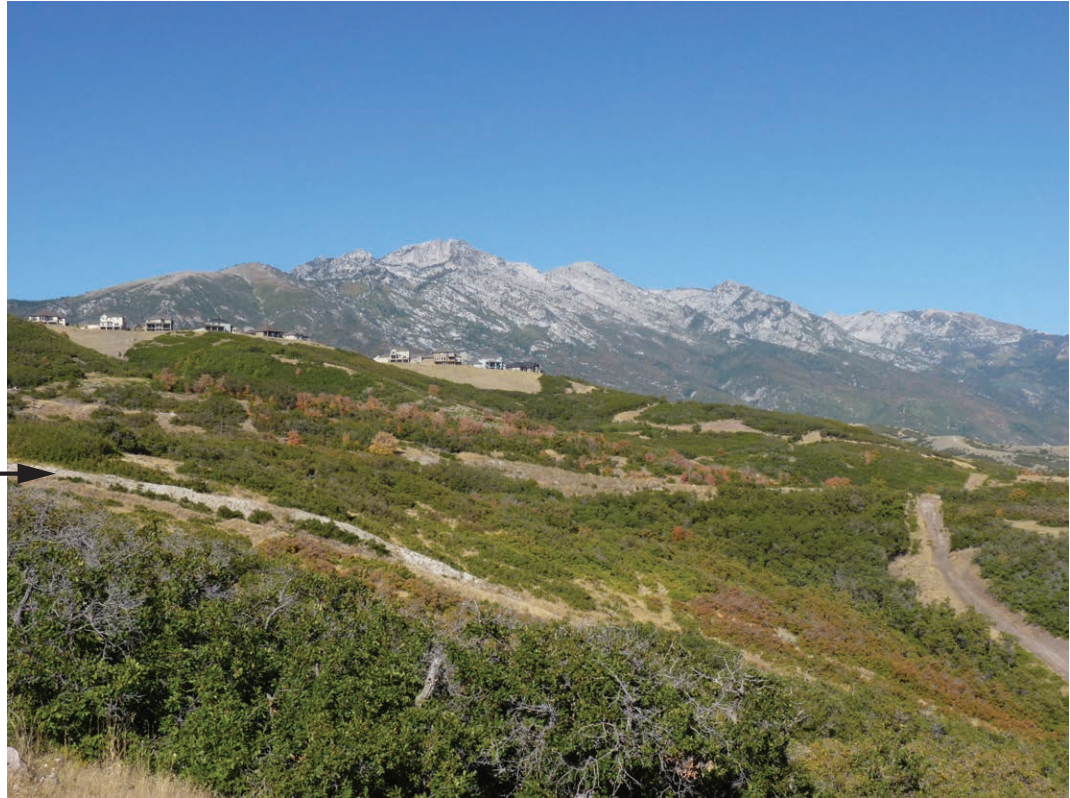
Figure 4 - Photo taken facing north-east on the south slope of the Traverse Mountains. In the far background are the Wasatch Mountains' western front. Houses in the image are approximately 0.8 km (0.5 mi) away on the crest of the landfill material brought in for housing development. Trench 14 is visible in this photo with the light grey exposed rocks and soil excavated in 2007. In the foreground below the houses, is our study area with heavy vegetation. (Photo by John Hoopes, 2010)

Access to the Oligocene and Pennsylvanian rock unit outcrops is difficult for our study area since the Traverse Mountains are covered by soil and dense vegetation (Figure 4). The interpretation of geologic units is based on a few outcrops and surface debris that later has been observed in excavated trenches (1-3 m deep, Figure 5a). In most locations, the immediate subsurface is a dark, organic rich soil (commonly referred to as the ‘A horizon’) followed by a less organic rich ‘B horizon’ (Figure 6). Both have volcanic rock fragments increasing with depth to more massive block and ash flow tuffs or andesite lavas 2-3 m below the ground surface.

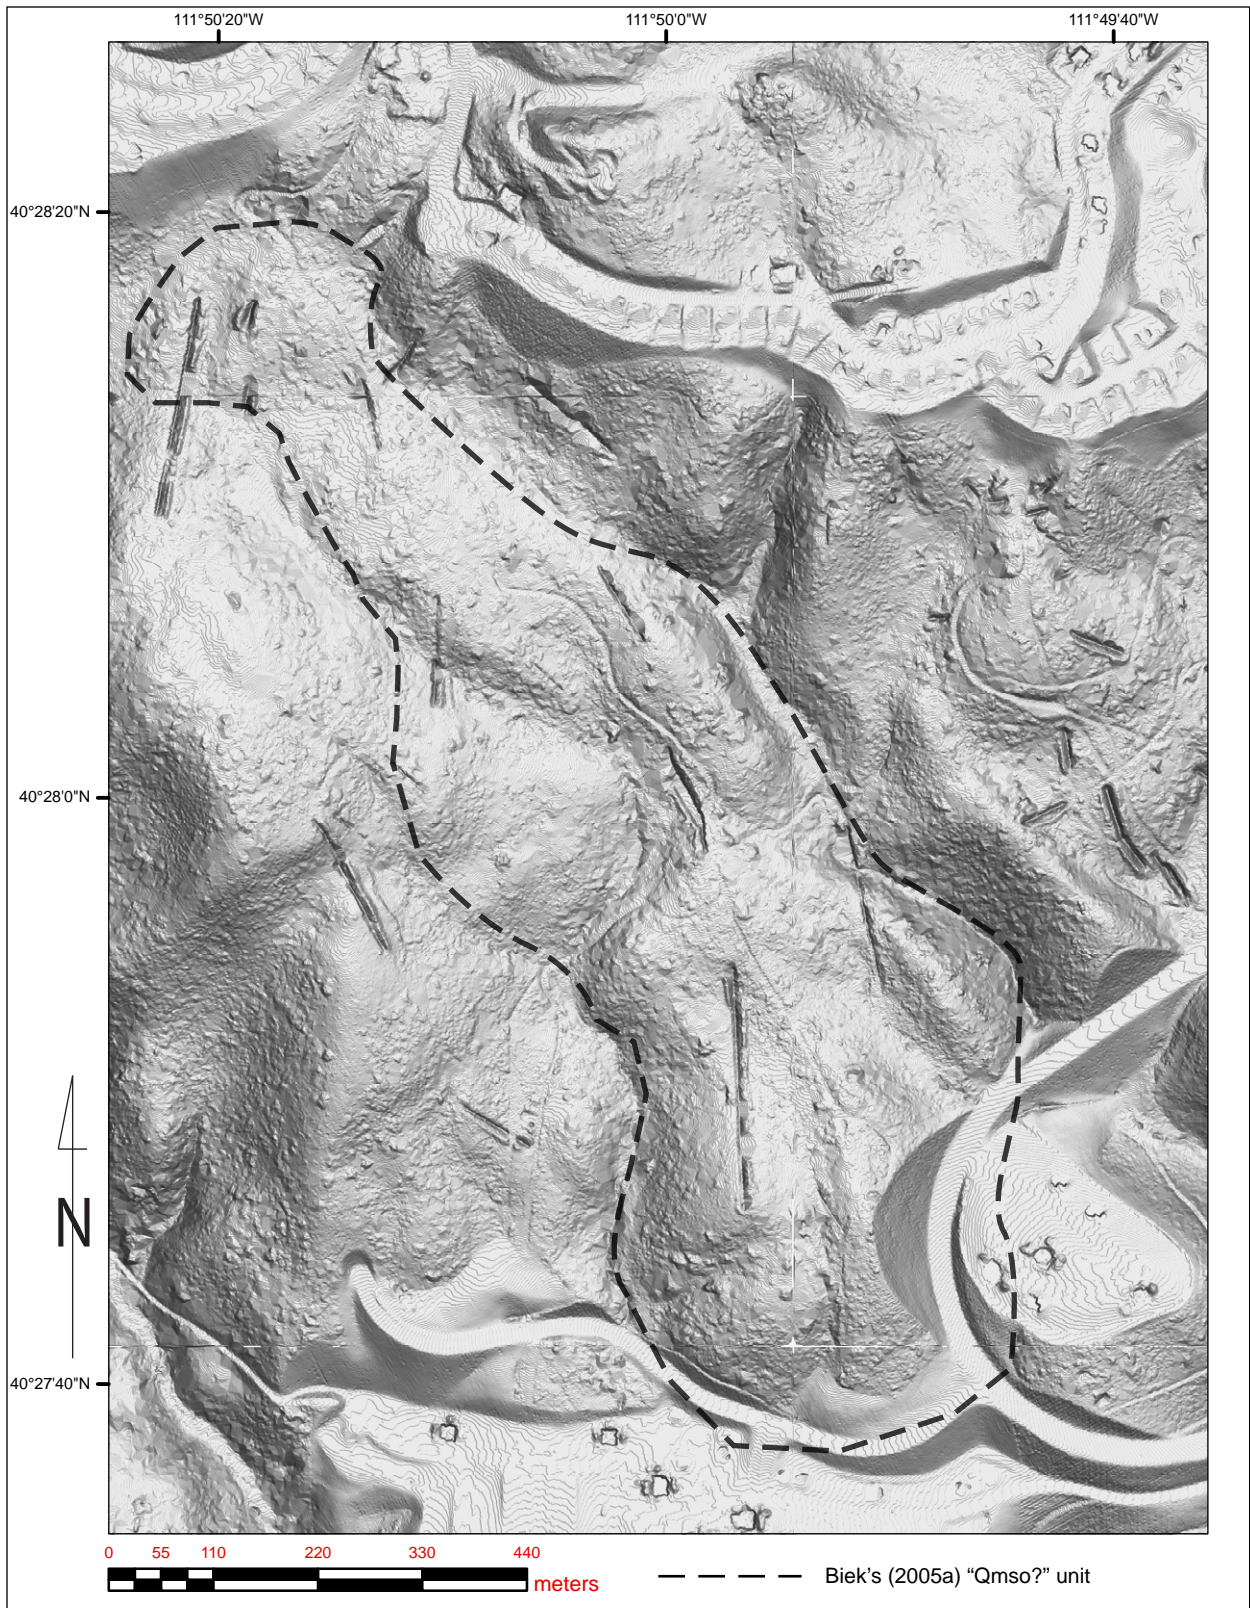
Figure 5b—A shaded relief map constructed with second return LiDAR data of the study area overlain. Resolution is estimated to be approximately 0.5 meters.

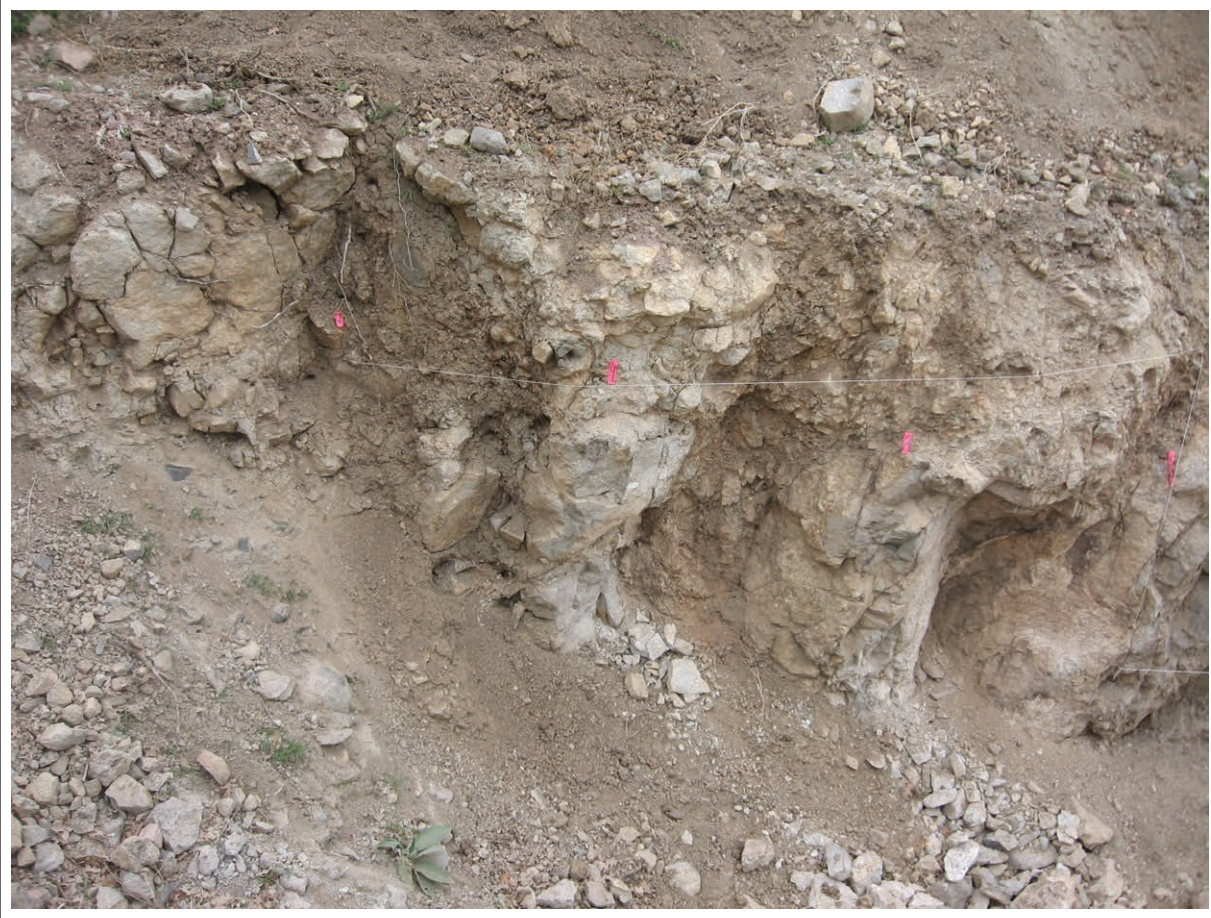
Figure 8 – A photo of the south-east wall of trench DT-1 (Figure 5a) between 0-20 ft (0-6 m) from the north end. This portion of the trench is dominated by heavily fractured andesite lava. Other, less fractured portions exist throughout the study area. (Photo by Geostrata LLC, 2007)

Volcanic rocks in the study area are primarily block and ash flow tuffs and andesite lavas with varied amounts of fracturing and degrees of hydrothermal alteration. Ash and block and ash flow tuffs usually contain suspended fragments of andesite lava (pebble to boulder sized) in their matrices (Figure 7). Intact fabrics of these tuffs are commonly dipping southward, similar to those volcanic bodies in the east Traverse Mountains documented during the aqueduct tunnel construction (Murphy and Gwynn, 1979). Andesite lavas are black to reddish brown in color and vary to boulder and horizontal configurations (Figure 8). The range of hydrothermal

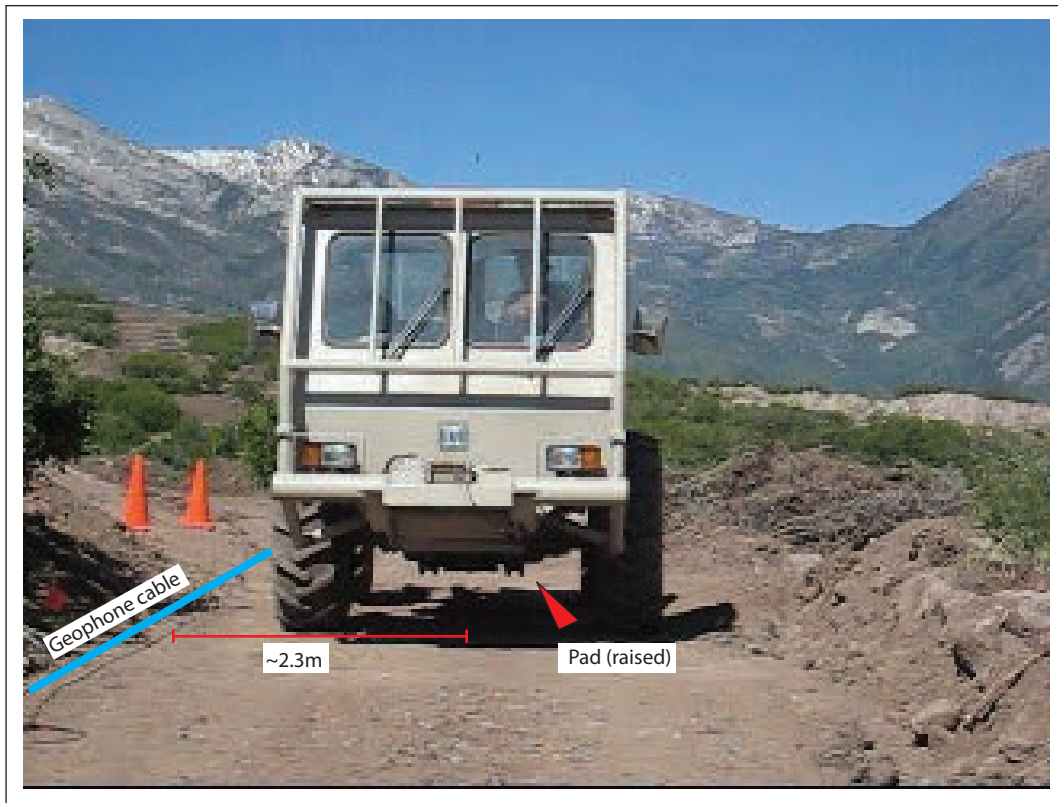
Figure 9 - Photo facing east on seismic line 9. The vibroseis vehicle (IVI Minivibe) with approximately 6 ft (~2.3 m) offset from the geophones. (Photo by Bill Keach, 2007)

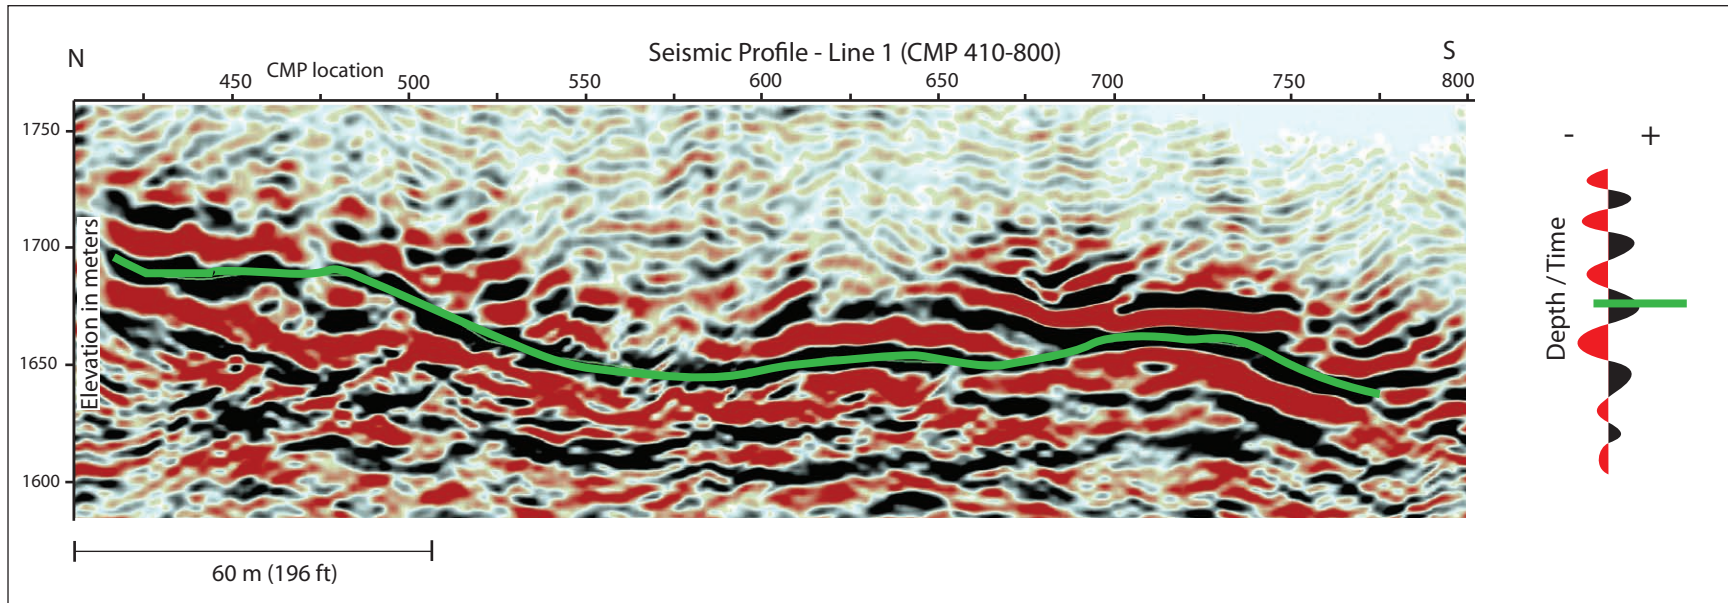
Figure 12- A portion of line 1 (CMP 410-800) showing the data in greater detail and the interpretation strategy. Our interpretation or 'pick' of the basal reflector was made on the first, most laterally continuous positive amplitude excursion. The wavelet (right) shows the positive excursion in black and green line where the pick would be made. The other major positive excursions or horizons seen in the processed profile were not as laterally continuous and were thus not as suitable for interpretation. This strategy was repeated for lines 7, 8, 9, and 10.

same positive excursion to line 1 (Figures 12 and 17). Some manual adjustments to elevation were made to the strike lines to improve the match. Cross lines 7, 8, 9, and 10, although much shorter than line 1, help to constrain the 3D geometry of the basal reflection observed in line 1. These strike lines show the same reflector character as seen on line 1 at the same depth when correlated. Line 8 is somewhat anomalous in that it does not correlate well with line 1. It may be that its profile is on the edge of a discontinuity or fault where it intersects line 1.

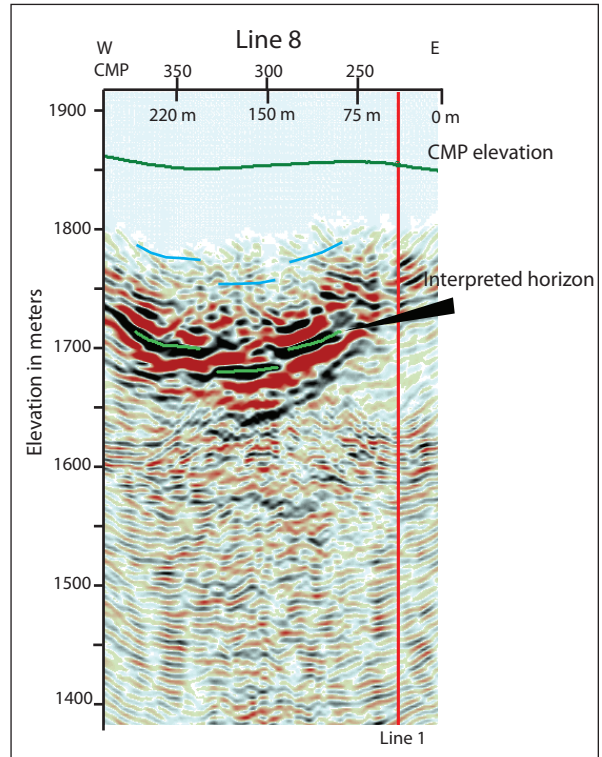
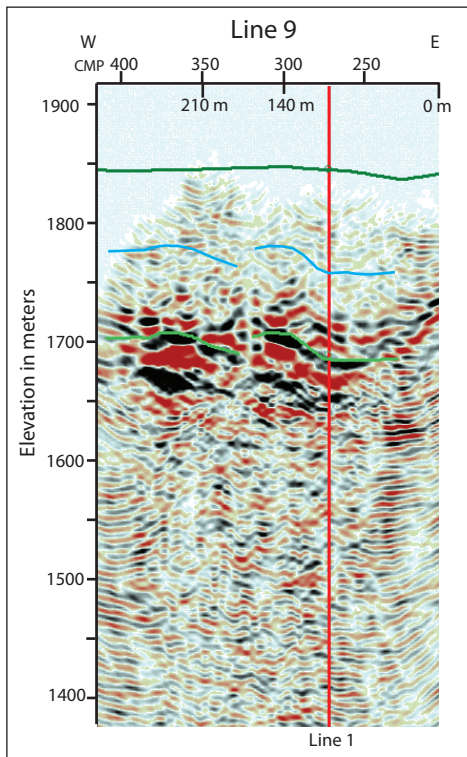
Figure 17 - Final CMP stacked sections of seismic lines 1, 7, 8, 9, 10. CMP elevations are indicated by green line above. The green line within the seismic profile indicates our interpretation of the main reflector horizon using the replacement velocity for time-depth conversion. The blue line represents where the horizon would be using the RMS velocity model (about 70 m above the replacement velocity model). Elevations on left axis are referenced to the elevation datum of 2000 m, approximately 110 m higher than the greatest elevation in the study area. (Refer to Figure 5a for locations of the seismic profiles)

Two versions of the depth-converted CMP sections were derived from the 2.7 km of 2D seismic profiles processed. The replacement velocity of 2200 m/s offers a conservative depth (deeper) of the basal reflector (Figures 11 and 17). This version is considered conservative in the sense that a thicker mass of material that could potentially be mobilized as part of a landslide mass would increase the landslide hazard. The RMS velocity model offers a less conservative or shallower estimate for the basal reflector. RMS velocity modeling takes into account the averaging of high- and low-velocity zones instead of assuming a uniformly constant (i.e., replacement) velocity (Figure 11). Having observed such a heterogeneous body of rock in the trenches and boreholes, the RMS velocity model likely provides a more accurate assessment of the reflector's depth.
