Georeferenced Video Mapping to Classify Streambank Erosion Susceptibility

(2019) "Georeferenced Video Mapping to Classify Streambank Erosion Susceptibility," *Journal of Spatial Hydrology*. Vol. 15, Article 3.

Brett Connell¹, Paul Ayers², Andrea Ludwig², Keil Neff³, James Parham⁴

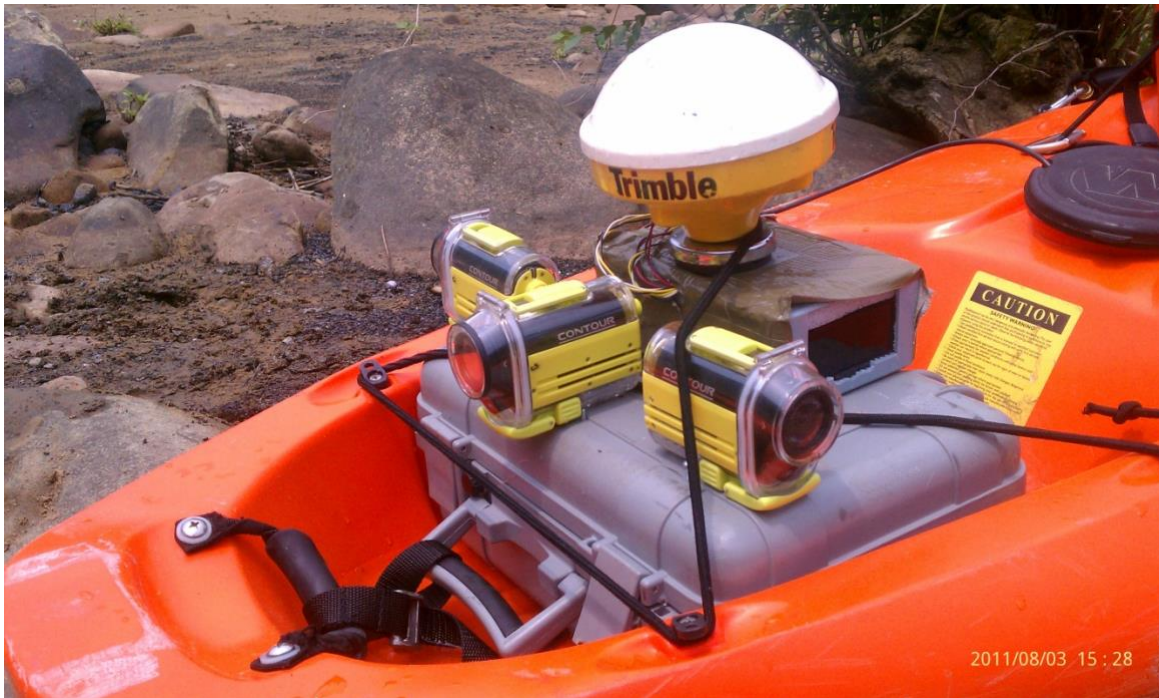
Figure 1 Streambank video mapping system

The Streambank Video Mapping System (SVMS) consisted of a sit-on-top kayak (Wilderness Systems Tarpon 100); three GPS-enabled video cameras (Contour cameras) mounted facing forward, left, and right (90°); a flush-mounted depth sensor (Cruz-Pro ATU-120S); a National Marine Electronics Association multiplexer; and a GPS receiver (Trimble 132) (Figure 1). The GPS receiver provided sub-meter GPS accuracy and outputted time and location data at 1Hz. The GPS data was combined with the depth data within the multiplexer and then was recorded onto a flash drive. The Contour GPS cameras included a Neo-6 GPS module and recorded video at 1280 by 720-pixel resolution. The georeferenced video was combined with the GPS and depth data such that each data point is associated with Coordinated Universal Time (UTC) and coordinate information.

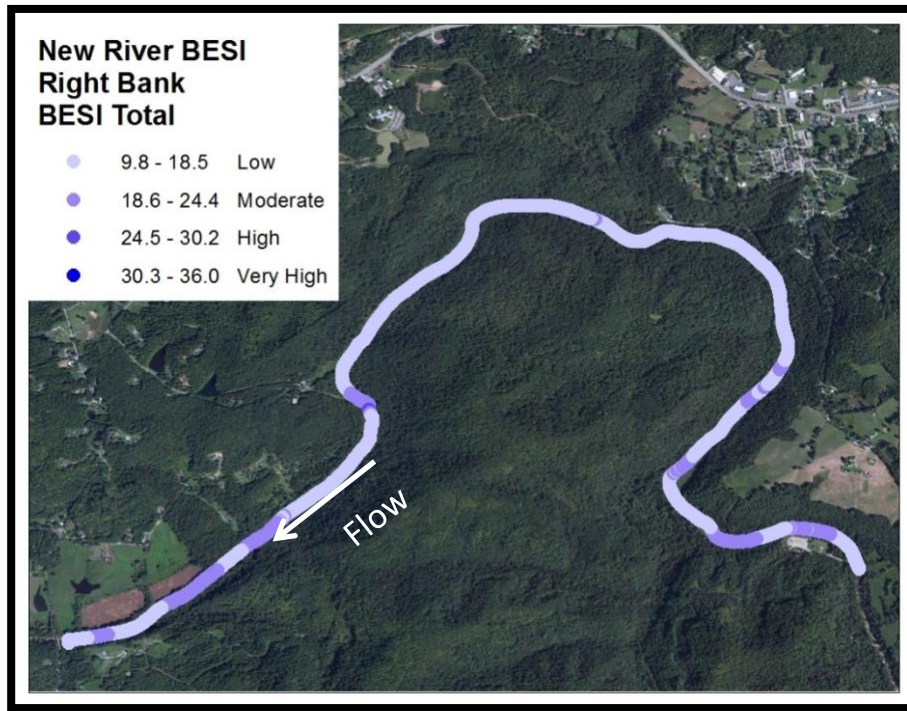
Figure 2 New River segment right bank erosion susceptibility index score

The SVMS collected GPS, depth, and video data for the two test stream segments at 1 second intervals. Classification of the video was completed for the entirety of both streambanks for each of the two stream segments. Areas of varying erosion susceptibility were determined and displayed using thematic mapping within ArcGIS. In the New River segment, 78% of the streambank length received a low erosion susceptibility rating, 21% scored moderate, and the remaining 1% was identified as high erosion susceptibility (Figure 2). The total distance of streambank that was rated as high erosion susceptibility was 135 meters, with a maximum score of 25.0 determined. Average BESI score for the entire reach was 15.3, giving it a low streambank erosion susceptibility score. Similar to the New River segment, the Beaver Creek survey documented limited areas of high erosion susceptibility (Figure 3). In Beaver Creek, a total length of 190 meters was classified with high erosion susceptibility, which represents approximately 1% of the surveyed reach. With 81% low, 18% moderate, and an average BESI score of 14.0, Beaver Creek also received an overall low erosion susceptibility score. The BESI scores for the New River and Beaver Creek reaches are shown in Figure 4, providing a visual of the total streambank health in terms of erosion susceptibility.

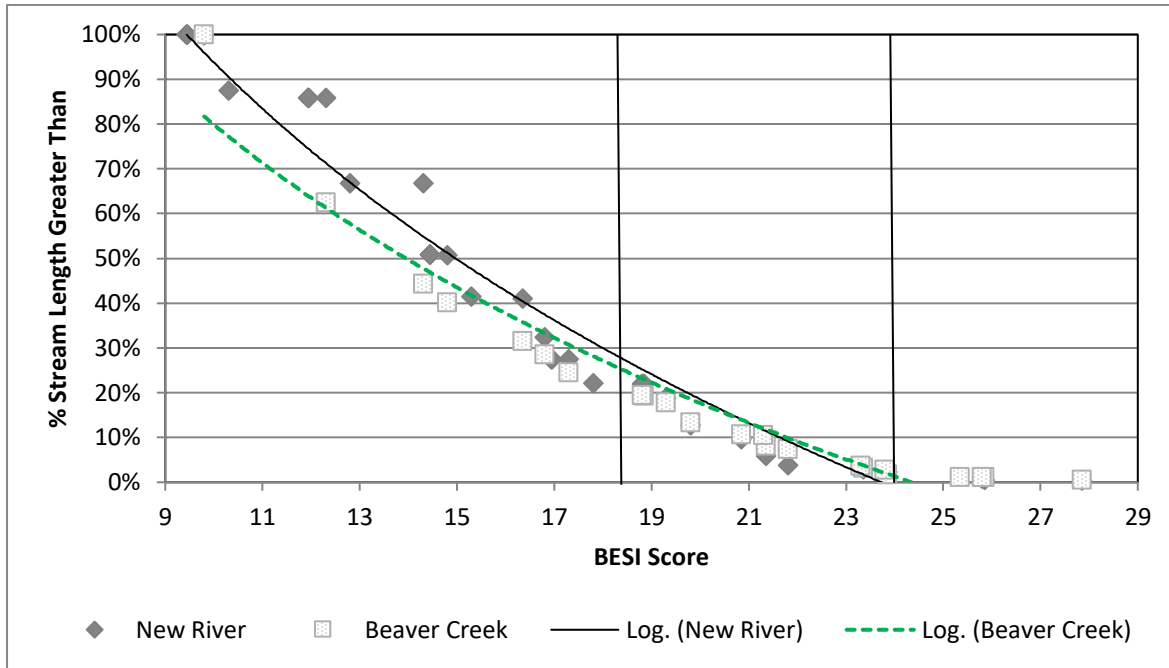
Figure 4 Comparison of New River and Beaver Creek bank erosion susceptibility index scores

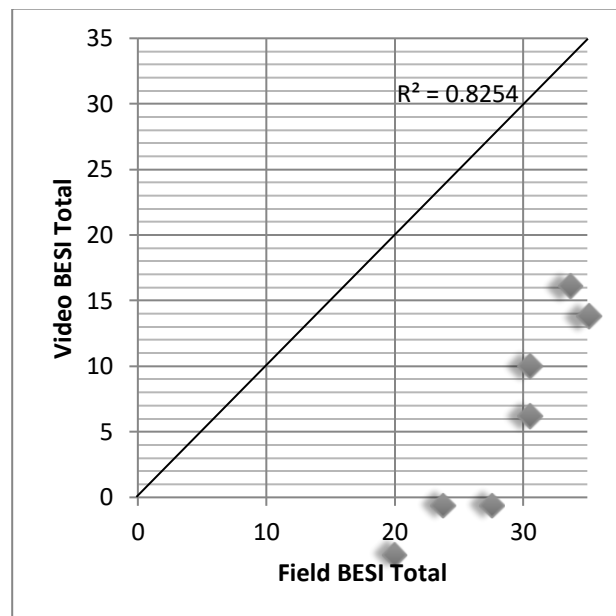
Figure 5 Individual field vs. video total bank erosion susceptibility index scores

Given that the majority of the segment was determined to be in the low BESI range, the randomly selected field validation sites did not represent the full range of BESI documented throughout the reach. Therefore, nine of the field validation sites along the Beaver Creek right bank were chosen using stratified random selection to pick 3 sites near each of the low, medium and high BESI score ranges (Connell 2012). The field validation conducted at these sites provided comparison in a larger range of BESI scores. Table 2 shows the results when comparing the field measurements to the video assessment at these nine stratified random locations. Figure 5 displays the field measurements compared to video interpretation for total BESI scores on a 1:1 ratio expressing a strong correlation.
