An Investigation of Wear-Resistant Coatings on an A390 Die-Cast Aluminum Substrate

AN INVESTIGATION OF WEAR-RESISTANT COATINGS
ON AN A390 DIE-CAST ALUMINUM SUBSTRATE

Master of Science

Department of Mechanical Engineering

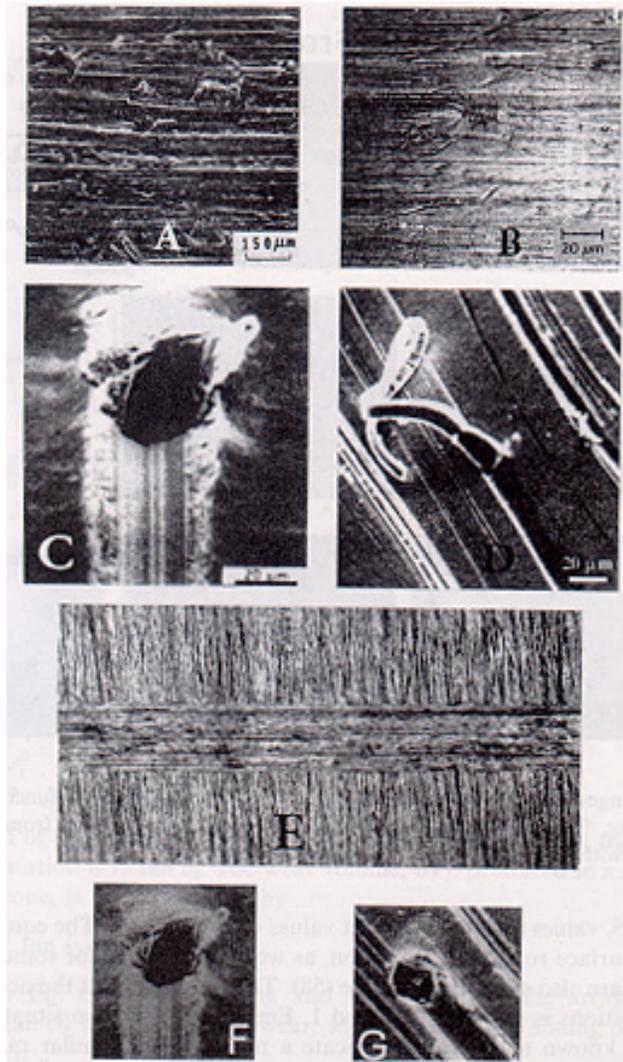
Figure 2-1 Examples of wear scar morphology on metal surfaces, resulting from single-cycle deformation during sliding contact. A-D, F, and G are from three-body abrasive wear situations. E is a wear scar resulting from a single sliding stroke between a hard ball and a softer flat [3].

Because abrasive wear is most commonly single-cycle deformation, the micrographs of abrasive wear look similar to those shown in Figure 2-1 and Figure 2-3.

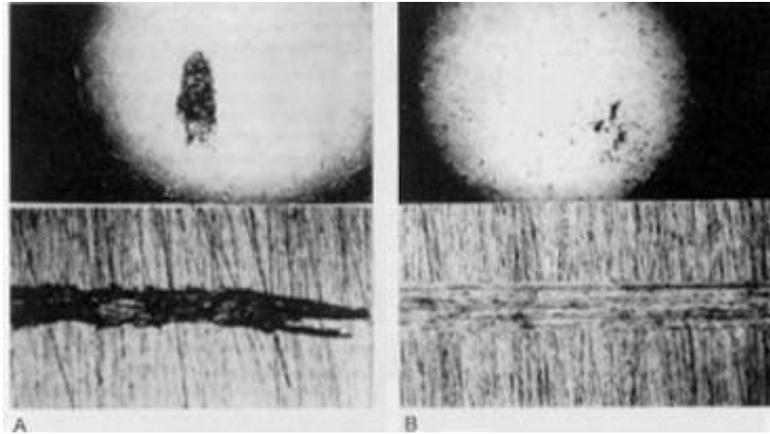
Figure 2-2 Picture A shows adhesive wear or galling at a normal pressure above the threshold pressure. Picture B shows adhesive wear below the threshold pressure [3].

Figure 2-2 shows material being removed by the round pins, (the upper pictures), from the wear surfaces, (the lower pictures). The dark area on the pins is the material from the wear surface. Picture A, showing galling, has much more material loss than picture B, showing normal adhesion wear, because the normal force is higher than the threshold pressure.

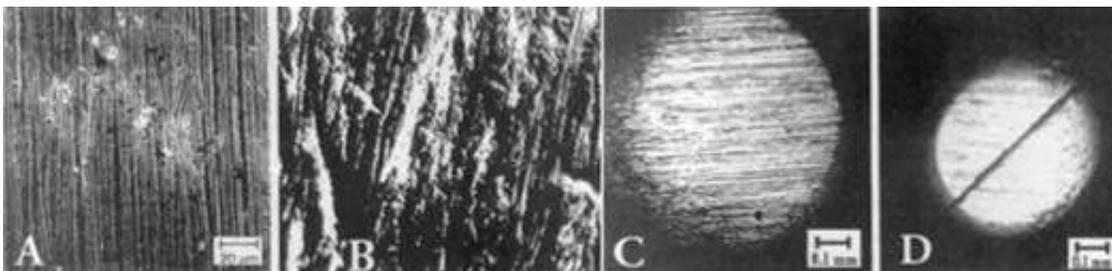
Figure 2-3 Examples of wear scars, in varying degrees, resulting from three-body abrasion [3].

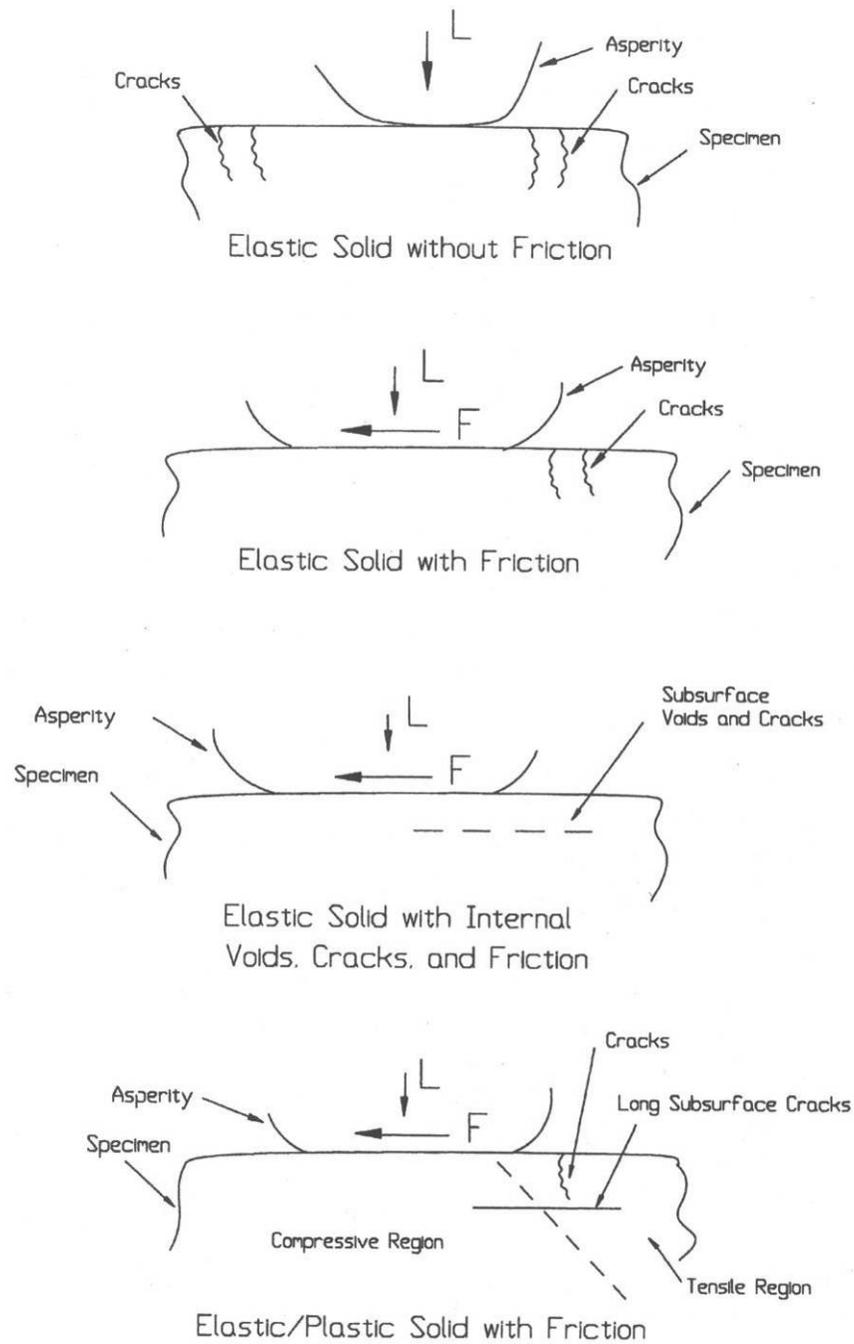
Figure 2-4 Examples of the influence of the nature of stress system on crack formation [3].

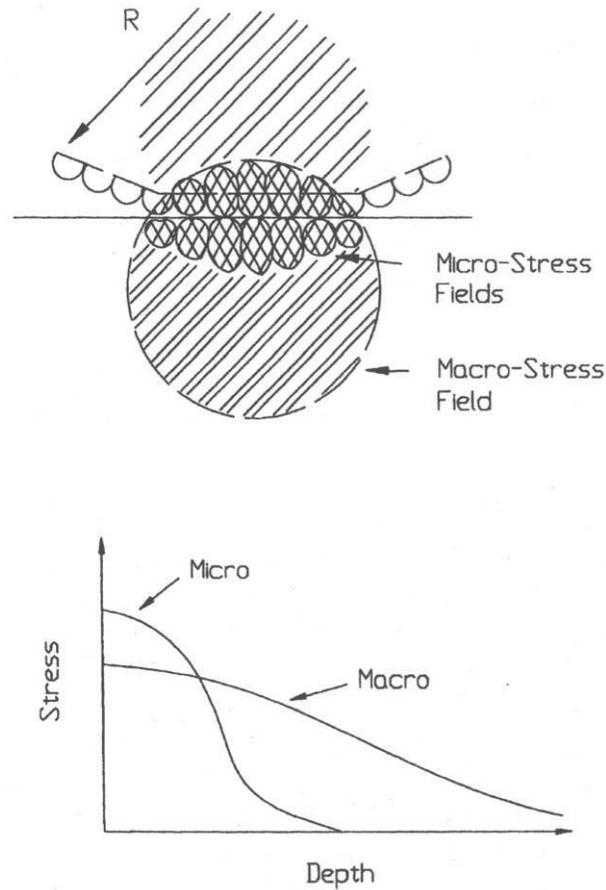
Figure 2-5 General nature of the stress field in contact situation, illustrating the relative effects of contact geometry and asperities on stress[3].

Figure 2-5 for graphics of stress distribution and crack formation under the influence of different stresses.

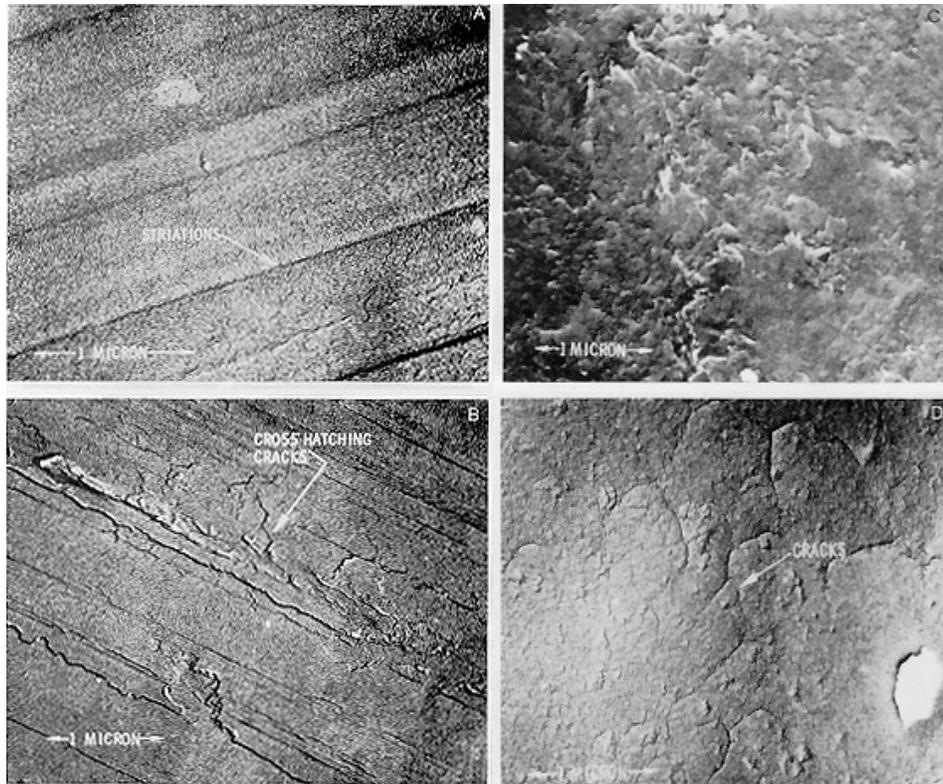
Figure 2-6 Wear scar morphology of single-crystal copper in lubricated sliding [3].

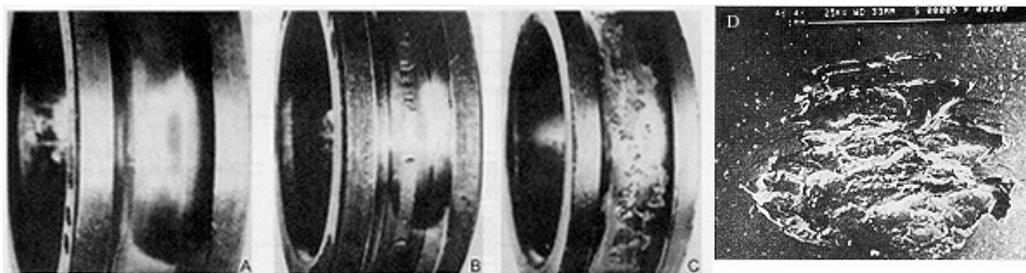
Figure 2-7 A - C Shows the progression of severe rolling contact wear. C shows normal rolling contact fatigue wear scar [3].

In rolling and impact fatigue wear, wear scars tend to be much larger, even on the macroscopic level. These wear scars are usually pits of various sizes formed by large particles being removed. Examples of rolling contact wear scars are shown in Figure 2-7.

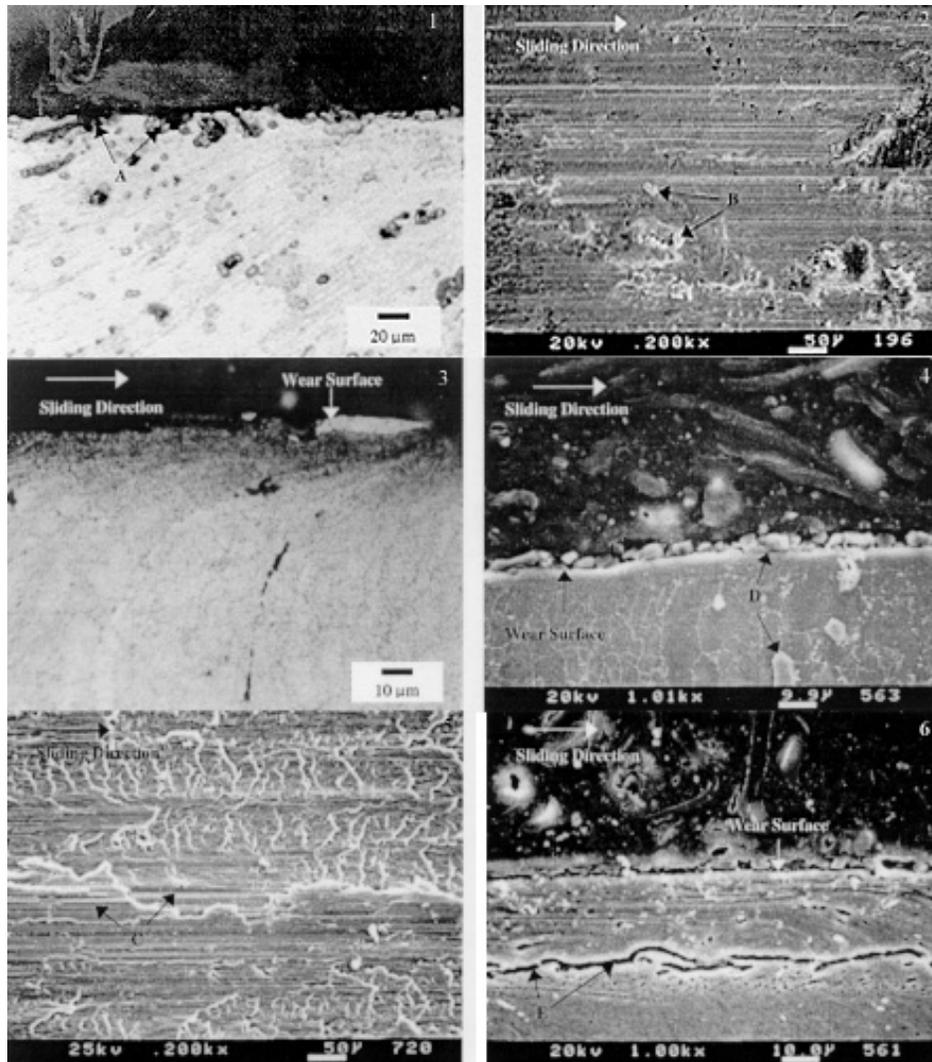
Figure 2-8 (Previous Page): 1) Cross section of a 2014-T6 sheave wheel specimen indicating adhesive and abrasive wear 2) Wear Surface of 2014-T6 sheave wheel specimen indicating abrasive wear (grooves) and wear particles at B 3) Cross section of a 2014-T6 specimen indicating adhesive wear (lines of shear induced plastic deformation) 4) Cross section of a 2014-T6 specimen revealing aluminum-oxide particle formation at D 5) Wear surface of a 2014-T6 specimen indicating adhesive wear (galling) and abrasive wear (grooves at C) 6) Cross-section of 7050-T7451 specimen indicating adhesive wear (lines of shear-induced plastic deformation with void formation and coalescence at E) [10].

graphs were taken with both an SEM and an optical microscope. The aluminum showed signs of adhesive wear to some degree in all of the alloys. Additionally, the softer alloy had severe abrasive wear, and the harder alloys showed fatigue wear; see Figure 2-8 for micrographs of these types of wear.

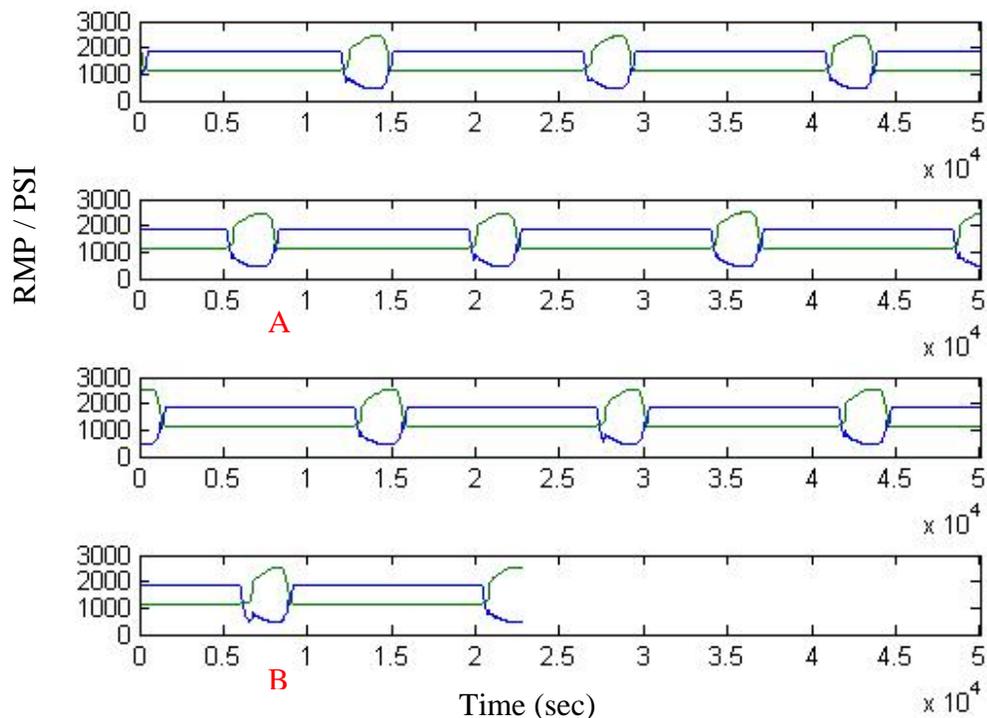
Figure 4-1 Example plot taken from B-2. The blue line is pressure in psi the green line is rpm of the secondary clutch.

As the wear test stand ran at high load, wear grooves developed on the sheaves at a radius near the center of the primary clutch sheaves. By plotting the hydraulic fluid pressure with the rpm of the secondary clutch as a function of time, the amount of delay can be seen between the time the pressure drops and the time the clutch responds. Early in the test the CVT shifted very quickly after a drop in load, shown as noted at A. As the test continued, a delay would develop in shift and in some cases progress until the CVT would not shift at all through an unloading cycle. An example of this delay can be seen at point B noted in Figure 4-1.

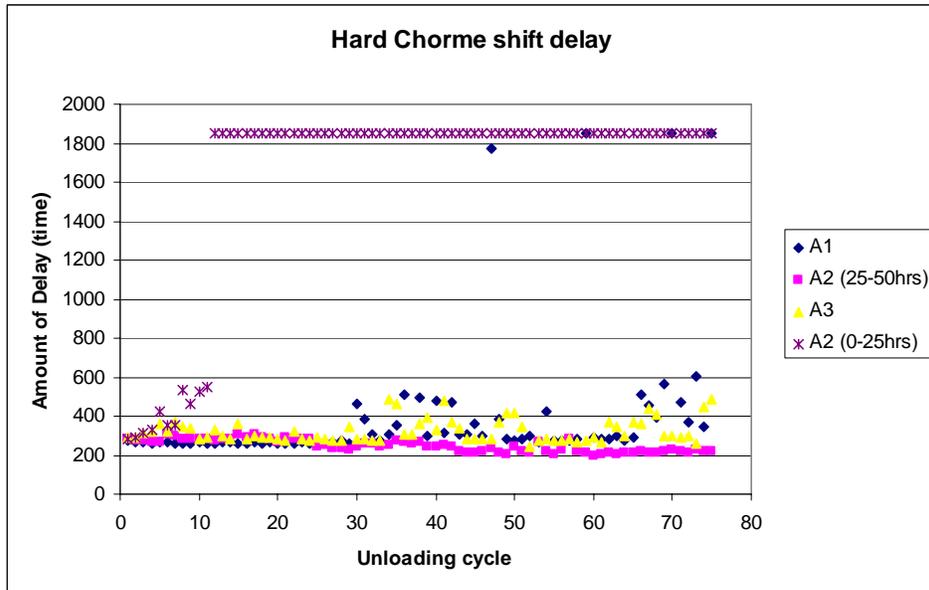
Figure 4-3 Hard chrome shift delay with first 25 hours of A2 test.

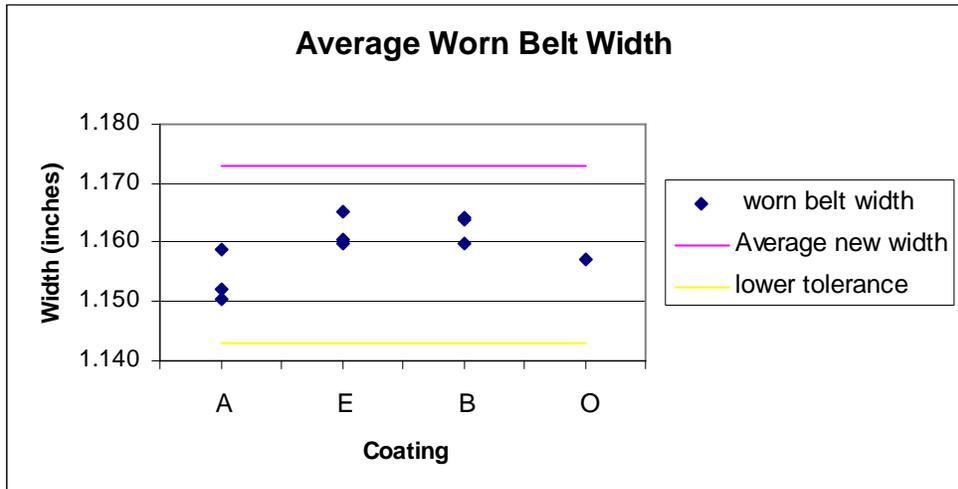
Figure 4-4 Belt width measurements after 25 hours of testing.

table also shows that on average, the belt wear for the hard chrome was 4% greater than for the electroless nickel coated sheaves and the uncoated clutches.

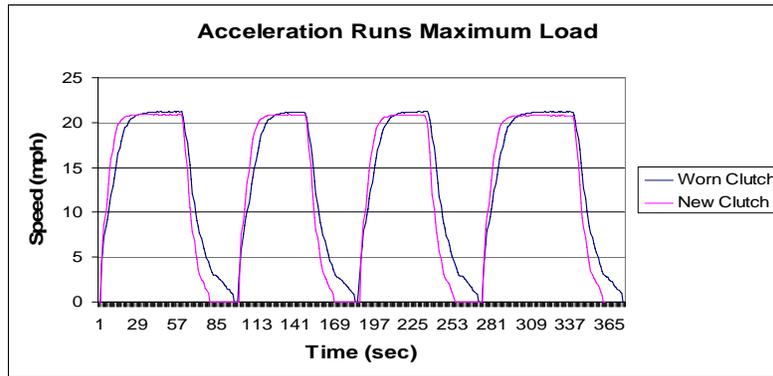
Figure 4-5 Example of formatted acceleration curves.

As described in chapter 3 the dynamometer software recorded the wheel speed of the ATV. Speed was plotted versus time to yield acceleration curves. Figure 4-5 shows an example of the acceleration curves.

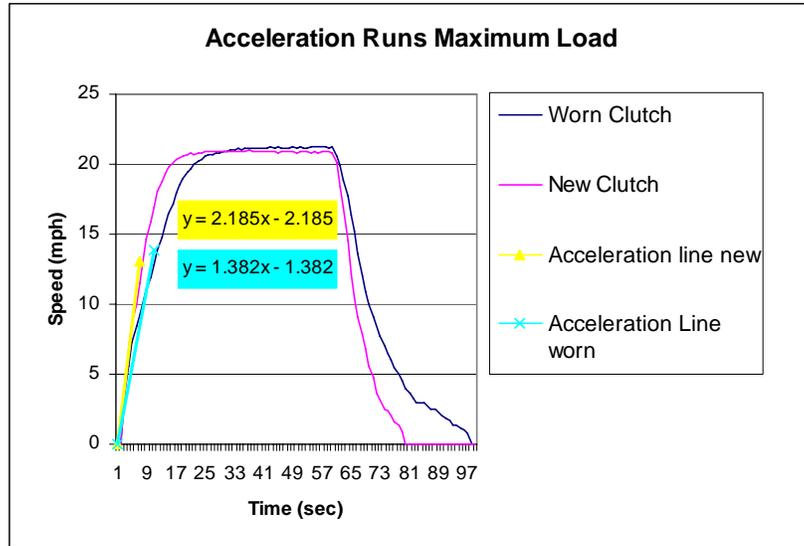
Figure 4-6 Example of acceleration slope.

The slope during acceleration and deceleration was calculated. The slope of the curves gave a single value that could be compared to other runs. Because the slope of the curve near the top was not linear, a percentage of the maximum speed, or the high point of the curve, was used to calculate the slope. The acceleration curves from the dynamometer fit a first order system so the time constant, 62%, of the first order system was used to determine the acceleration slope. Figure 4-6 shows an example of how the acceleration slopes are determined and Table 4-2 shows the calculated values.

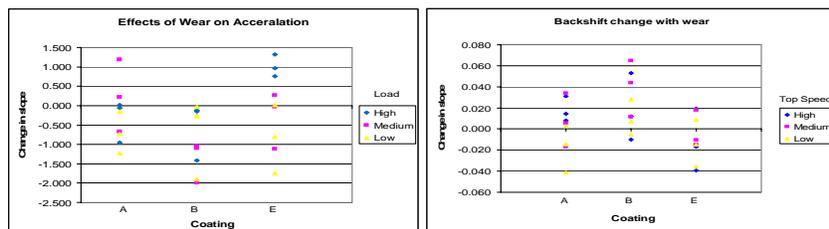
Figure 4-7 Plots showing the change in slope with wear.

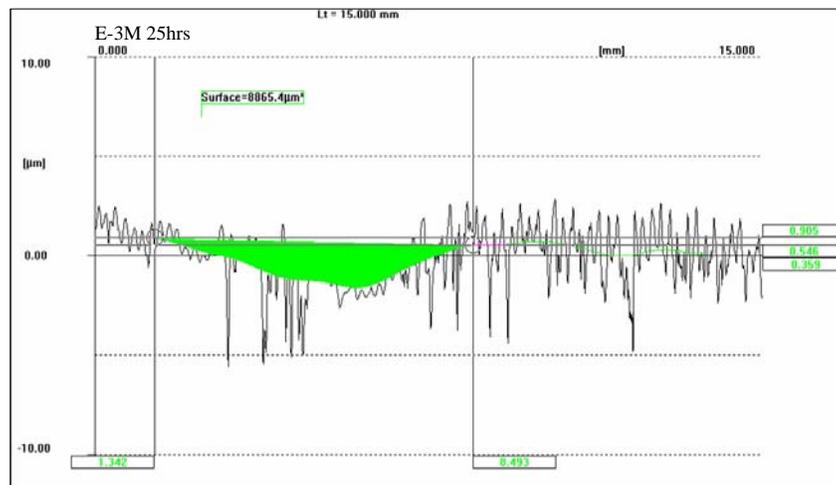
Figure 4-8 Profilometer profile of a moveable sheave after 25 hours of wear.

In evaluating the surface waviness and roughness for unworn (new) sheaves, six sheaves had insignificant waviness. Therefore, the assumption was made that all unworn sheaves could be considered to have negligible waviness. All other surface waviness data was taken at 25 hours of wear time. Figure 4-8 is an example of a profile of a worn sheave.

In Figure 4-8 the black line is the surface roughness profile, the green line is the surface waviness profile, and the green area is the area evaluated as the wear groove. The wear groove areas for both the fixed and movable sheaves were evaluated in this way. Figure 4-9 shows a plot of the fixed, movable, and total sheave cross sectional area. Appendix I shows the actual profile data for all of the sheaves tested.

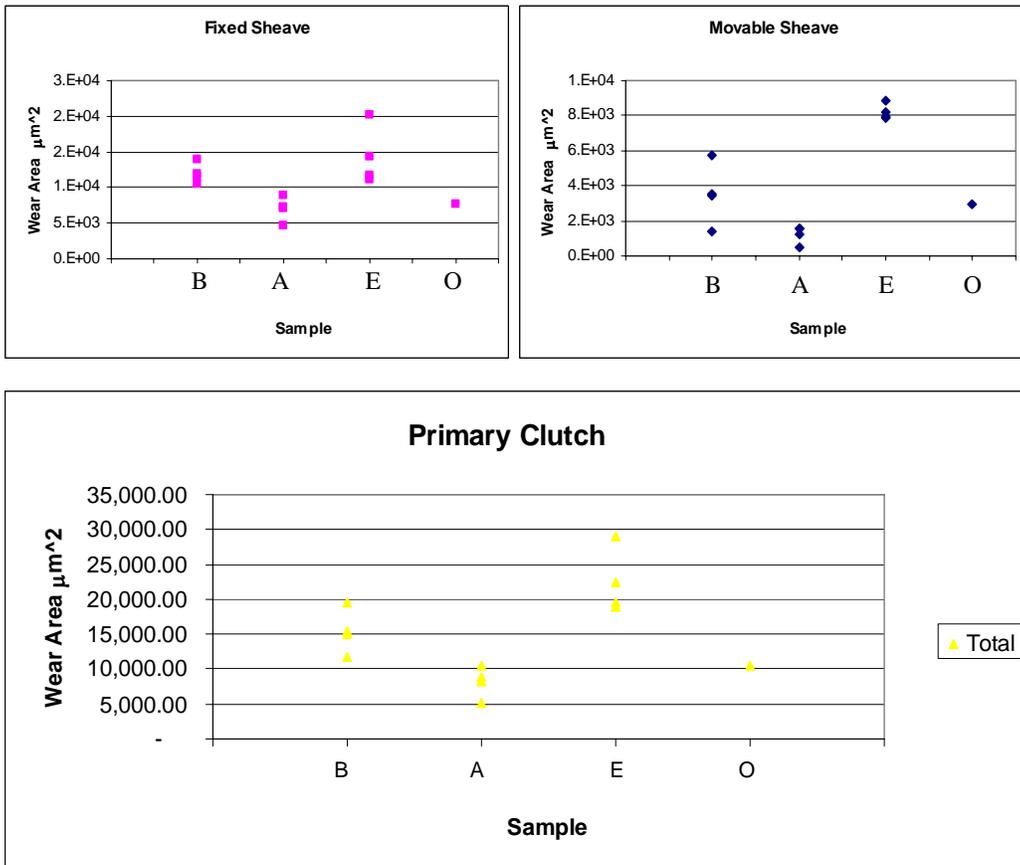
Figure 4-9 Plot showing cross sectional area of wear groove.

From Figure 4-9, it can be seen that the fixed sheave wears more than the movable sheave. Currently, there is no evidence as to the cause of this trend. Another trend was noticed in the wear groove area. Most wear grooves actually exhibited two grooves, one deep groove and one shallow groove with a small peak between the two grooves. Figure 4-10 shows an example of this trend.

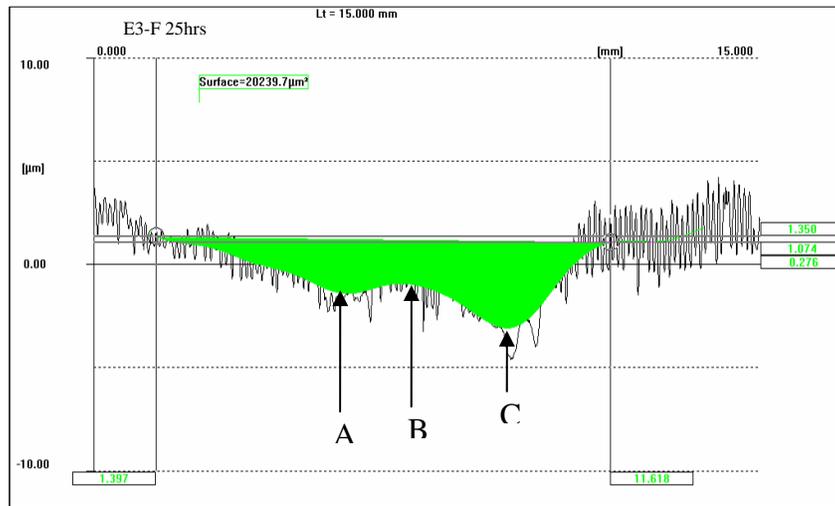
Figure 4-10 Example profile of the two groove trend; where A is the shallow groove, B is the peak, and C is the deep groove.

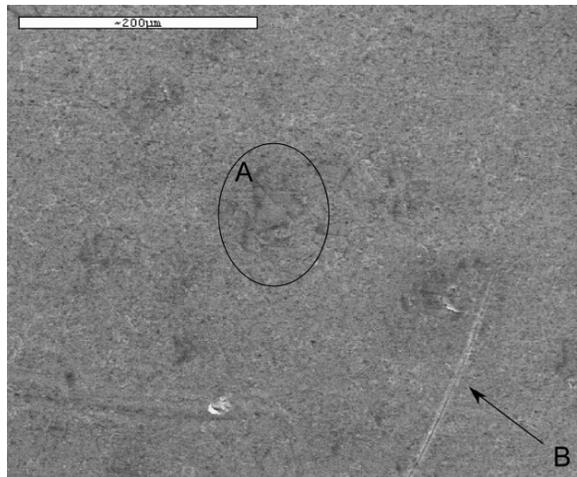
Figure 4-11 Large area view uncoated wear surface A) Large Si grain B) Radial abrasive scar. Radial direction is vertical.

The scans from the uncoated (base) clutch sheaves did not show very many distinct wear scars or wear morphology. Figure 4-11 shows a scan of a relatively large area of the wear groove. Only one abrasion scar in the radial direction is present. The rest of the area appeared generally smooth.

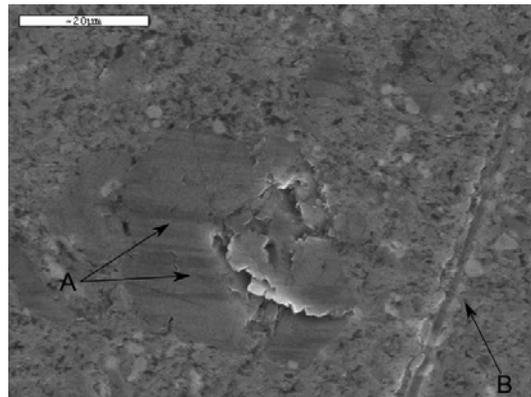
Figure 4-12 Silicon grain with brittle fracture A) Striations in the Si grains, B) Radial wear scar. Radial direction is vertical.

Using x-ray the darker grains were analyzed for chemical composition. They were found to be mostly silicon. Upon closer investigation and greater magnification (see Figure 4-12 and Figure 4-13) these silicon grains were found to show striations in the direction of wear and show some brittle fracture, labeled A and B in the figure.

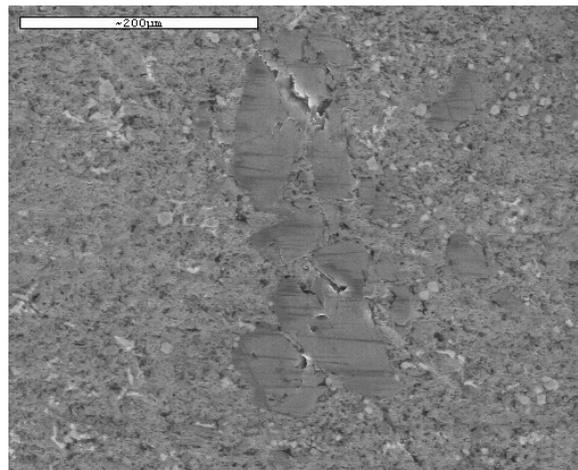
Figure 4-13 Large silicon grain, radial direction is vertical.

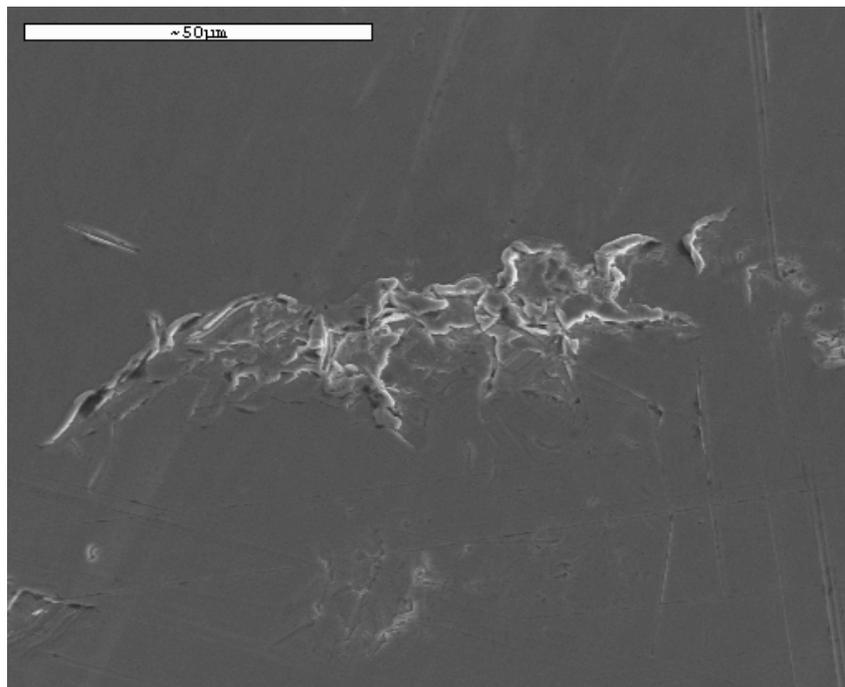
Figure 4-14 Example of surface fatigue. Radial direction is vertical.

From the SEM scans of the electroless nickel metal coated sample, it could be seen that, in general, the wear surface was very smooth. The SEM scans distinctly showed two different types of wear scars; pitting and flaking shown in Figure 4-14 and abrasive wear seen at A in Figure 4-15.

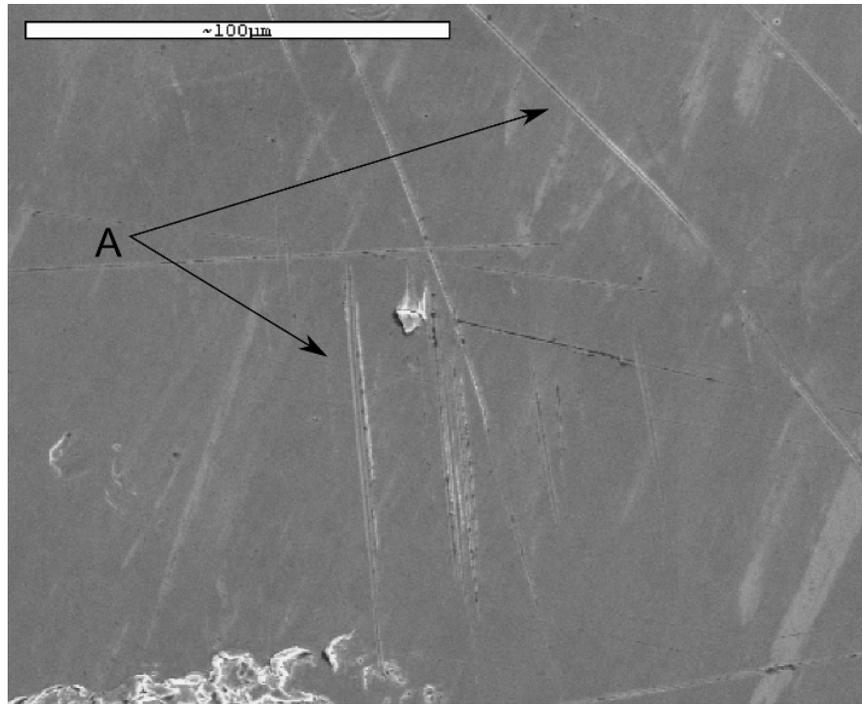
Figure 4-15 Example of abrasion A) radial abrasive wear scars. Radial direction is vertical.

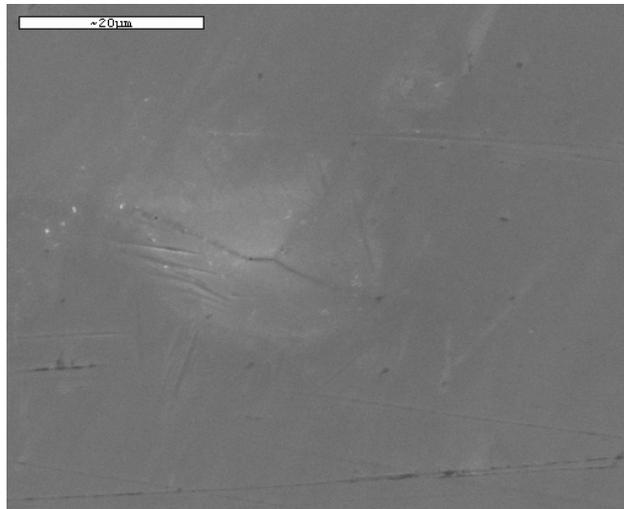
Figure 4-16 Possible delimitation. Radial direction is vertical.

On the electroless nickel SEM sample there were no areas found where the wear had penetrated the coating. The SEM x-ray analysis system has a penetration depth of one micrometer and the aluminum substrate never showed through the coating indicating that the coating is at least one micrometer thick. Note that the original coating thickness was approximately 0.001 inches or 25 micrometers thick. Although the wear never penetrated the coating Figure 4-16 shows possible delimitation of the coating. If wear were to continue this could become a severe problem.

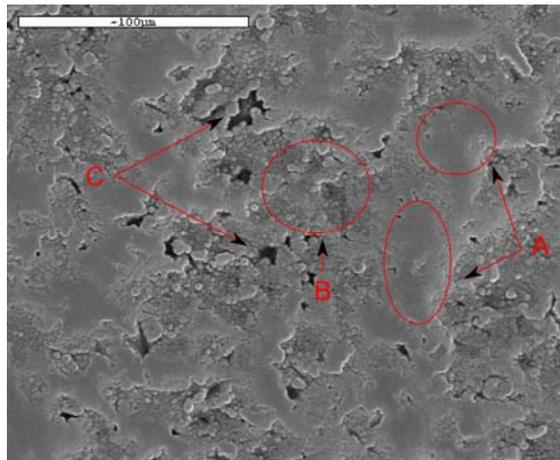
Figure 4-17 Area of high wear A) worn area B) Rough low area C) pits in coating. Radial direction is horizontal.

The scans from the hard chrome coating were very different from the other SEM scans. The hard chrome surface (see Figure 4-17) is very rough compared to the other coatings even in areas of high wear. The surface also had many holes that seemed relatively deep. As seen in Figure 4-17 and Figure 4-18 the visible effects of wear are apparent where the asperity peaks have been worn. In the areas of high wear, only the valleys have the original surface topology. Also, there were no abrasive scars on the surface.

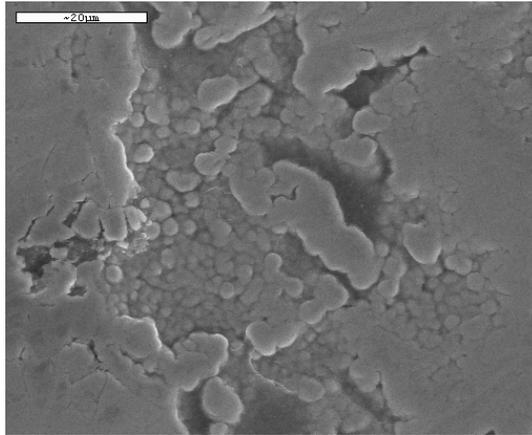
Figure 4-18 No visible abrasive or surface fatigue wear scars. Radial direction is horizontal.

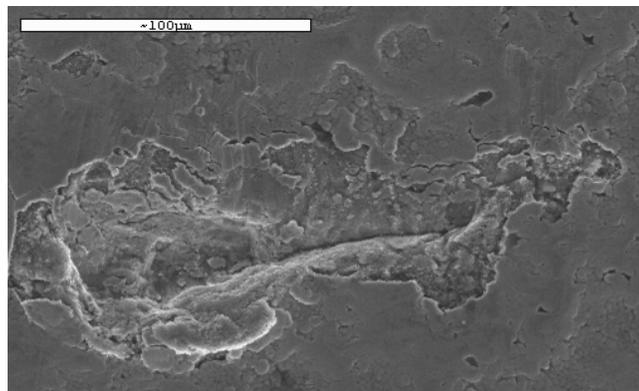
Figure 4-19 Large particle lost due to surface defect. Radial direction is horizontal.

Figure 4-19 shows where a sizeable particle was removed. Although a large particle was removed, only one of these wear scars of was found. Also in this case the particle lost was a piece of the coating as well as a piece of the substrate. The edges of the coating can be seen where coating came off the substrate. It is believed that this particle was a due to a surface defect.
