A Study of the Cause of Failure of Rotationally Molded, High-Density Polyethylene, Sodium Hypochlorite Storage Tanks

A Study of the Failure Mechanisms in Rotational Molded,
High Density Cross-Linked Polyethylene,
Sodium Hypochlorite Storage Tanks

A thesis submitted to the faculty of
Brigham Young University
in partial fulfillment of the requirements for the degree of
Master of Science

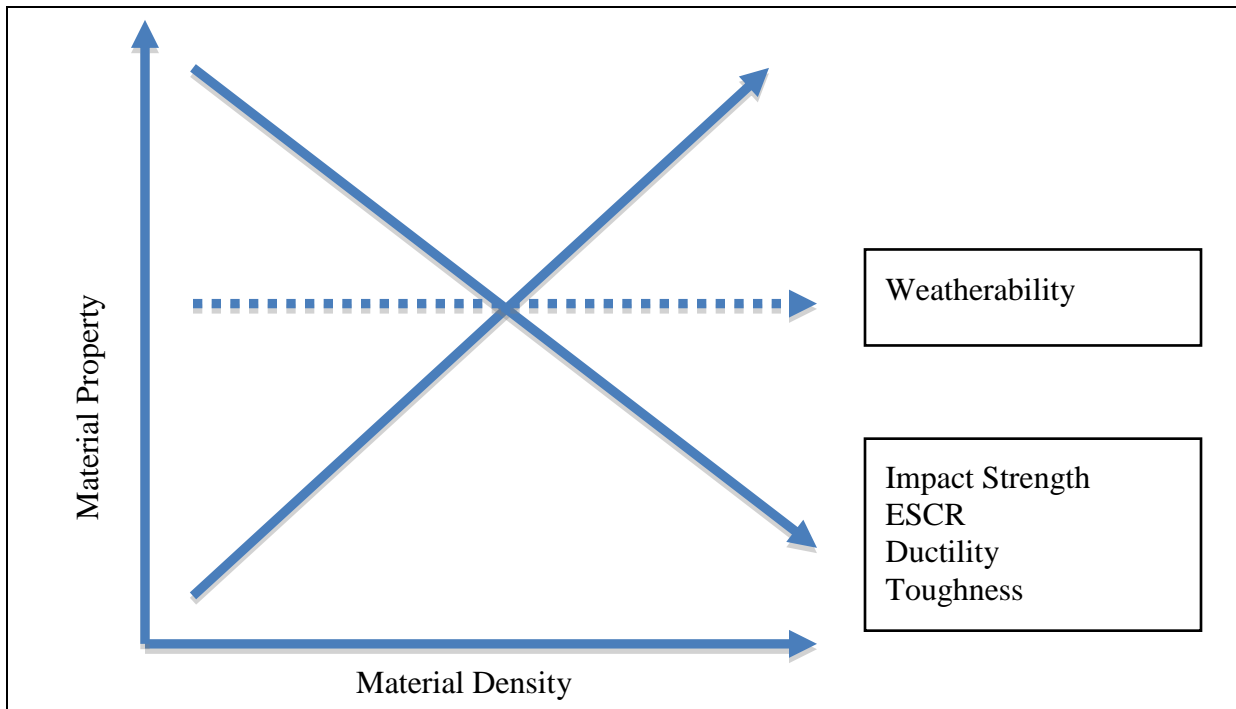
density, properties such as impact strength, ductility, toughness, and Environmental Stress Crack Resistance are compromised. Figure 2-1 illustrates the relationship between material density and key properties.

Figure 2-1 General Effect of Material Density on the Properties of Polyethylene

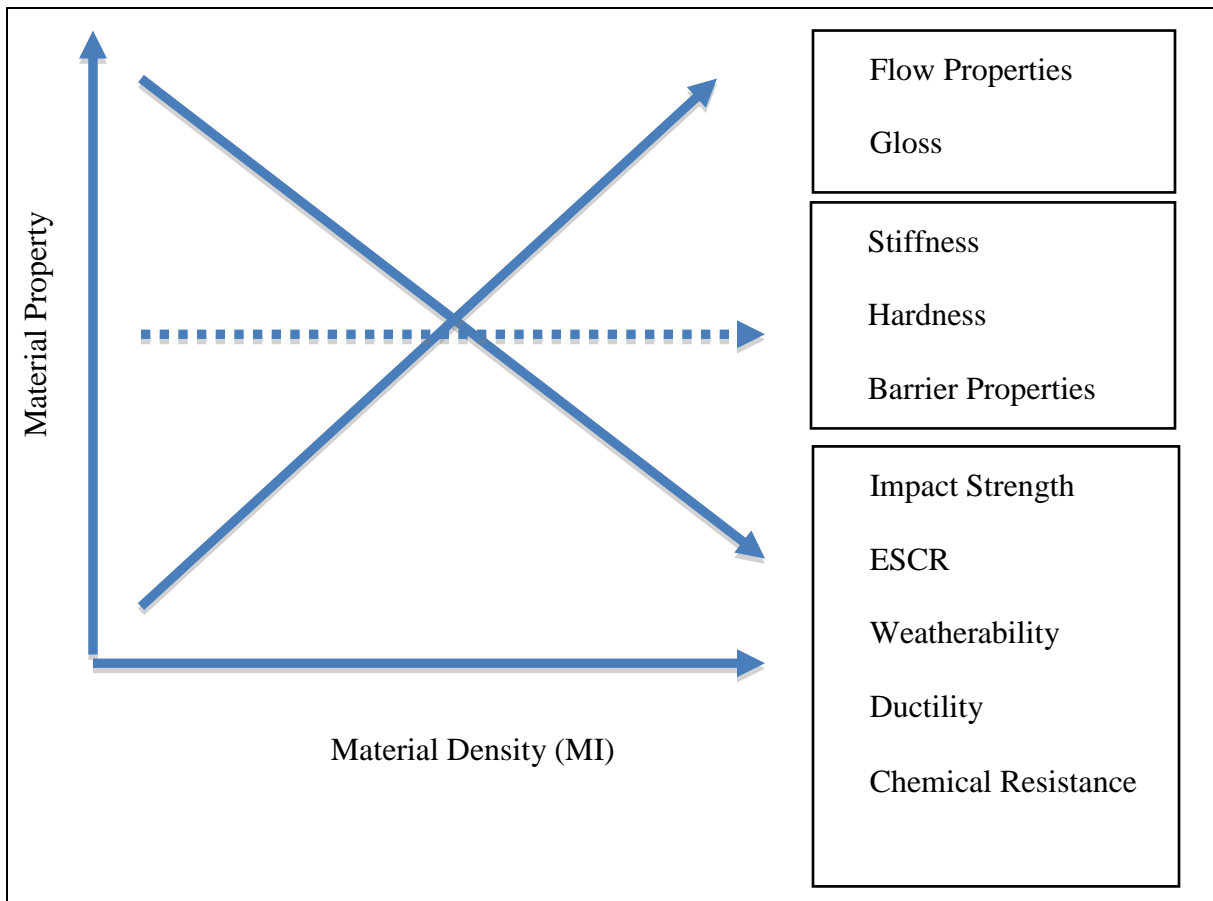
As melt index increases, the moldability of the material improves allowing the material to reproduce fine surface detail in a mold. However, as Figure 2-2 shows, properties such as impact strength, ESCR, weatherability, and chemical resistance will decrease as the melt index increases.

Figure 2-2 General Effect of Melt Index on the Properties of Polyethylene

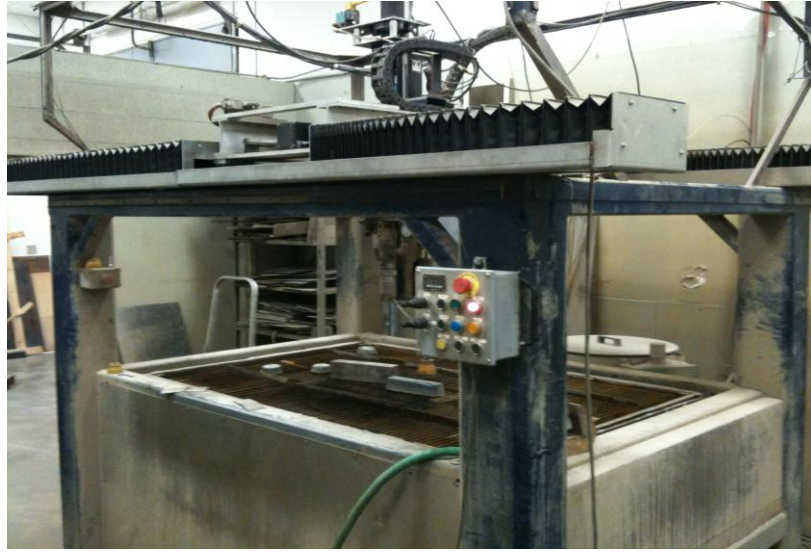
The cutting process included two separate parts and cuts: (1) cutting the initial shape of the dog-bone tension bar. This is done by cutting the shape of the dog-bone tension bar through the entire wall thickness of the tank sq. ft. section. (2) Cutting multiple (4-6) dog bone tension bars throughout the wall thickness of the first cut (accomplished by cutting multiple cross-sectional cuts throughout the wall thickness of the first cut, the initial dog bone tension bar). These two cuts, done to dimension, gave an adequate number of samples from each tank wall to be tested.

Figure 3-1 Water Jet Cutter Machine

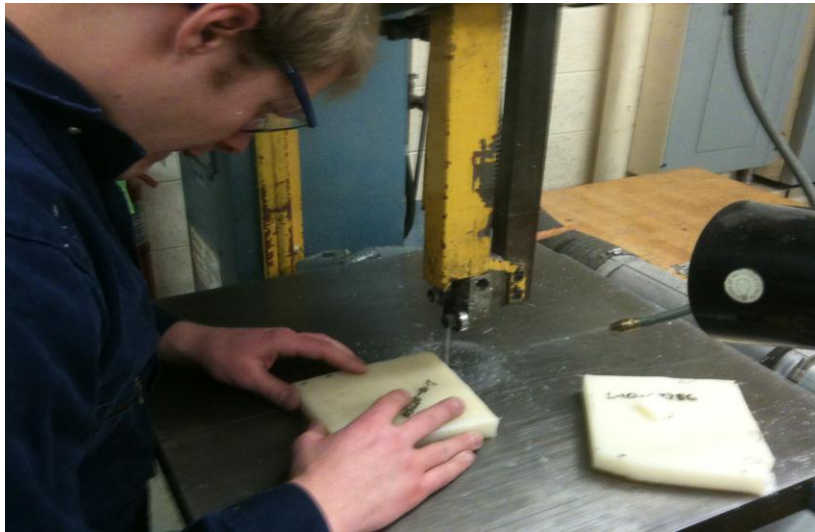
Since the bandsaw lacked automated tools and processes, the quality of the samples from the bandsaw was initially compromised as flash, rough surfaces, and irregularities were common. To create the needed surface finish for the spectroscopy, polishing was needed.

Figure 3-3 Bandsaw Cutting Samples

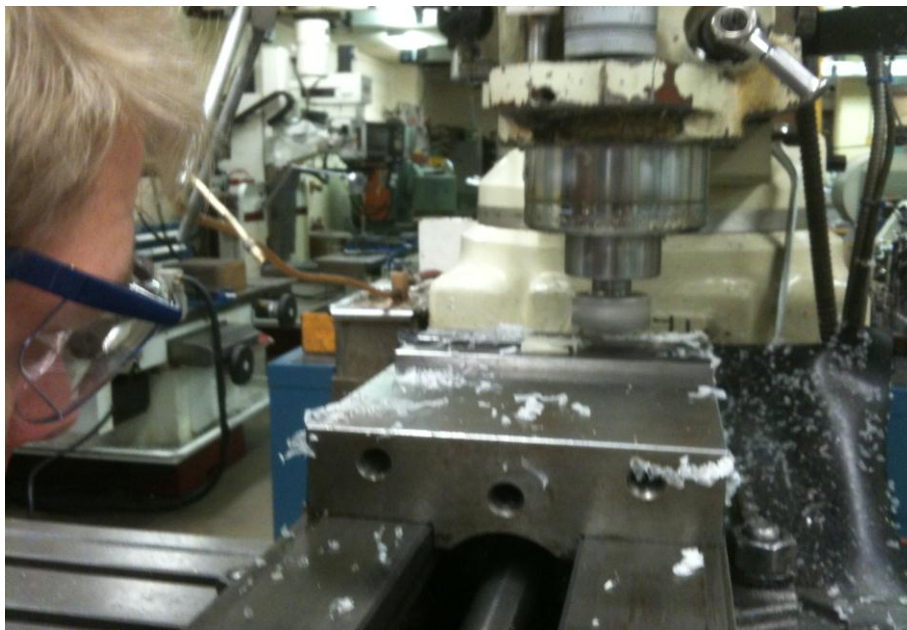
Once the samples were cut to roughly the desired dimension (0.25" x 0.25" x "tank wall thickness") by the bandsaw, the samples were moved to the mill where flash was removed, rough surfaces made smooth, and irregularities made even. If the samples were properly mounted and the angle of cut perfectly calibrated, the samples were cut to exact dimension.

Figure 3-4 Mill Polishing Samples

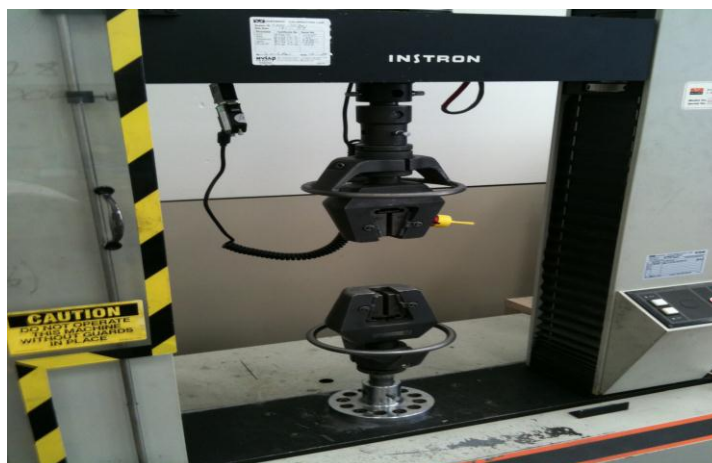
Figure 3-5 Instron Tension Machine Used for Mechanical Testing

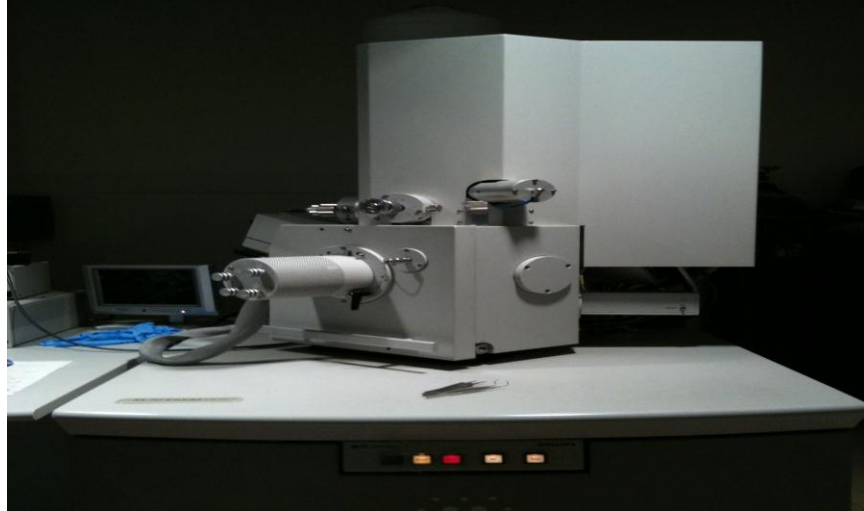
Figure 3-6 SEM-EDX Used for Chemical Testing

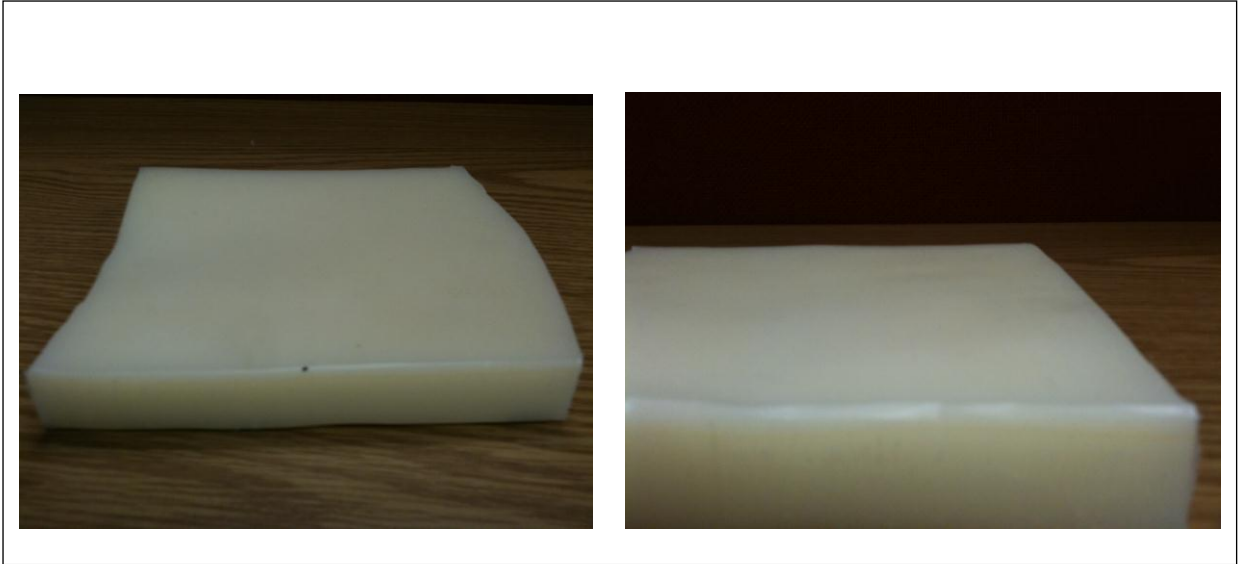
The virgin PE samples (Figure 4-2) do not show visible surface defects attributable to chemical oxidation or cyclic stress – only minor scratches from handling, testing, etc.

Figure 4-2 Interior Surfaces of Virgin Samples Showing no Surface Defects

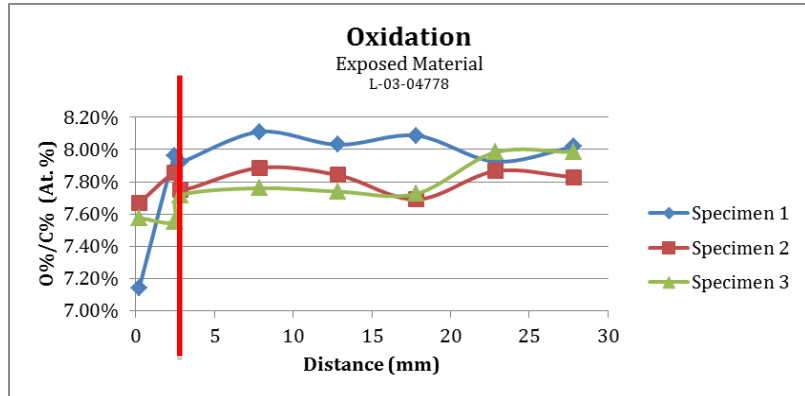
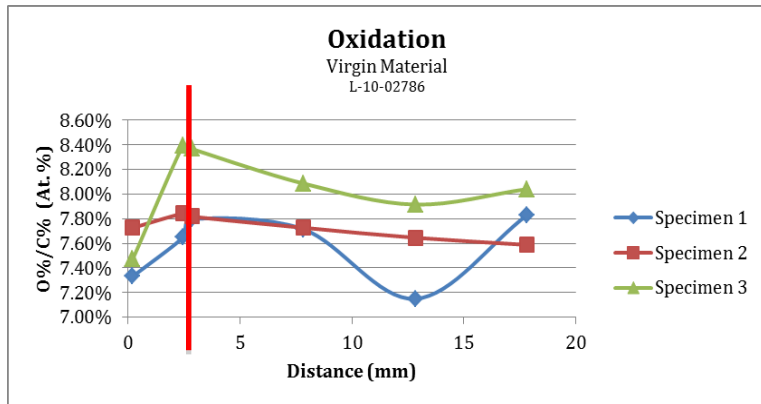
Figure 4-7 EDS O/C Ratio (Atomic Percentage)

Third, each specimen, virgin and exposed, follows a similar trend in that the O/C ratios increase from the OR to the start of the high-density cross-linked polyethylene. This occurrence shows the difference of chemical resistance in the two separate materials. At the change in material, the oxidation generally increases not typically decreasing until the middle layers of the specimens.

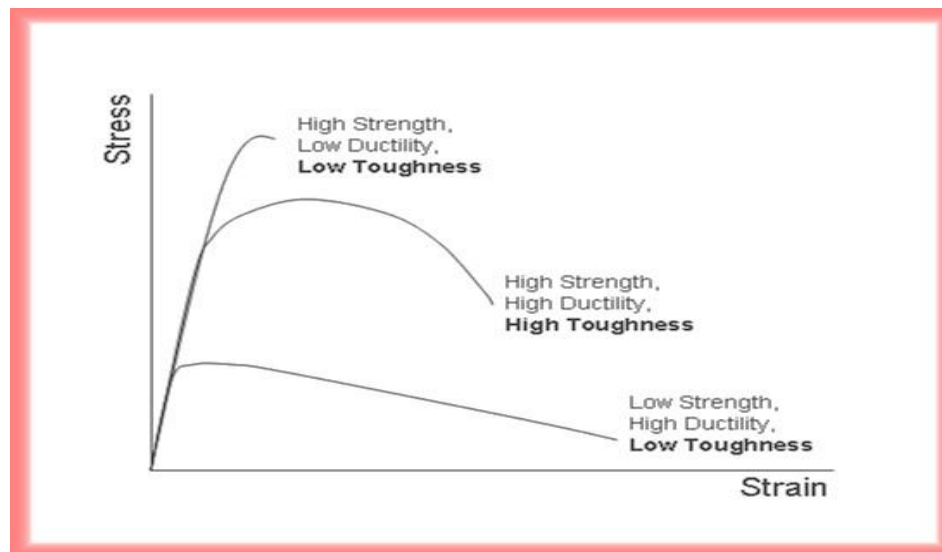
imposed stress. For engineering materials there are only two modes of failure, ductile and brittle. In general, the main difference between brittle and ductile fracture can be attributed to the amount of plastic deformation that the material undergoes before fracture occurs. Ductile materials demonstrate large amounts of plastic deformation while brittle materials show little or no plastic deformation before fracture. A tensile stress-strain curve represents the degree of plastic deformation exhibited by both brittle and ductile materials before fracture. The graphical representation of the tensile stress-strain curves illustrates the stress-strain behavior for ductile materials loaded to fracture. An analysis and comparison between the stress-strain curve in Figure 4-8 and Figure 4-9 supports the argument that the examined samples, virgin and exposed, are materials that have high strength, high ductility, and high toughness. Figure 4-8 (Roylance, 2001) shows how the stress-strain curve affects the mechanical properties of a material. Figure 4-9 is a typical stress-strain curve for the examine samples, virgin and exposed.

Figure 4-8 Stress-Strain Curve and Associated Mechanical Properties

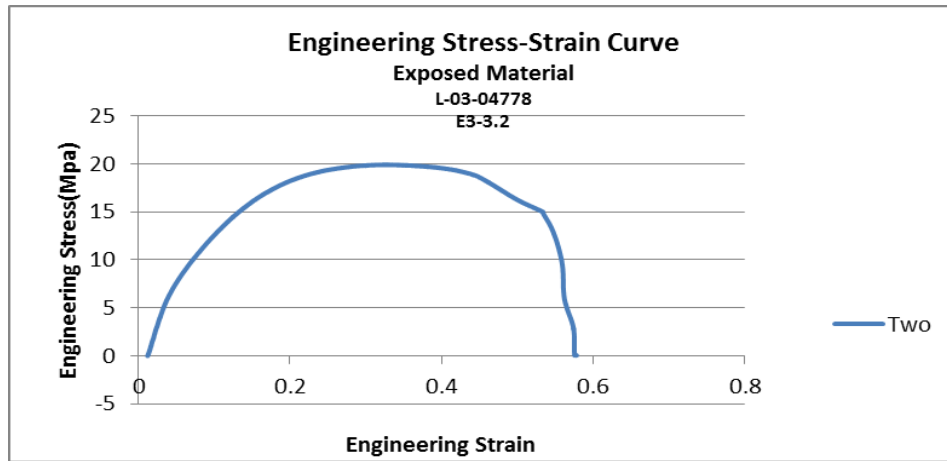
Figure 4-9 A typical Stress-Strain Curve for Examined Samples Showing that the Material has High Ductility

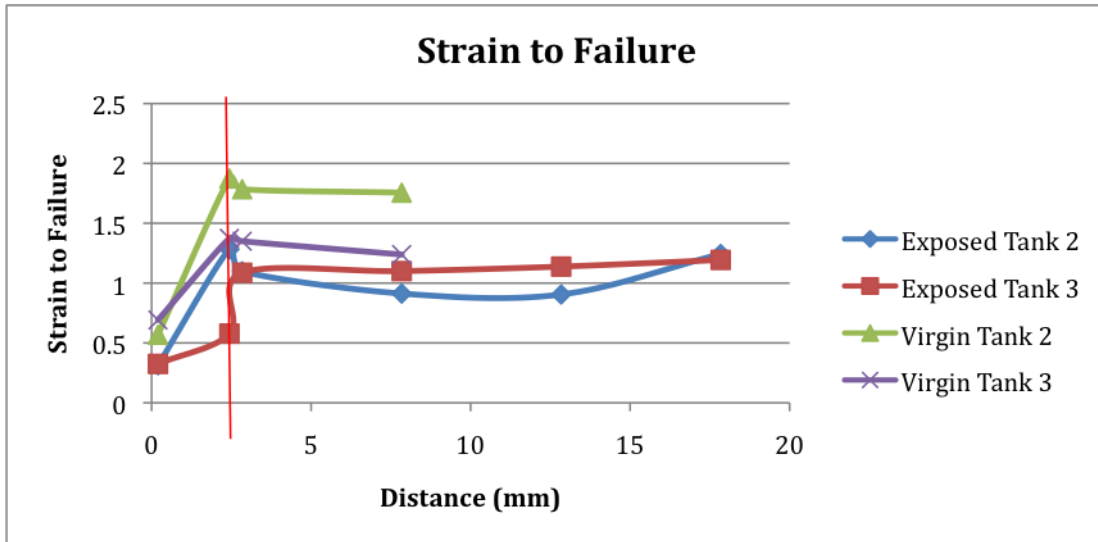
Second, the strain to failure curves (Figure 4-10) indicates that there is less ductility in the inner layers of the samples, virgin and exposed. Limited ductility, in the form of stretching, was found primarily within the interior surface. Less ductility means the material is more likely to deform under tensile stress. A loss of ductility, specifically in plastic, translates to less toughness and higher strength. This high strength makes the material more brittle. As a result, the material is more prone to fracture.

Figure 4-10 Less Ductility in Inner Layers of Material

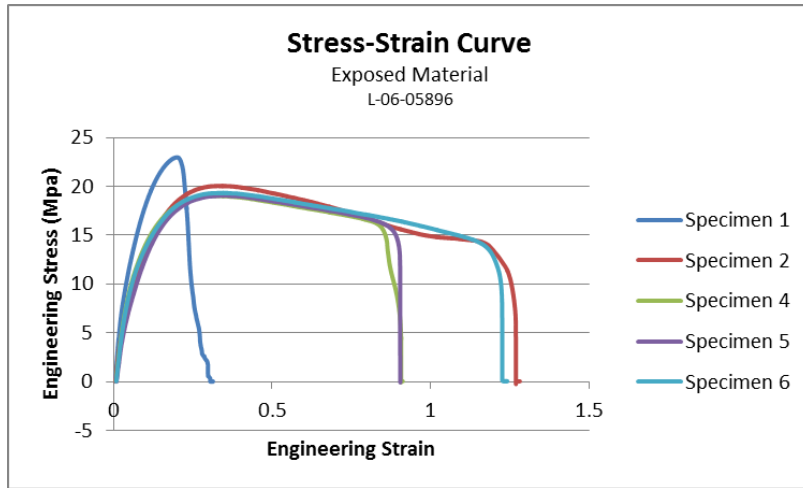
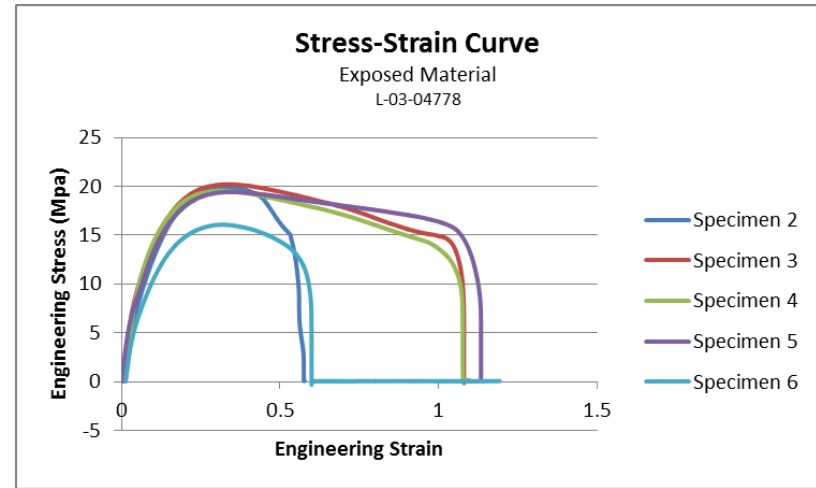
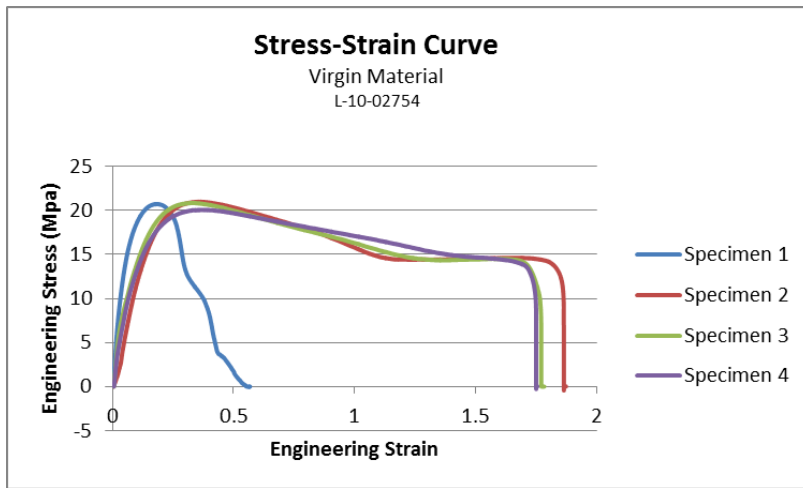
First, the area underneath the curve of the innermost specimen layer is significantly smaller than the remaining outer specimen layers. The area underneath the stress-strain curve is toughness. Therefore, if the area underneath the curve for the innermost layers is smaller than the remaining curves, the innermost layer must be less tough. This means that this layer absorbs less energy before it breaks. PE sodium hypochlorite storage tanks undergo multiple stresses and strains while in service. The inner layer being less tough than the outer layers suggests that crack initiation and propagation is more likely to begin at that weaker point and at an earlier time than the outer layers.

Second, the ability of a plastic to deform is what keeps a part from breaking. The initial modulus of all the specimens is steep. If the slope is steep, then the sample has a high tensile modulus, which means it resists deformation. Although this material resists deformation well, it has an adverse effect in that it lacks the flexibility needed to deform without breaking. PE sodium hypochlorite tanks are constantly expanding and contracting as tank load and unload liquid. If the material of the tank is unable to flex and bend, the tank wall will eventually break.

Figure 4-12 Stress-strain Curves for Virgin and Exposed Material

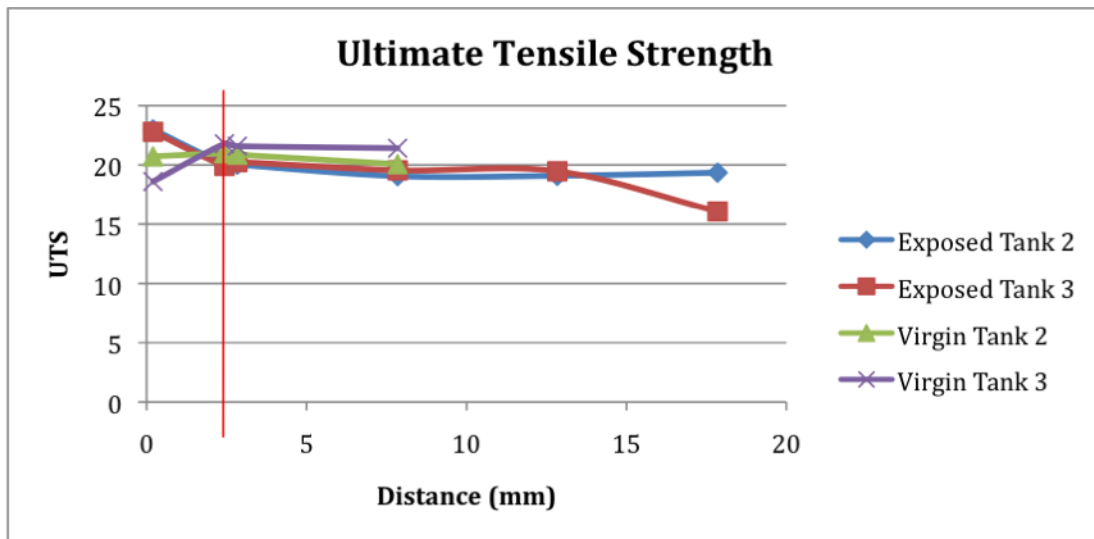
The tensile strength data (Figure 4-13) shows no clear trends across the sample set. The percent change for all the tensile data was minimal. With such small changes, variation masks any trends. The small degree of change in tensile strength is not surprising. A suspected reason for the absence of clear trends in oxidation/tensile strength studies is that there may be complex differing mechanisms behind oxidative tensile failure. Crosslinking and accompanying stiffening (Lewis, 2004) may compete against chain scission and the resultant loss in molecular weight. Also, as oxidation is typically surface intensive, properties that depend on surface fracture mechanics like elongation will naturally show more change during exposure than will a property that focuses on integrated strength of the sample bulk like tensile strength.

Figure 4-13 Ultimate Tensile Strength in Samples Show no Significant Percent Change that Indicates a Trend
